Investigative Report

2022-0407

Officer Involved Critical Incident - 1783 Penfield Road, Columbus, OH (L)

Investigative Activity: Scene Documentation

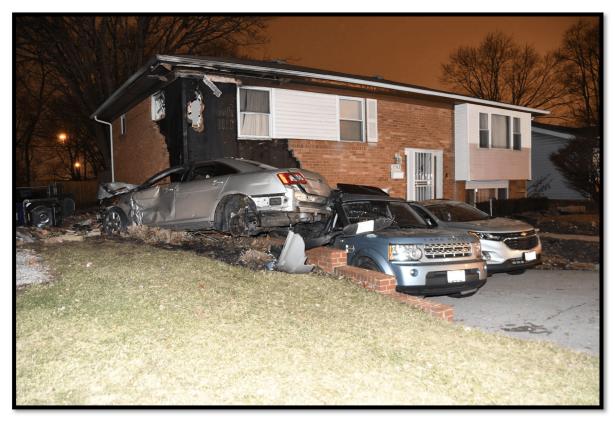
SA Holcomb arrived on scene at 0456 hours. The scene was photographed as it was upon arrival. A 2012, silver, four-door Ford Taurus (JNV5161) was sitting in the middle of two yards, 1789 Penfield and 1783 Penfield Road. The vehicle had extensive front end damage and the interior of the car had major fire damage. The front windshield was completely missing. Standing water was observed in the front floorboards of the vehicle. The residence of 1783 Penfield Road was closer to the final location of the Taurus and was described as a split-level style home with a garage underneath and sunken driveway with a retaining wall. The south side of the garage area and a Land Rover SUV in the driveway had visible damage from the impact of the vehicle Ball was driving. The second floor had a hole in the siding and agents were able to see inside of what appeared to be a bedroom. 1789 Penfield, a ranch style home, had visible damage to the north side of the structure near the garage door. Bricks from the houses were scattered throughout the side yards.

(Ford Taurus located at 1783 Penfield Road)

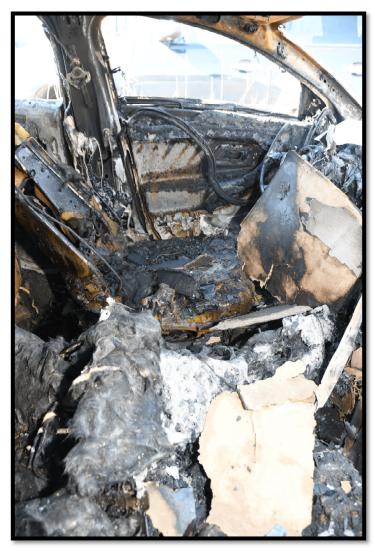
The vehicle had been covered up with a large tarp in an attempt to protect it from the outside elements. All doors were unable to be opened except the rear passenger side door. The truck and the front driver side door were forced open in an attempt to further examine the vehicle. The interior of the vehicle had extensive fire damage and no items were located in the vehicle due to the fire damage. The Ohio State Highway Patrol (OSP) located the vehicle's black-box and removed it to be analyzed. OSP stated there was no data on the black-box from the crash on February 24th.

(Fire damage to the interior front seats of the vehicle)
