**Ohio Bureau of Criminal Identification & Investigation**  
**INVESTIGATIVE REPORT**

**12/10/2012 SHOOTING INCIDENT RECONSTRUCTION: CPD CRUISER #217**

<b>File Number: CS-18-12-82-1488</b>	<b>File Title: Timothy R. Russell (S) &amp; Malissa A. Williams (S)</b>
<b>Case Agent: Daniel Winterich</b>	<b>Authoring Agent: Daniel Winterich</b> DRW
<b>Date of Report: 12/20/12</b>	<b>Exhibit #: 4</b>
<b>Investigative Activity: Officer Involved Shooting</b>	<b>Supervisor Approval: SAS Dennis Sweet</b>

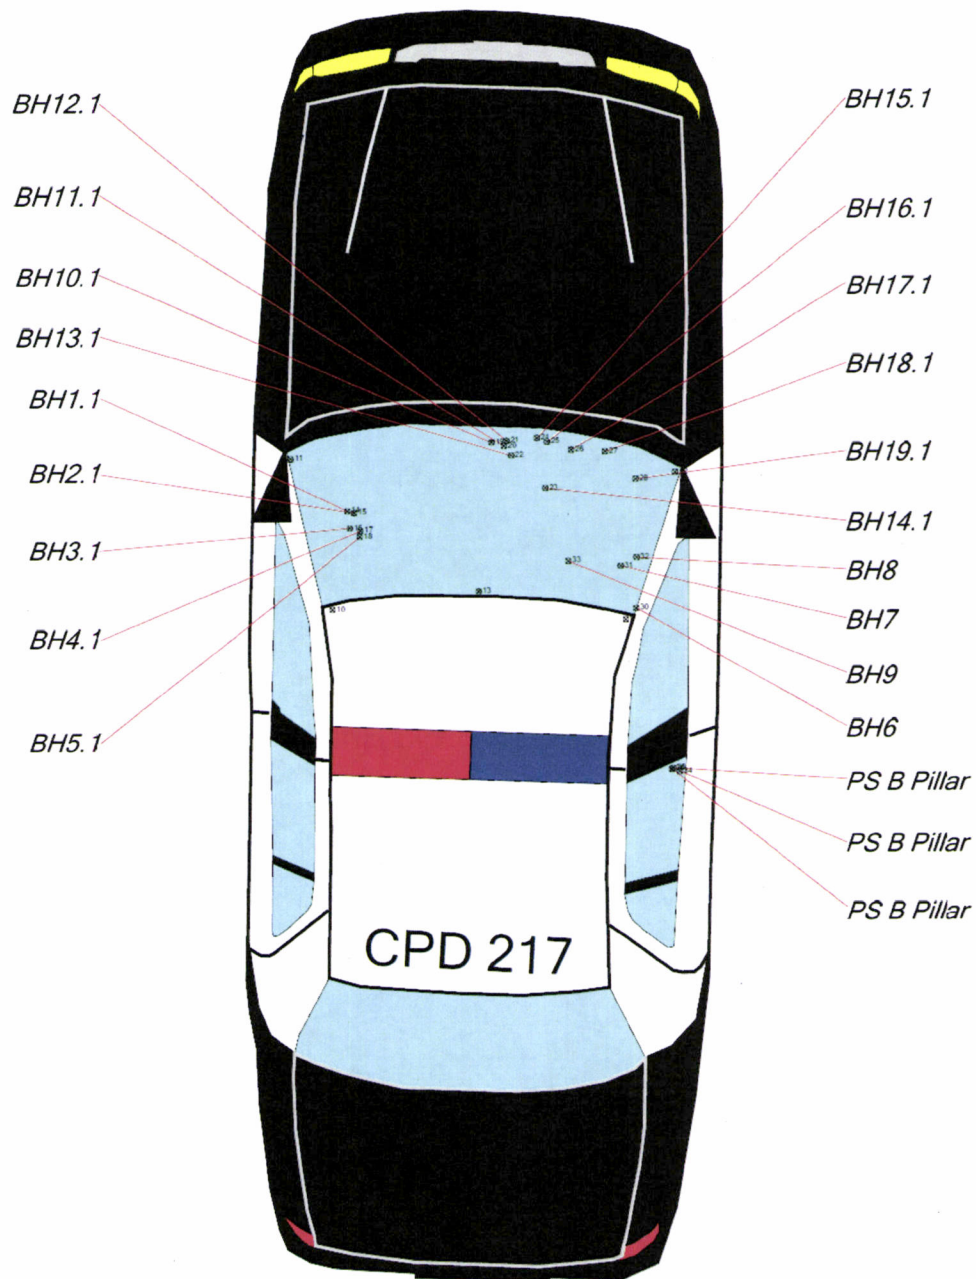
Figure 1 (bullet holes mapped with total station)

After the exterior was examined, the bullet holes were labeled and mapped. All bullet holes were photographed via macro photography. Each bullet hole or bullet strike was labeled with "BH" followed by a number (e.g. "BH1" for an entry or "BH1.1" for an exit). These numbers do not indicate shot sequence but were arbitrarily selected. There were a minimum of nineteen bullet holes found on the vehicle (see Figure 1). Five bullet holes were concentrated on the driver's side windshield, ten were concentrated on the passenger's side windshield, and four were on the passenger's side front doorframe and interior. The cone fractures on the bullet holes on the windshield and the shapes of the other bullet holes indicate that all of these shots were fired from the inside outward or from the outside through the open passenger's side door. None of the bullet holes had two impact points so the trajectories could not be accurately determined with trajectory rods.

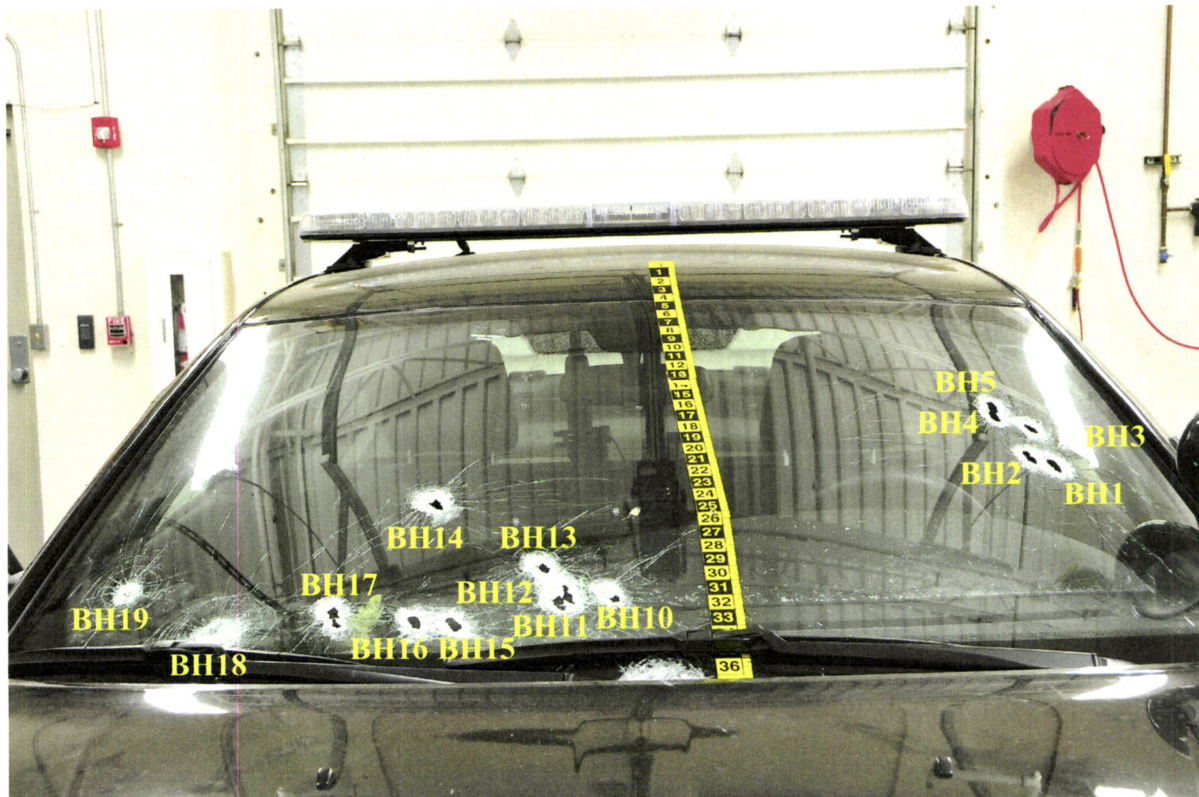
**Figure 2 (BHs 1-5, 10-19)**

There were fifteen bullet holes found on the windshield (see Figure 2). The cone fractures indicate that these shots were all fired from the inside outward. The following data was collected from these holes:

BH1	Driver's side windshield	N/A	N/A	Outward through windshield, from 5 o'clock to 11.
BH2	Driver's side windshield	N/A	N/A	Outward through windshield, from 5 o'clock to 11.
BH3	Driver's side windshield	N/A	N/A	Outward through windshield, from 5 o'clock to 11.
BH4	Driver's side windshield	N/A	N/A	Outward through windshield, from 5 o'clock to 11.
BH5	Driver's side windshield	N/A	N/A	Outward through windshield, from 5 o'clock to 11.
BH10	Passenger's side windshield	N/A	N/A	Outward through windshield, from 5 o'clock to 11.
BH11	Passenger's side windshield	N/A	N/A	Outward through windshield, from 5 o'clock to 11.
BH12	Passenger's side windshield	N/A	N/A	Outward through windshield, from 5 o'clock to 11.
BH13	Passenger's side windshield	N/A	N/A	Outward through windshield, from 5 o'clock to 11.
BH14	Passenger's side windshield	N/A	N/A	Outward through windshield, from 5 o'clock to 11.
BH15	Passenger's side windshield	N/A	N/A	Outward through windshield, from 5 o'clock to 11.

BH16	Passenger's side windshield	N/A	N/A	Outward through windshield, from 5 o'clock to 11.
BH17	Passenger's side windshield	N/A	N/A	Outward through windshield, from 5 o'clock to 11.
BH18	Passenger's side windshield	N/A	N/A	Ricochet, did not penetrate glass.
BH19	Passenger's side windshield	N/A	N/A	Slight perforation of windshield outward.

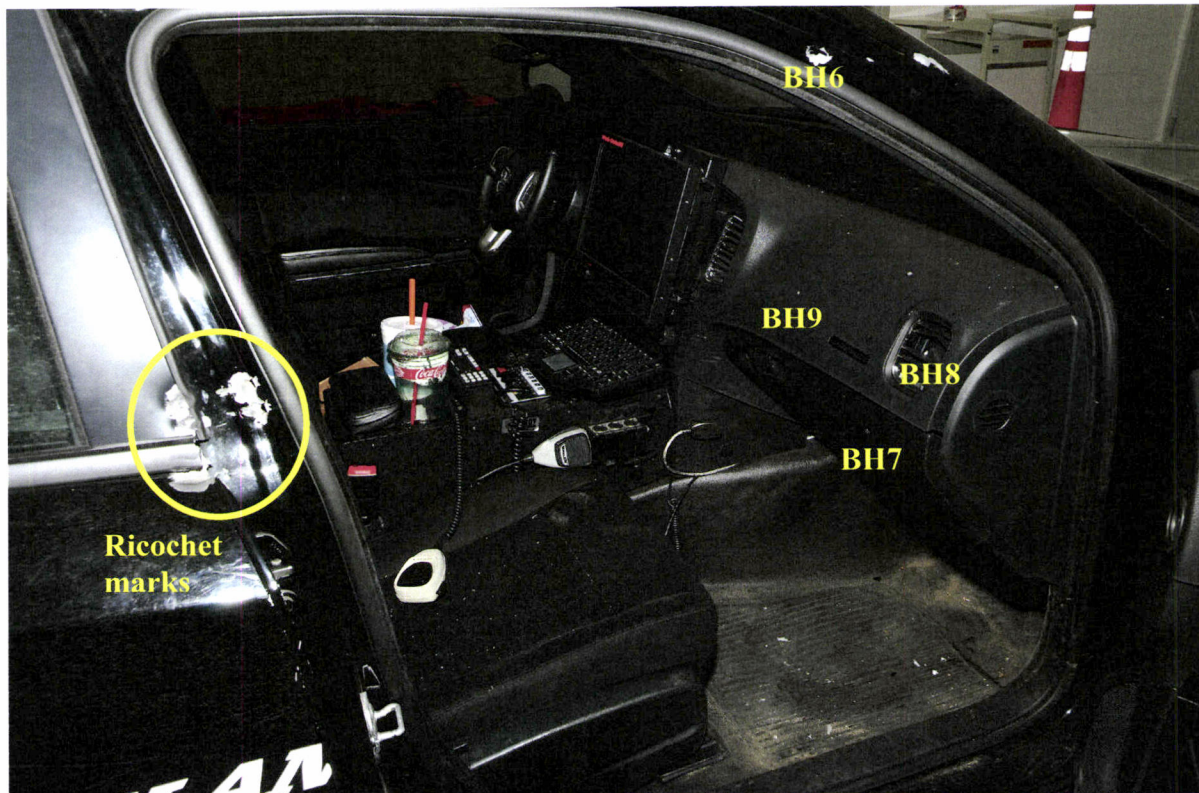
Figure 3 (BHs 6-9)

There were four bullet holes on the passenger's side front doorframe and interior (see Figure 3). These shots were all fired with the door open and into the vehicle. There were also five ricochet marks on the passenger's side B-pillar (see Figure 3). The door was open when these were fired. Four of these marks are in line with each other and could have been caused by two bullets. These marks were not numbered because they most likely were related to bullets that went through the windshield but could not be lined up accurately. The following data was collected from these holes:

Bullet Hole #	Location	Vertical Impact Angle	Horizontal Impact Angle	Direction of Travel*
BH6	Passenger's side A-pillar	N/A	N/A	Door opened when fired and penetrated A-pillar.
BH7	Glovebox	N/A	N/A	5 o'clock to 11, penetrated glovebox.
BH8	Passenger's side air vent	N/A	N/A	5 o'clock to 11, penetrated into air vent.
BH9	Passenger's side dashboard	N/A	N/A	5 o'clock to 11, penetrated dashboard.
