Ohio Bureau of Criminal Identification & Investigation
INVESTIGATIVE REPORT

12/4/2012 SHOOTING INCIDENT RECONSTRUCTION: CHEVROLET MALIBU

File Number: CS-18-12-82-1488	File Title: Timothy R. Russell (S) & Malissa A. Williams (S)
Case Agent: Daniel Winterich	Authoring Agent: Daniel Winterich DRW
Date of Report: 12/17/12	Exhibit #: 2
Investigative Activity: Officer Involved Shooting	Supervisor Approval: SAS Dennis Sweet

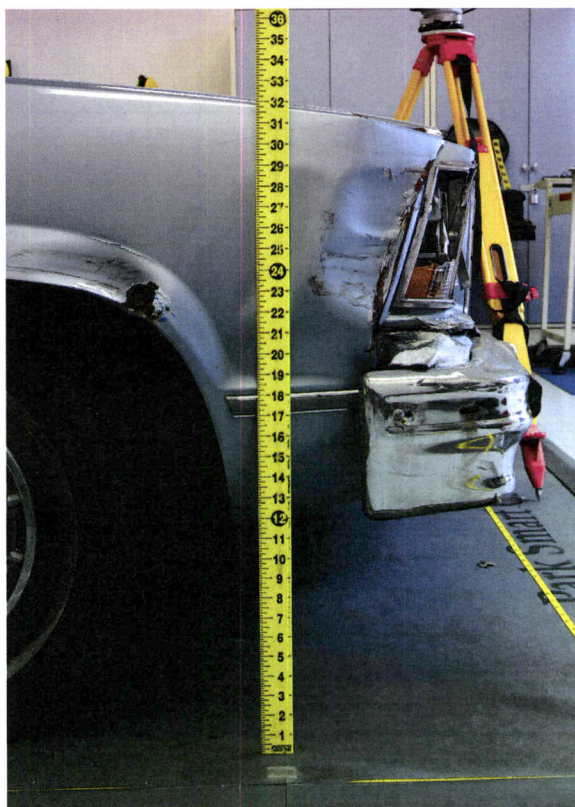
Figure 1 (pass. front fender damage)

Examination of the exterior revealed body damage to the passenger's front end and both rear quarter panels (see Figures 1, 2, 3, and 4). Within the damage to the front fender was white and blue transfer material that was consistent with the decals found on the CPD cruisers. A sample was collected. Rubber transfer material was also found on the driver's side rear bumper near the quarter panel damage.

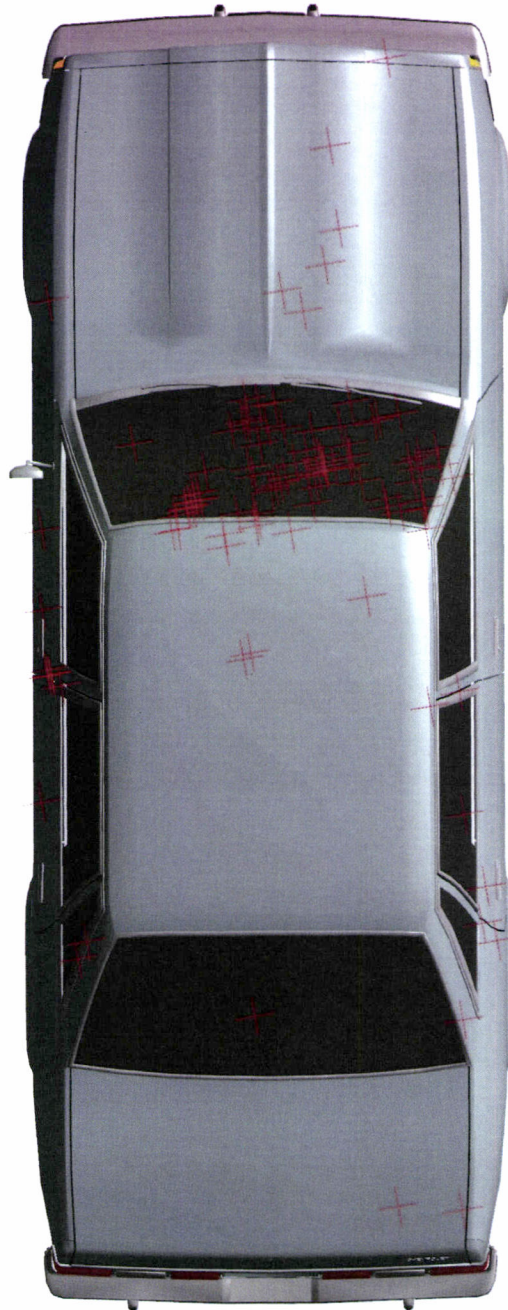
Figure 5 (bullet holes mapped with total station)

After the exterior was examined, the bullet holes were labeled and mapped. All bullet holes were photographed via macro photography. Each bullet hole or bullet strike was labeled with "BH" followed by a number (e.g. "BH1"). These numbers do not indicate shot sequence but were arbitrarily selected with numbering beginning at the passenger's side front end and proceeding counter-clockwise around the vehicle. A minimum of ninety-two bullet holes were found on the exterior of the vehicle (see Figure 5). An additional five bullet holes were found

within the interior of the vehicle that could be classified as entry holes and these were bullets that most likely traveled through open windows and struck a surface within the interior. Not every bullet hole had two impact points therefore the trajectory could not be accurately determined for every bullet hole using trajectory rods. The trajectory was determined for thirty of the bullet holes. All the holes that were examined except one (BH78E) were fired from outside the vehicle inward. BH78E which was located on the rear window was most likely a shot exiting the interior from a bullet that entered through the windshield.

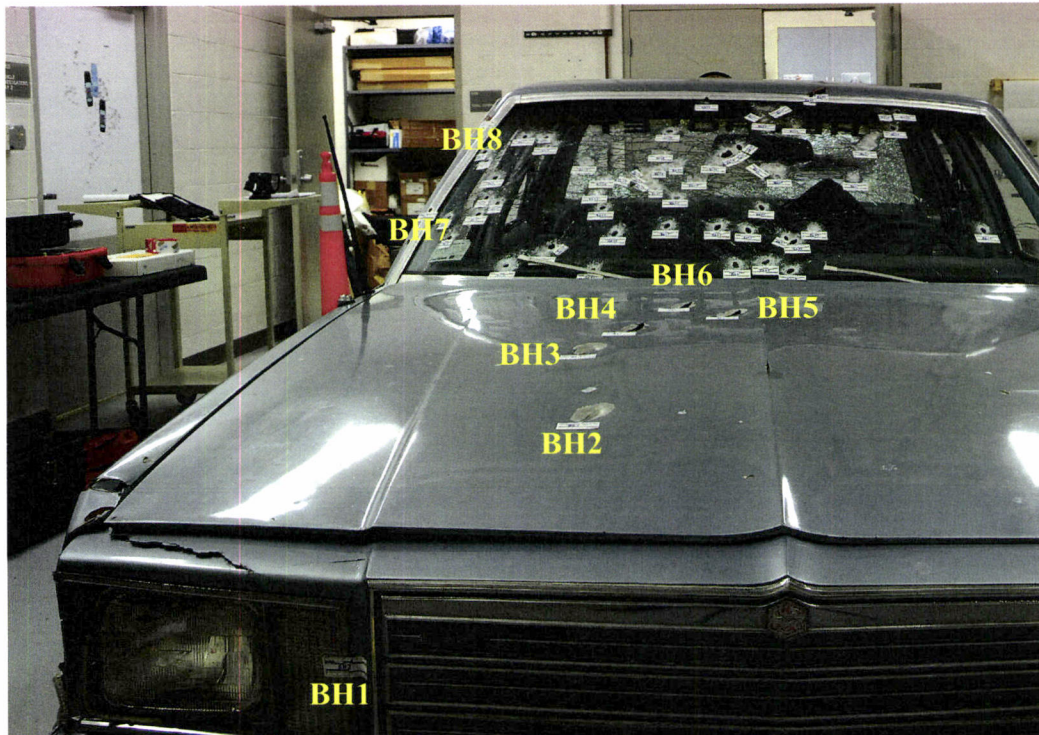
Figure 6 (BHs 1-8)

There were eight bullet holes found on the passenger's side front end, hood, and passenger's side A-pillar (see Figure 6). The following data was collected from these holes:

Bullet Hole #	Location	Vertical Impact Angle	Horizontal Impact Angle*	Direction of Travel**
BH1	Passenger's side front end near fog lamp	-15°	106°	Downward, from 1 o'clock to 7, penetrated into engine compartment.
BH2	Passenger's side hood	-3°	112°	Downward, from 1 o'clock to 7, ricochet.
BH3	Passenger's side hood	-10°	114°	Downward, from 1 o'clock to 7, ricochet.
BH4	Passenger's side hood	-9°	115°	Downward, from 1 o'clock to 7, penetrated into engine compartment.
BH5	Passenger's side hood	-10°	117°	Downward, from 1 o'clock to 7, penetrated into engine compartment.
BH6	Passenger's side hood	-10°	114°	Downward, from 1 o'clock to 7, penetrated into engine compartment.
BH7	Passenger's side A-pillar	-21°	115°	Downward, from 2 o'clock to 8, perforated A-pillar into passenger compartment.
BH8	Passenger's side A-pillar	-22°	119°	Downward, from 2 o'clock to 8, penetrates into A-pillar.

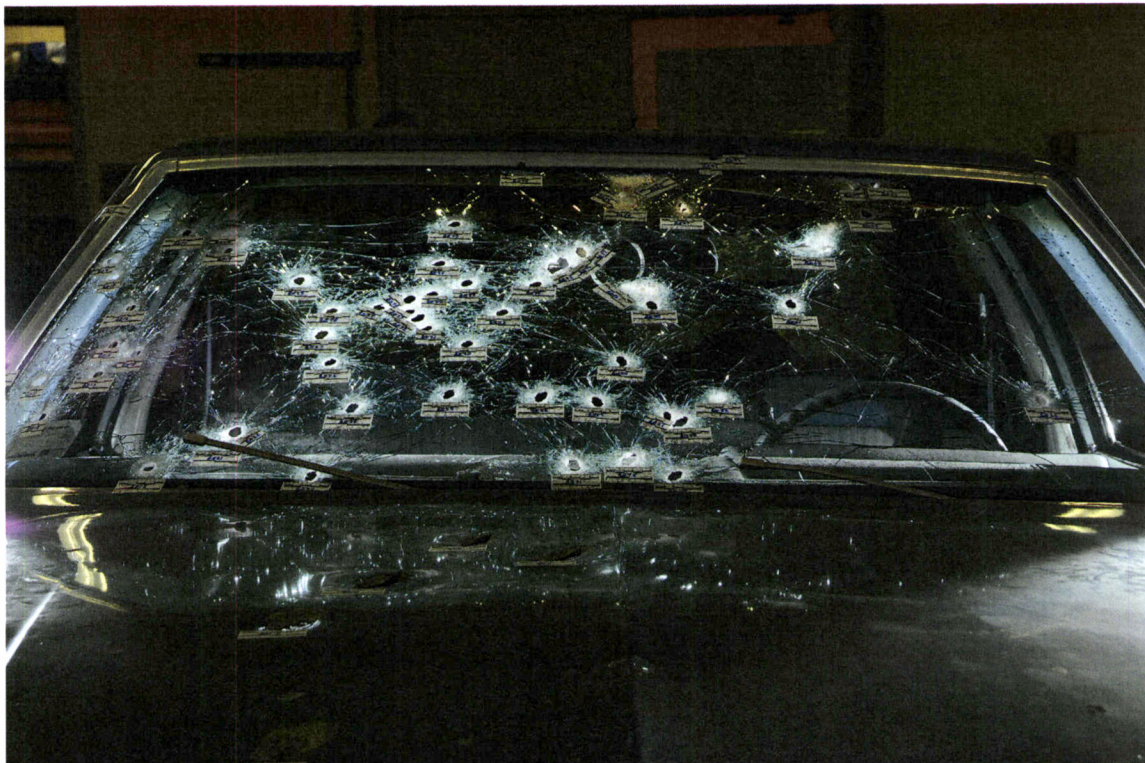
Figure 7 (BHs 9-66)

There were fifty-eight bullet holes in the windshield (see Figure 7). The cone fractures of these holes indicated that they were all fired from the exterior of the vehicle inward. Most of the holes were concentrated on the passenger's side of the windshield. The following data was collected from these holes:

Bullet Hole #	Location	Vertical Impact Angle	Horizontal Impact Angle*	Direction of Travel**
BH9	Passenger's side windshield	N/A	N/A	1 o'clock to 7 into passenger compartment.
BH10	Passenger's side windshield	N/A	N/A	1 o'clock to 7 into passenger compartment.
BH11	Passenger's side windshield	N/A	N/A	1 o'clock to 7 into passenger compartment.
BH12	Passenger's side windshield	N/A	N/A	1 o'clock to 7 into passenger compartment.
BH13	Passenger's side windshield	N/A	N/A	1 o'clock to 7 into passenger compartment.
BH14	Passenger's side windshield	N/A	N/A	1 o'clock to 7 into passenger compartment.

BH15	Passenger's side windshield	N/A	N/A	1 o'clock to 7 into passenger compartment.
BH16	Passenger's side windshield	N/A	N/A	1 o'clock to 7 into passenger compartment.
BH17	Passenger's side windshield	N/A	N/A	1 o'clock to 7 into passenger compartment.
BH18	Passenger's side windshield	-29°	120°	Downward, 1 o'clock to 7, penetrated dashboard.
BH19	Passenger's side windshield	N/A	N/A	1 o'clock to 7 into passenger compartment.
BH20	Passenger's side windshield	N/A	N/A	1 o'clock to 7 into passenger compartment.
BH21	Passenger's side windshield	N/A	N/A	1 o'clock to 7 into passenger compartment.
BH22	Passenger's side windshield	-19°	130°	Downward, 2 o'clock to 8 into passenger compartment.
BH23	Passenger's side windshield	N/A	N/A	12 o'clock to 6 into passenger compartment.
BH24	Passenger's side windshield	-6°	106°	Downward, 1 o'clock to 7, perforated dashboard and then into passenger compartment.
BH25	Passenger's side windshield	N/A	N/A	1 o'clock to 7 into passenger compartment.

BH26	Passenger's side windshield	N/A	N/A	1 o'clock to 7 into passenger compartment.
BH27	Passenger's side windshield	N/A	N/A	1 o'clock to 7 into passenger compartment.
BH28	Passenger's side windshield	N/A	N/A	1 o'clock to 7 into passenger compartment.
BH29	Passenger's side windshield	N/A	N/A	1 o'clock to 7 into passenger compartment.
BH30	Passenger's side windshield	N/A	N/A	2 o'clock to 8 into passenger compartment.
BH31	Passenger's side windshield	N/A	N/A	2 o'clock to 8 into passenger compartment.
BH32	Passenger's side windshield	N/A	N/A	2 o'clock to 8 into passenger compartment.
BH33	Passenger's side windshield	N/A	N/A	2 o'clock to 8 into passenger compartment.
BH34	Passenger's side windshield	N/A	N/A	2 o'clock to 8 into passenger compartment.
BH35	Passenger's side windshield	N/A	N/A	2 o'clock to 8 into passenger compartment.
BH36	Passenger's side windshield	N/A	N/A	2 o'clock to 8 into passenger compartment.

BH37	Passenger's side windshield	N/A	N/A	2 o'clock to 8 into passenger compartment.
BH38	Passenger's side windshield	N/A	N/A	2 o'clock to 8 into passenger compartment.
BH39	Passenger's side windshield	-14°	123°	Downward, 2 o'clock to 8, perforated rearview mirror and into passenger compartment.
BH40	Passenger's side windshield	N/A	N/A	12 o'clock to 6 into headliner.
BH41	Passenger's side windshield	-1°	74°	Downward, from 11 o'clock to 5, perforated dashboard and into passenger compartment.
BH42	Passenger's side windshield	N/A	N/A	1 o'clock to 7 into passenger compartment.
BH43	Passenger's side windshield	N/A	N/A	1 o'clock to 7 into passenger compartment.
BH44	Passenger's side windshield	N/A	N/A	1 o'clock to 7 into passenger compartment.
BH45	Passenger's side windshield	N/A	N/A	11 o'clock to 5 into passenger compartment.
BH46	Passenger's side windshield	N/A	N/A	11 o'clock to 5 into passenger compartment.

BH47	Passenger's side windshield	N/A	N/A	11 o'clock to 5 into passenger compartment.
BH48	Driver's side windshield	-4°	120°	Downward, 2 o'clock to 8, penetrated dashboard into instrument panel.
BH49	Driver's side windshield	-14°	112°	Downward, 1 o'clock to 7, penetrated into dashboard.
BH50	Driver's side windshield	N/A	N/A	1 o'clock to 7 into passenger compartment.
BH51	Driver's side windshield	N/A	N/A	11 o'clock to 5 into passenger compartment.
BH52	Driver's side windshield	N/A	N/A	Ricochet off of glass.
BH53	Driver's side windshield	N/A	N/A	11 o'clock to 5 into passenger compartment.
BH54	Driver's side windshield	N/A	N/A	11 o'clock to 5 into passenger compartment.
BH55	Driver's side windshield	N/A	N/A	11 o'clock to 5 into passenger compartment.
BH56	Driver's side windshield	N/A	N/A	Ricochet off of glass.

BH57	Driver's side windshield	N/A	N/A	11 o'clock to 5 into passenger compartment
BH58	Driver's side windshield	N/A	N/A	Ricochet off of glass.
BH59	Driver's side windshield	N/A	N/A	Ricochet off of glass, partial perforation of windshield.
BH60	Driver's side windshield	N/A	N/A	Ricochet off of glass.
BH61	Driver's side windshield	N/A	N/A	12 o'clock to 6 into passenger compartment.
BH62	Driver's side windshield	N/A	N/A	Ricochet off of glass.
BH63	Driver's side windshield	N/A	N/A	Ricochet off of glass.
BH64	Driver's side windshield	0°	85°	12 o'clock to 6, perforated driver's side visor into seat.
BH65	Driver's side windshield	N/A	N/A	12 o'clock to 6 into passenger compartment.
BH66	Driver's side windshield	N/A	N/A	12 o'clock to 6 into passenger compartment.

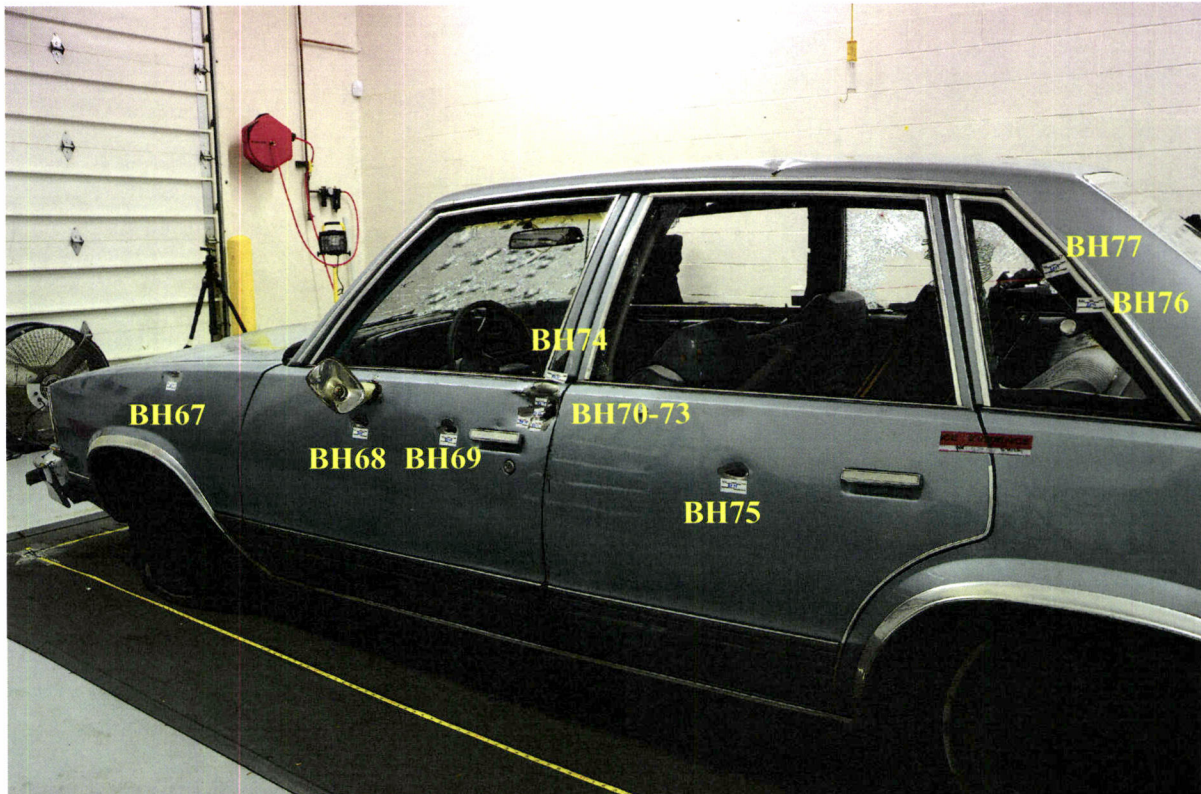
Figure 8 (BHs 67-77)

There were eleven bullet holes along the driver's side of the vehicle (see Figure 8). The following data was collected from these holes:

Bullet Hole #	Location	Vertical Impact Angle	Horizontal Impact Angle*	Direction of Travel**
BH67	Driver's side front fender	N/A	N/A	Ricochet, 12 o'clock to 6.
BH68	Driver's side front door	-7°	16°	11 o'clock to 5, penetrated door frame.
BH69	Driver's side front door	N/A	N/A	11 o'clock to 5, penetrated door frame.
BH70	Driver's side front door	N/A	N/A	11 o'clock to 5, penetrated door frame.
BH71	Driver's side front door	N/A	N/A	11 o'clock to 5, penetrated door frame.
BH72	Driver's side front door	N/A	N/A	11 o'clock to 5, penetrated door frame.
BH73	Driver's side front door	N/A	N/A	Ricochet, 12 o'clock to 6.
BH74	Driver's side B-pillar	N/A	N/A	11 o'clock to 5, perforated B-pillar into passenger compartment.
BH75	Driver's rear door	-3°	155°	Downward, 7 o'clock to 1, penetrated door frame.
BH76	Driver's side C-pillar	N/A	N/A	Ricochet.
BH77	Driver's side C-pillar	N/A	N/A	11 o'clock to 5, penetrated C-pillar.

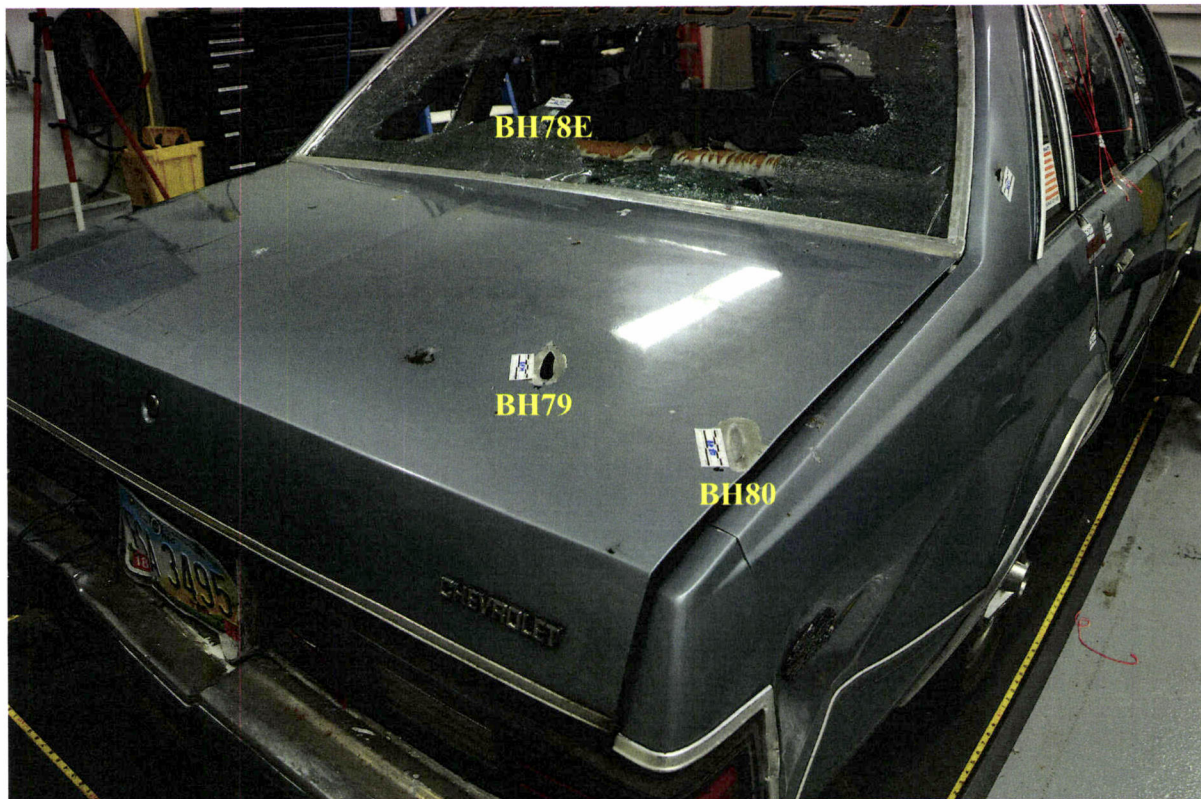
Figure 9 (BHs 78E-80)

There were three bullet holes found on the rear window and trunk (see Figure 9). The one bullet hole in the rear window (BH78E) was only partially intact. The cone fractures indicated that this shot traveled from the interior out through the window. This shot most likely came from through the front windshield. The following data was collected from these holes:

Bullet Hole #	Location	Vertical Impact Angle	Horizontal Impact Angle*	Direction of Travel**
BH78E	Rear window	N/A	N/A	Cone fracture located on exterior side of window.
BH79	Passenger's side trunk	-10°	126°	Downward, 5 o'clock to 11, penetrated trunk.
BH80	Passenger's side trunk	-4°	129°	Ricochet, 5 o'clock to 11.

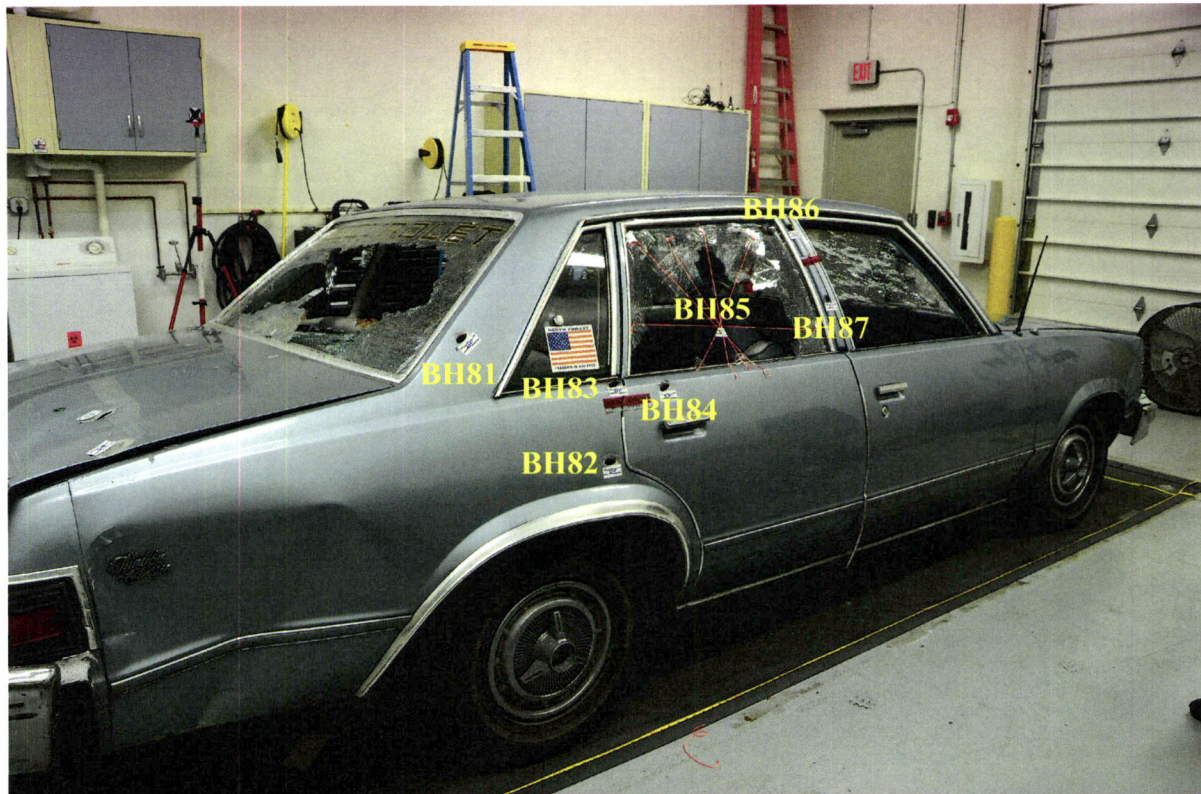
Figure 10 (BHs 81-87)

There were seven bullet holes found on the passenger's side (see Figure 10). The following data was collected from these holes:

Bullet Hole #	Location	Vertical Impact Angle	Horizontal Impact Angle*	Direction of Travel**
BH81	Passenger's side C-pillar	-7°	126°	Downward, 4 o'clock to 10 into passenger compartment.
BH82	Passenger's rear quarter panel	-14°	134°	Downward, 4 o'clock to 10 into tire well.
BH83	Passenger's rear quarter panel	0°	132°	Downward, 4 o'clock to 10, penetrated quarter panel.
BH84	Passenger's rear door	-15°	133°	Downward, 4 o'clock to 10, penetrated door.
BH85	Window of passenger's rear door	N/A	N/A	Into passenger rear compartment.
BH86	Passenger's side B-pillar	-20°	95°	Downward, 3 o'clock to 9, perforated B-pillar into passenger compartment.

BH87	Passenger's side B-pillar	-20°	78°	Downward, 3 o'clock to 9, perforated passenger's B-pillar and seatbelt into passenger compartment.
------	---------------------------	------	-----	--

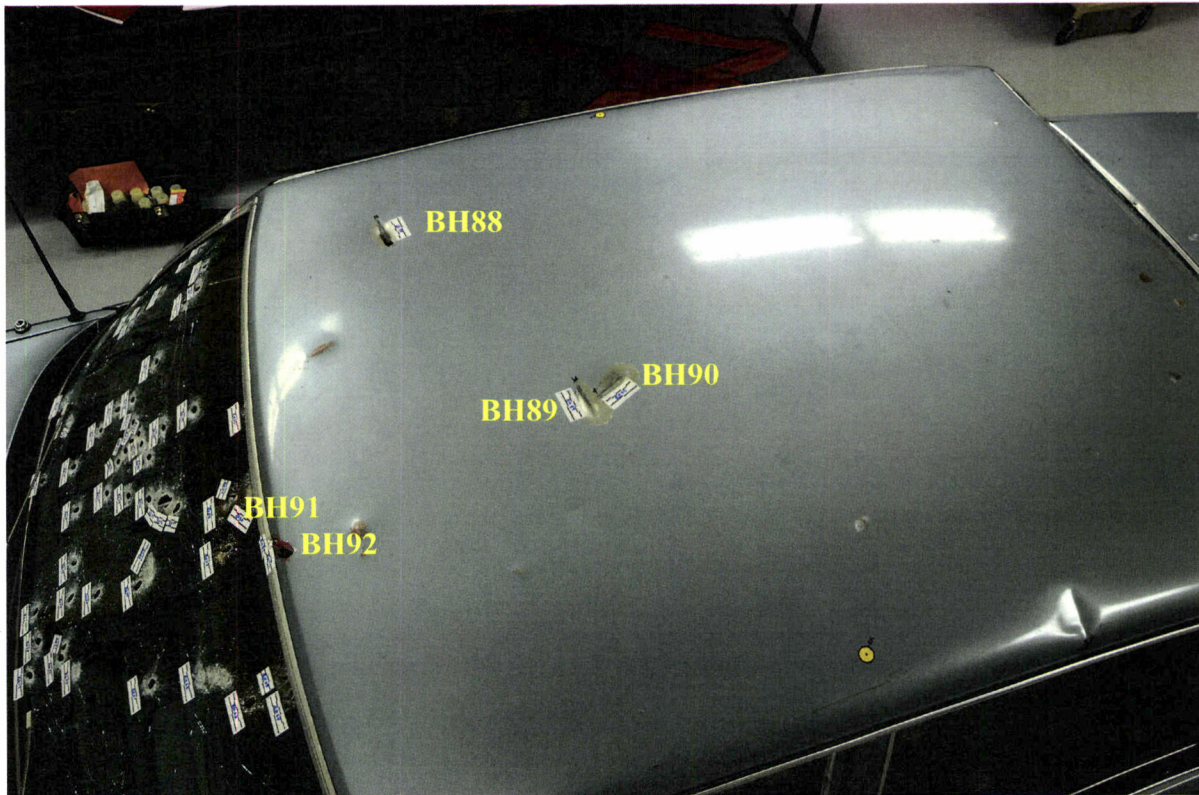
Figure 11 (BHs 88-92)

There were five bullet holes on the roof (see Figure 11). The following data was collected from these holes:

Bullet Hole #	Location	Vertical Impact Angle	Horizontal Impact Angle*	Direction of Travel**
BH88	Passenger's side roof	-10°	82°	Downward, 3 o'clock to 9, perforated roof into passenger compartment.
BH89	Driver's side roof	-7°	78°	Ricochet, 2 o'clock to 8.

BH90	Driver's side roof	-1°	59°	Ricochet, 11 o'clock to 5.
BH91	Driver's side roof near top edge of windshield	-10°	102°	Downward, 12 o'clock to 6, penetrated roof into headliner.
BH92	Driver's side roof near top edge of windshield	N/A	N/A	1 o'clock to 7, penetrated roof into headliner.

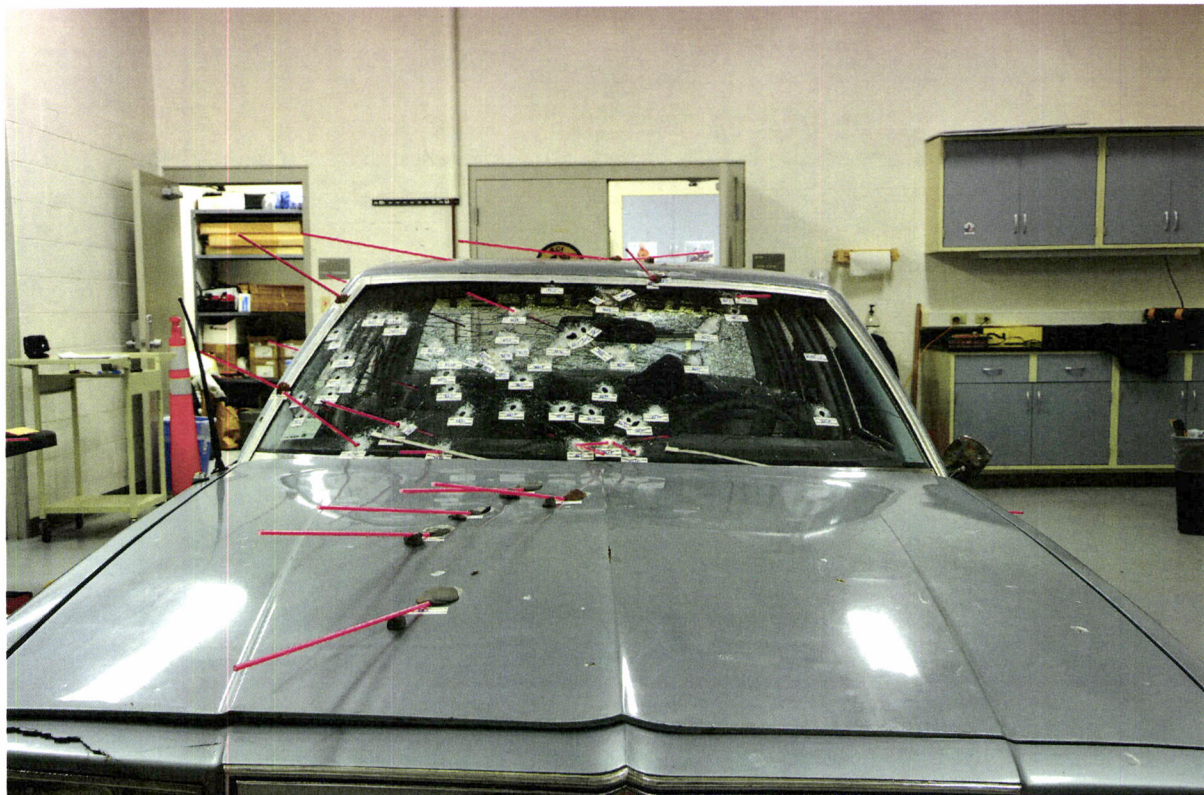
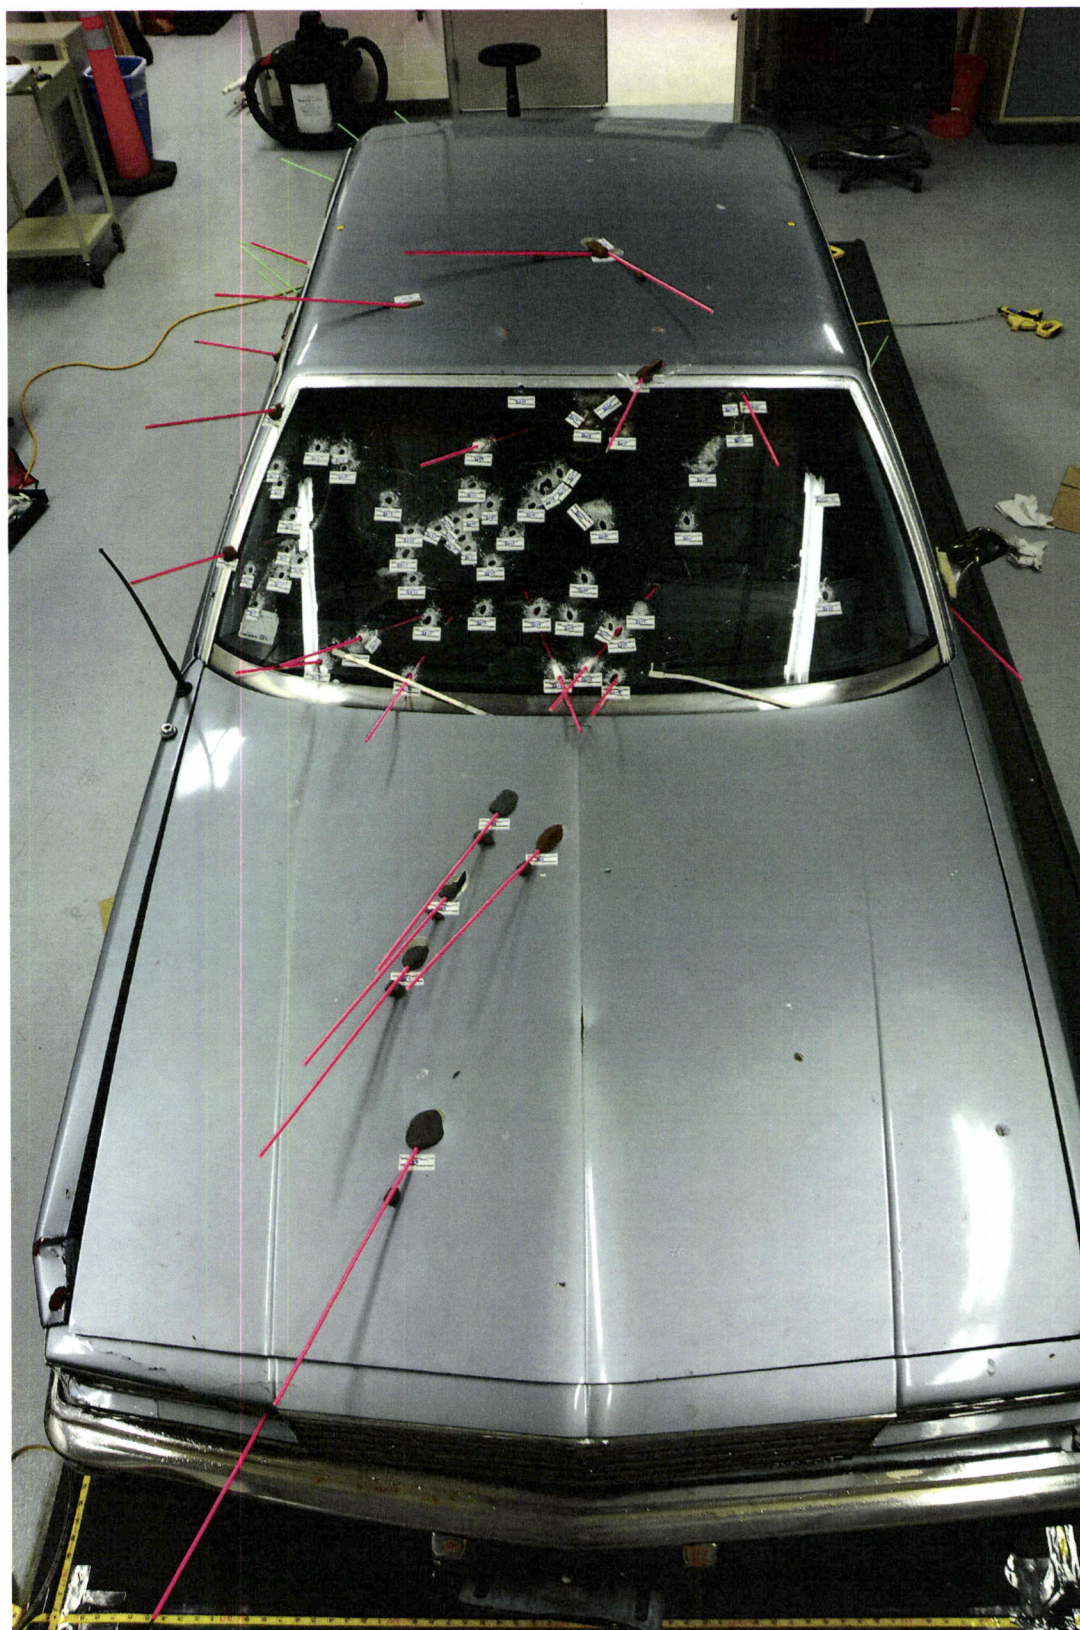
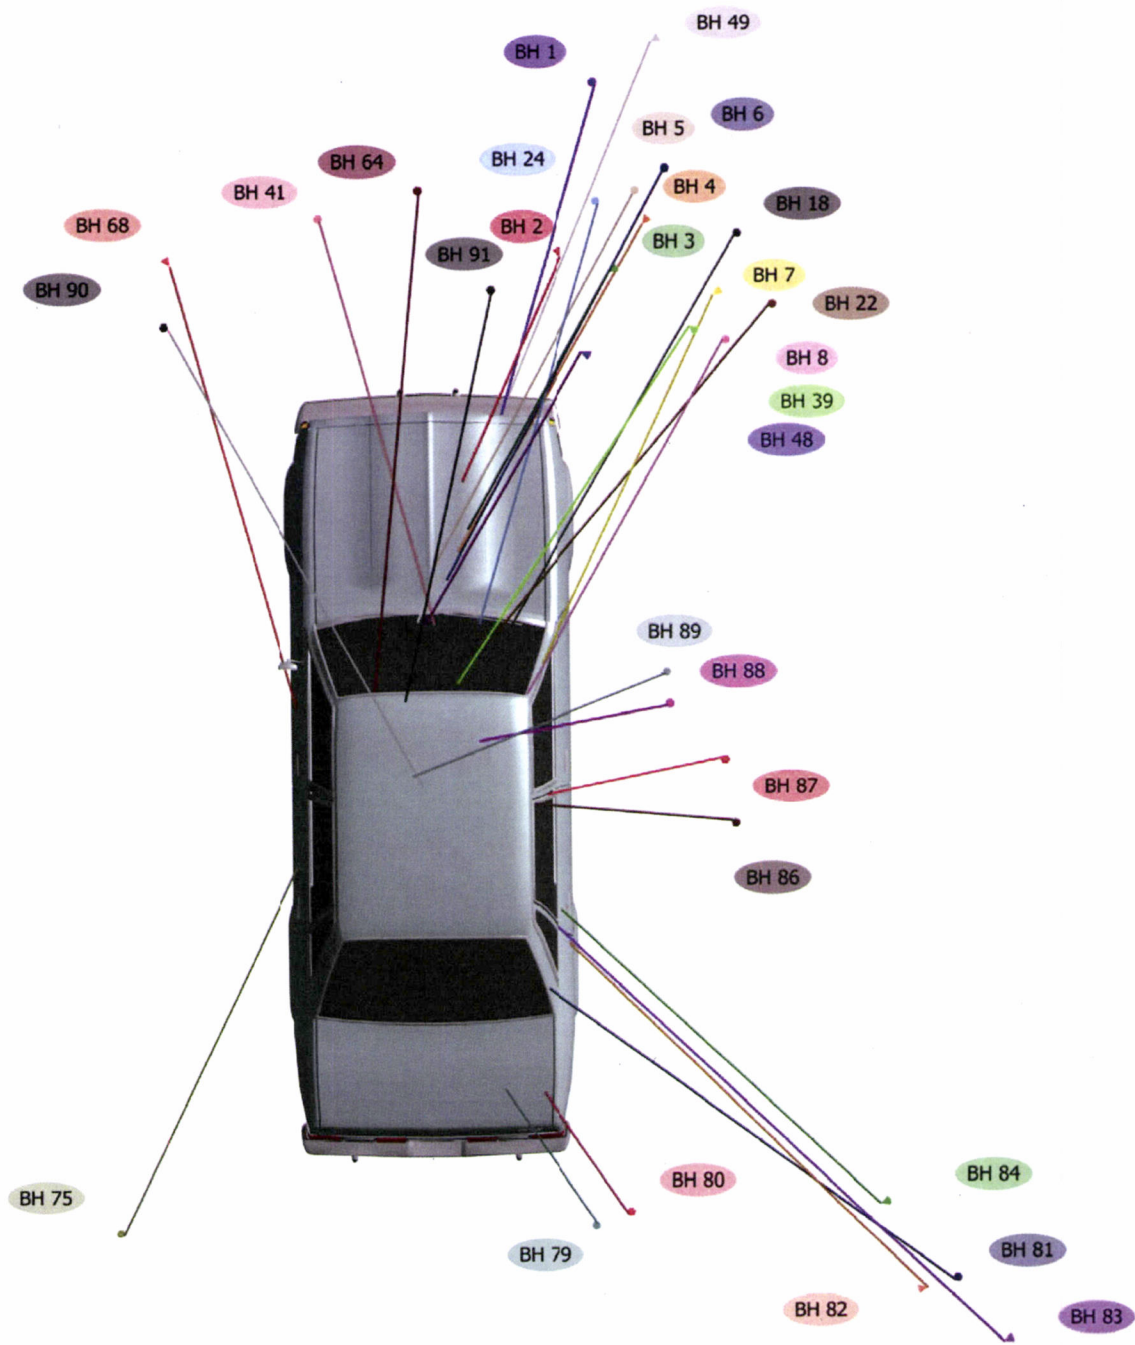
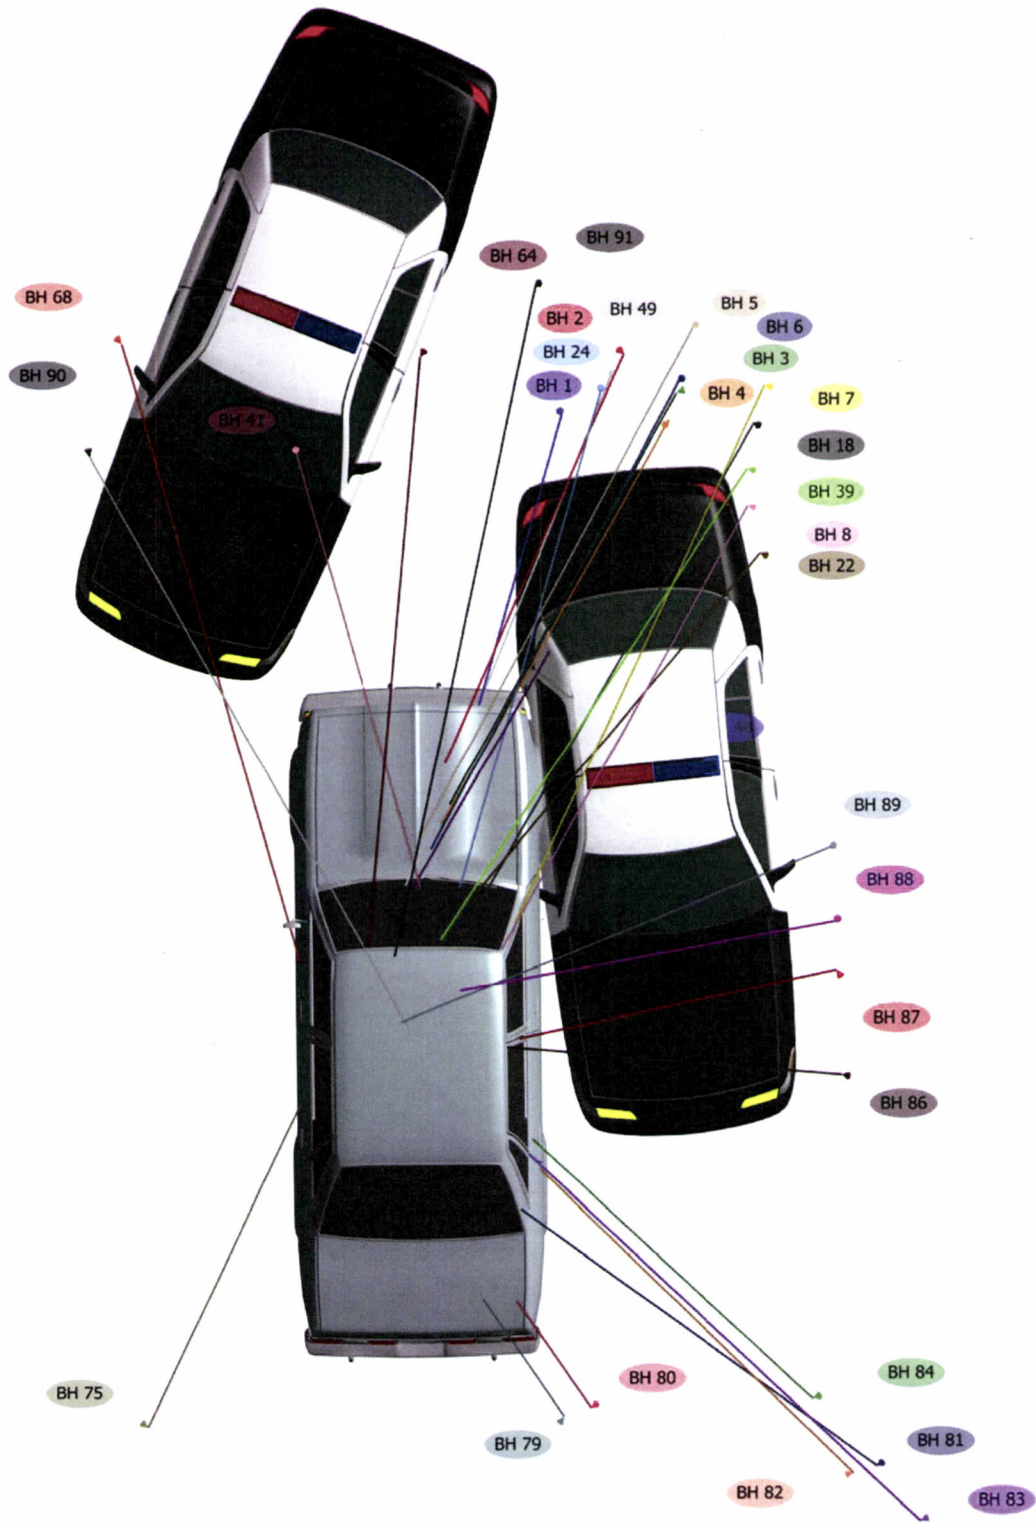
Figures 12, 13, 14, and 15 depict the trajectories that were determined during this analysis:
