**Ohio Attorney General's Office**  
**Bureau of Criminal Investigation**  
Investigative Report

2022-1356

Officer Involved Critical Incident - 1659 S. Main Street, Akron, Ohio  
44301

# Seek Now Maestro Report

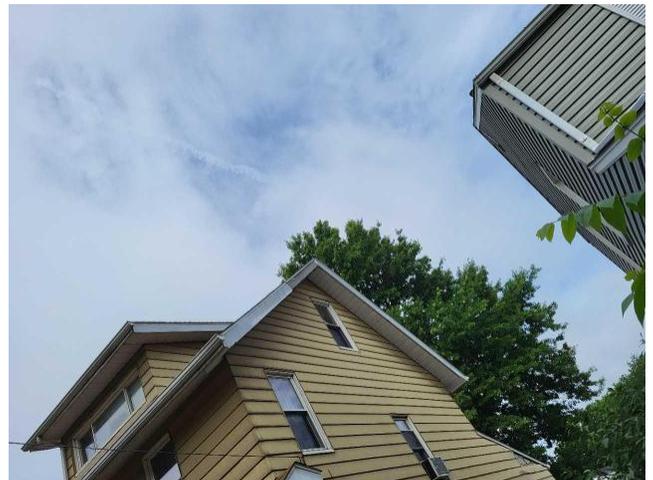
## Elevation - Right - Fascia

Size: 8 inch

Material: Metal

Painted/Stained

Storm related damage caused by Wind

Condition: Fair

Damaged : 10 LF of Aerial

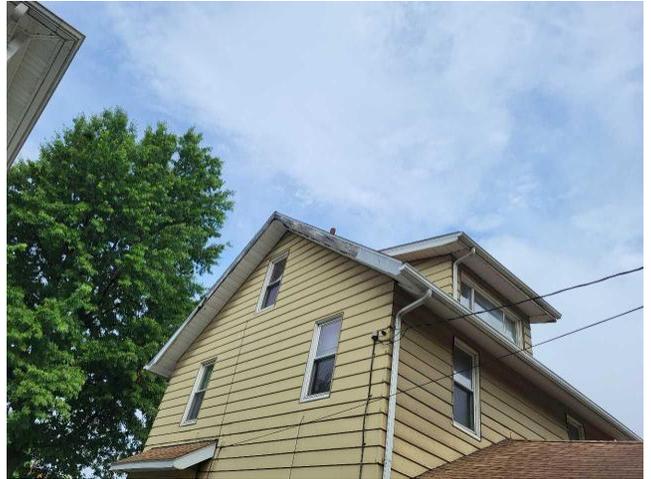
## Elevation - Left - Fascia

Size: 8 inch

Material: Metal

Painted/Stained

Storm related damage caused by Wind

Condition: Fair

Damaged : 26 LF of Aerial

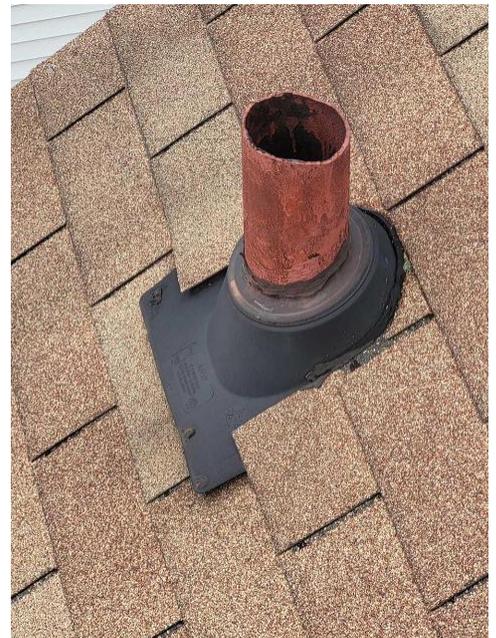
## Accessory - Front Slope

Pipe Boot

Galvanized with Rubber Collar

No Damage

Unsealed Condition

Size: 4.0"

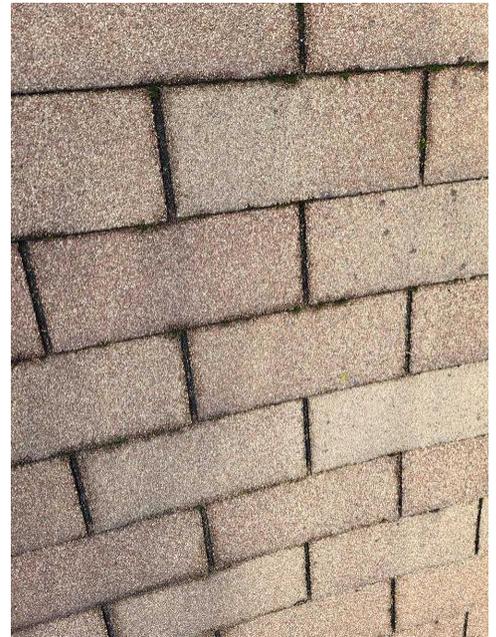
### Right Slope - Roof Condition

Fair Condition

Lichen

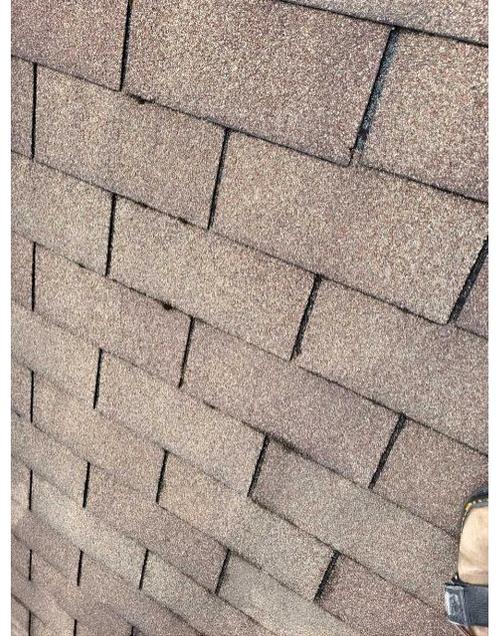
## Right Slope - Roof Condition

Fair Condition

Lichen

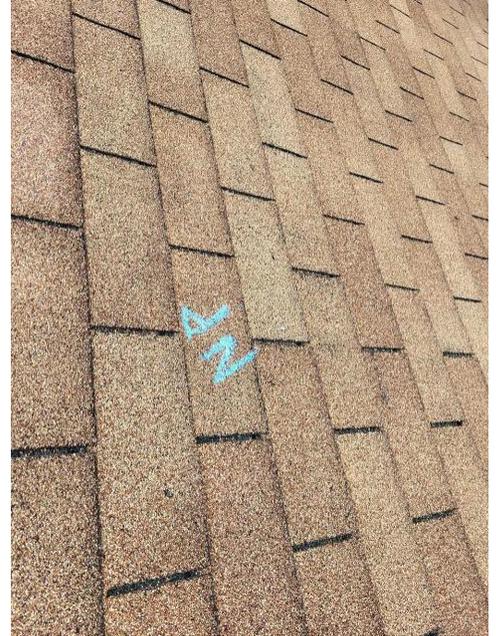
## Back Slope - Roof Condition

Fair Condition

Nail Pops

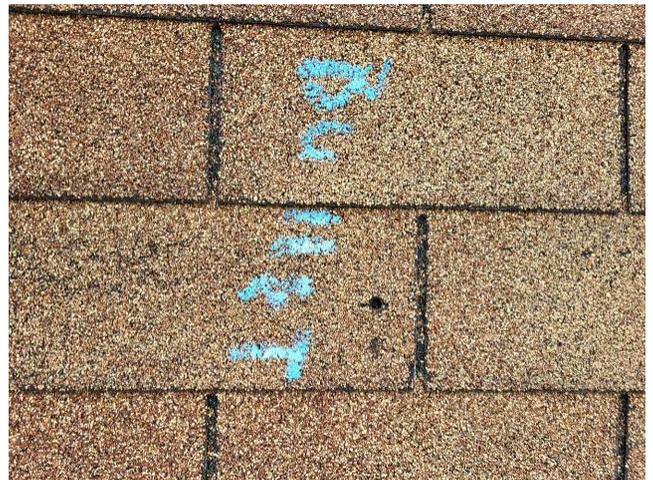
## Back Slope - Roof Condition

inspector advised Cathy that he had located a bullet hole in the roof. Cathy stated she contacted the police department to report the matter, and the police department, "had no interest."

Around June 1, 2022, he had a water leak in his kitchen, which prompted him to contact his insurance company and a roofer. On July 6, 2022, the insurance company and a roofer examined his roof and determined the water leak in his kitchen was from a seal around his sewer stack. They also informed Todd there was a bullet in his roof.

Fair Condition

bullet

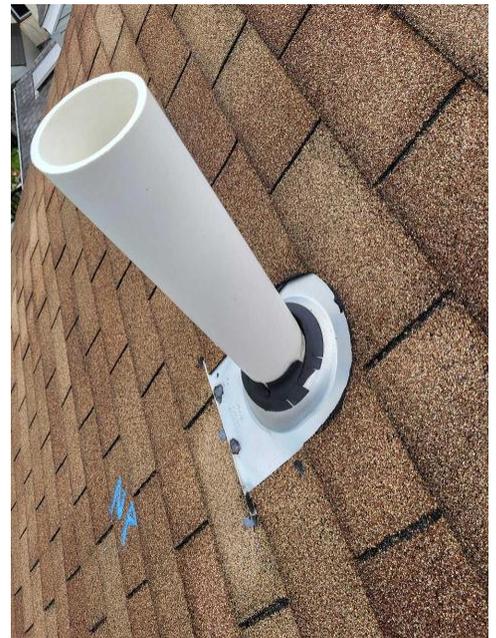
## Accessory - Back Slope

Pipe Boot  
Plastic  
Damage caused by mechanical  
Poor Condition  
Size: 3.0"  
July 6, 2022

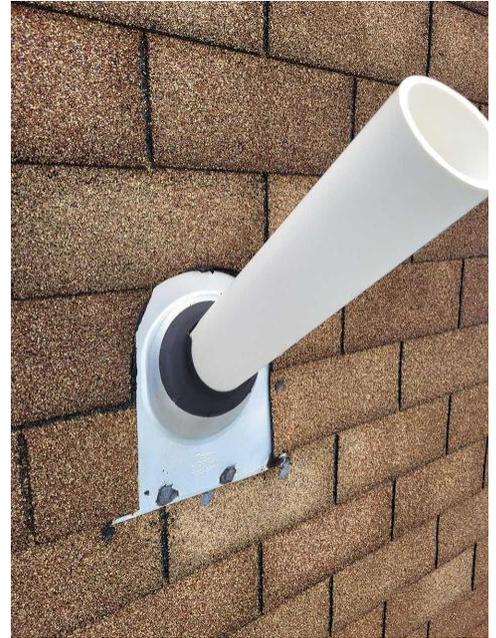
## Accessory - Back Slope

Pipe Boot

Plastic

Damage caused by mechanical

Poor Condition

Size: 3.0"

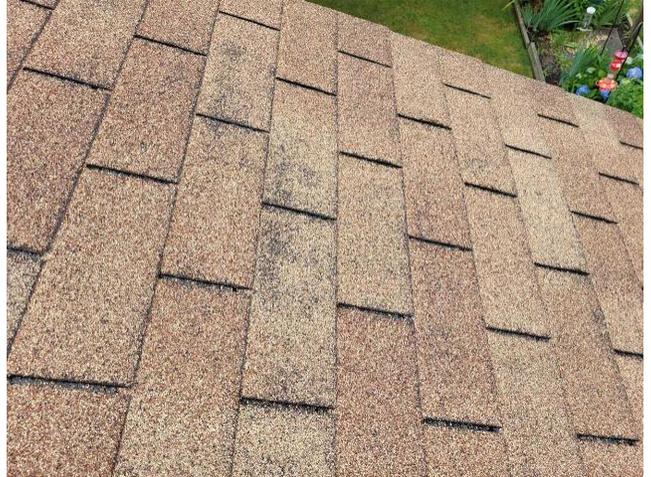
## Left Slope - Roof Condition

Fair Condition

Granule Loss
