**Investigative Report**

2023-2234

Officer Involved Critical Incident - Corey Andrew (S)

Investigative Activity: Crime Scene Examination

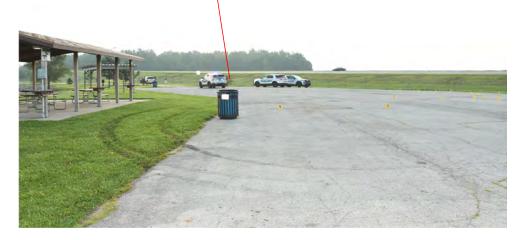
An area of tire tracks was located on the north side of the parking lot, near the shelter house. The tire tracks showed that a vehicle traveled off the parking lot, through the grass and back onto the parking lot. This area of tread transfer was identified with placards 19, 20, 23 & 24 in photographs.

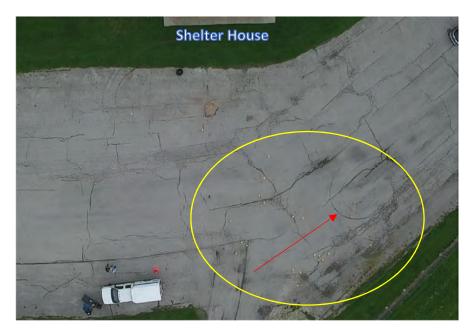
<u>Area of Evidence</u> – <u>Circular Tire Tread Marks</u>

A second area of tire tracks was located south and east of the shelter house. This set of tire tracks showed a vehicle moving in circular direction. The tread marks were dark and appeared to change in width. Placard 16 was used to identify the area of the tire tread transfer. The area of the parking lot pavement was searched for potential evidence. A concentration of evidence was located west of the circular tire tread marks and south of the tire tread marks in the grass and north portion of the parking lot.

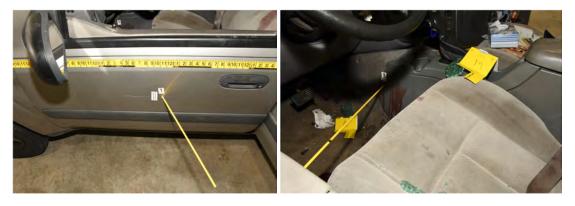
BI 1.0 - BI 1.2 - Driver's Door Area

Examination of the exterior of the vehicle located three potential ballistic incidents along the driver's side. They were identified as BI-1.0 – BI-3.0. Scaled photographs of the damaged areas were taken.

BI-1.0 was located on the exterior surface of the driver's door. It was located approximately 6'10" behind the front bumper and 3' ½" above the ground. This suspected bullet hole was found in the center of the door, in an area adjacent to the driver's seat. The suspected bullet hole was visually with a medium to large caliber bullet. The margins of the hole were pushed inward, visually consistent with an entrance hole the shape was slightly elongated but not elliptical.

A corresponding area of damage was found on the interior surface of the driver's door, in the molded plastic. This area of damage was identified as BI 1.1. The irregularly shaped area of damage was consistent with an exit hole.

It appears that the suspected bullet continued into the passenger compartment and struck a plastic trim piece near the vehicles center console. The impact site appeared to be circular in shape and visually consistent in size with a fired bullet. It appeared that a portion of the nearby plastic had been broken off by the impact. This area of plastic was covered in suspected blood. A search of the driver's floorboard in this area located a fired bullet (placard A) on the floor, in close proximity to the damaged area. Investigators related that the subject suffered a wound to his legs, during the incident.

A trajectory rod was threaded through the corresponding ballistic impacts (BI-1.0-1.2). The vertical angle was measured as -13 degrees (downward). The horizontal or azimuth angle was recorded as 67 degrees (0 rear of car / 180 front of car). This would indicate that the shot originated from a point slightly behind and out from the driver's door of the vehicle. The suspected bullet passed through the door, through the space at the front of the driver's seat and toward the engine area, in a downward trajectory.
