**Ohio Attorney General's Office
Bureau of Criminal Investigation
Investigative Report**

Officer Involved Critical Incident - 100 Block 8th Street, N.E.
New Philadelphia, Ohio 44663

Investigative Activity: Vehicle Processing (Tuscarawas County Sheriff Vehicle # [REDACTED])
Involves: Tuscarawas County Sheriff's Office
Activity Date: 04/03/2024
Activity Location: 2295 Reiser Avenue SE, New Philadelphia, OH 44663
Authoring Agent: Crime Scene Technician Michael Rostocil #204

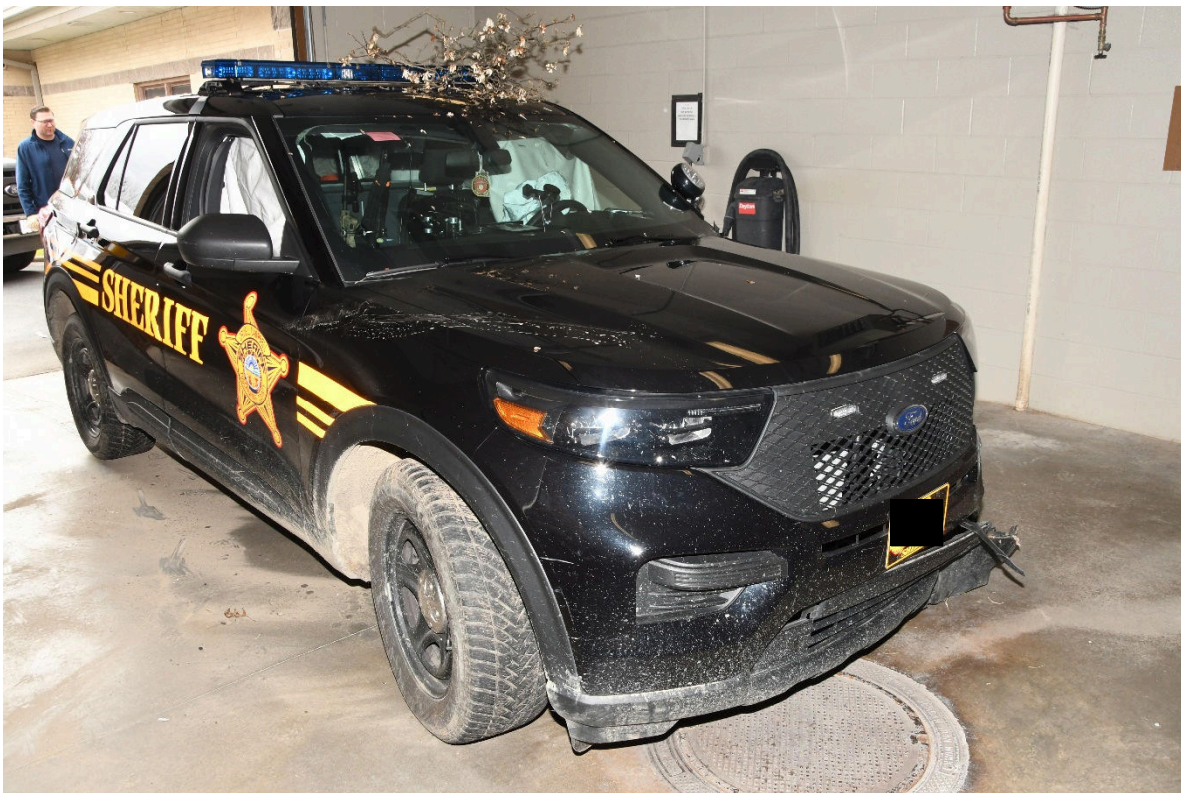
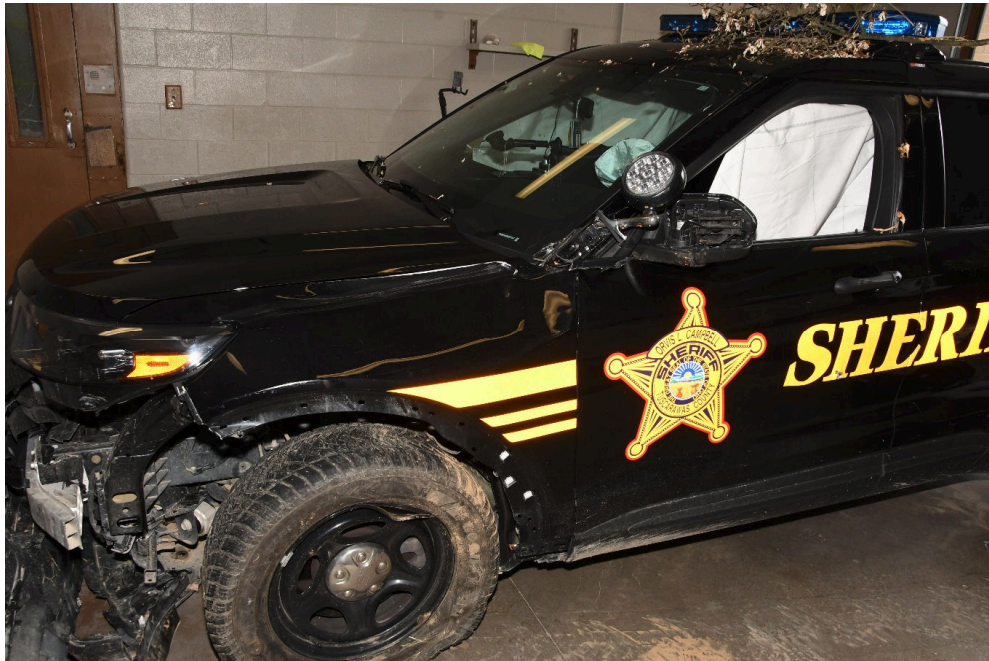
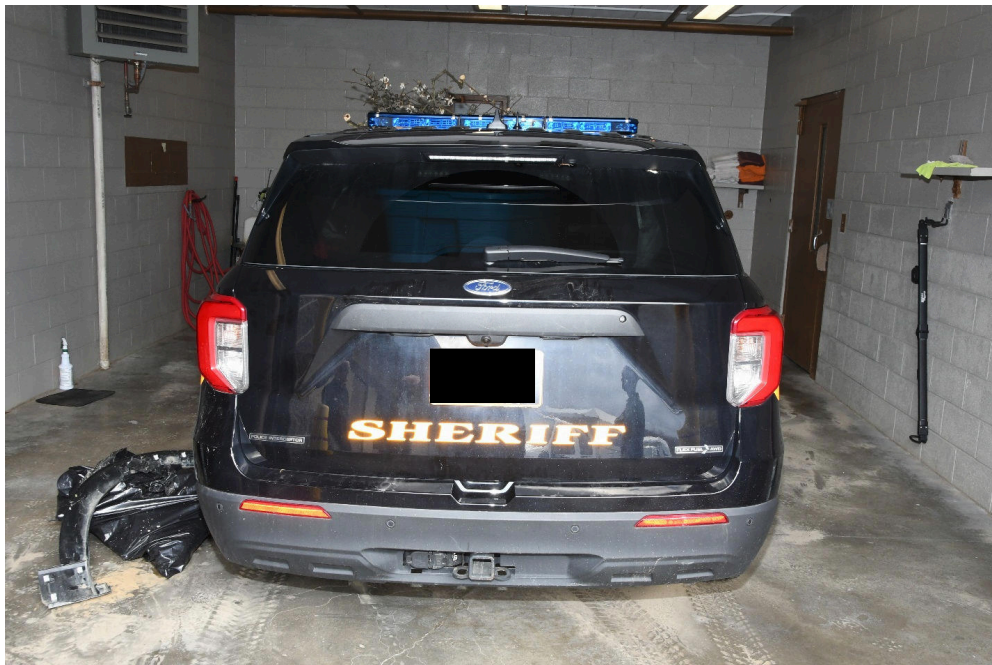
SA Doran photographed the exterior and interior of the vehicle as it was found in a secured sally port (Figures #1-6). The vehicle exhibited damage to the driver side front end and airbags were deployed. The vehicle was searched for items of suspected evidence and several items of suspected evidence were located, photographed, and collected (Table 1, Items of Suspected Evidence) (Figures #7-12). Evidence from the front passenger side was located as items were being removed during the search. [REDACTED] s cell phone was located on the front driver floorboard and given to Captain Adam Fisher.

Figure #1 - Overall of vehicle

Figure #2 - Overall of vehicle

Figure #3 - Overall of vehicle

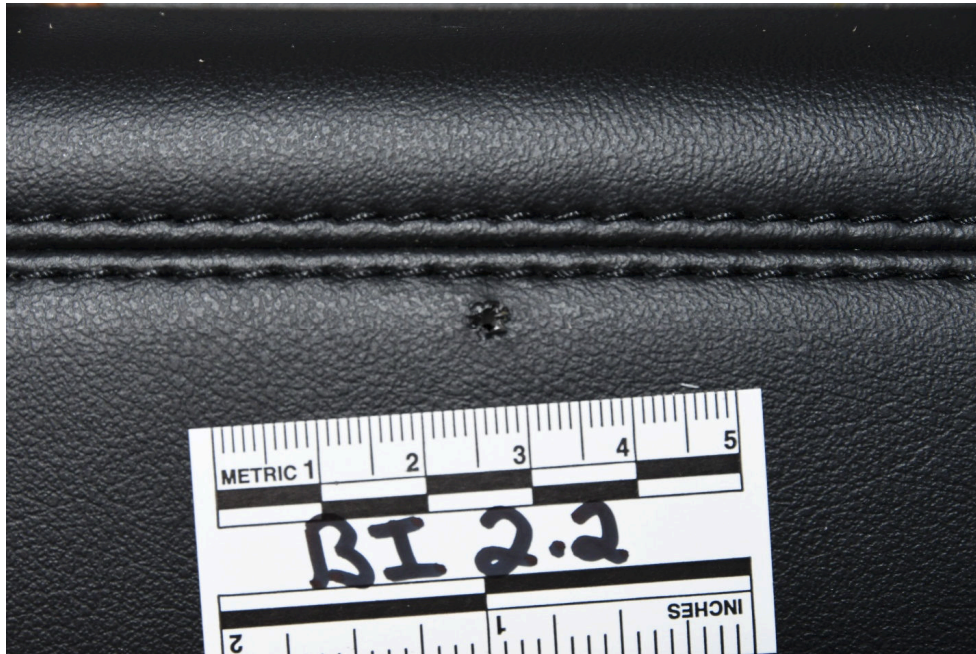
BI 2.2 was located on the interior front driver door (Figure #13). The defect was approximately 11.5 inches from the outer door edge and 11.5 inches from the bottom of the window. BI 2.2 was an entrance defect, circular in shape with a smooth margin. The bullet impacted the interior door traveling from passenger side to driver side. A corresponding exit defect (BI 2.3) was located on the exterior front driver door (Figure #14). The defect was approximately 11 inches from the outer door edge and 1 foot 4 inches from the bottom of the window. The defect was circular in shape with outwardly bent metal surrounding it.

Figure #13 - Close-up of BI 2.2

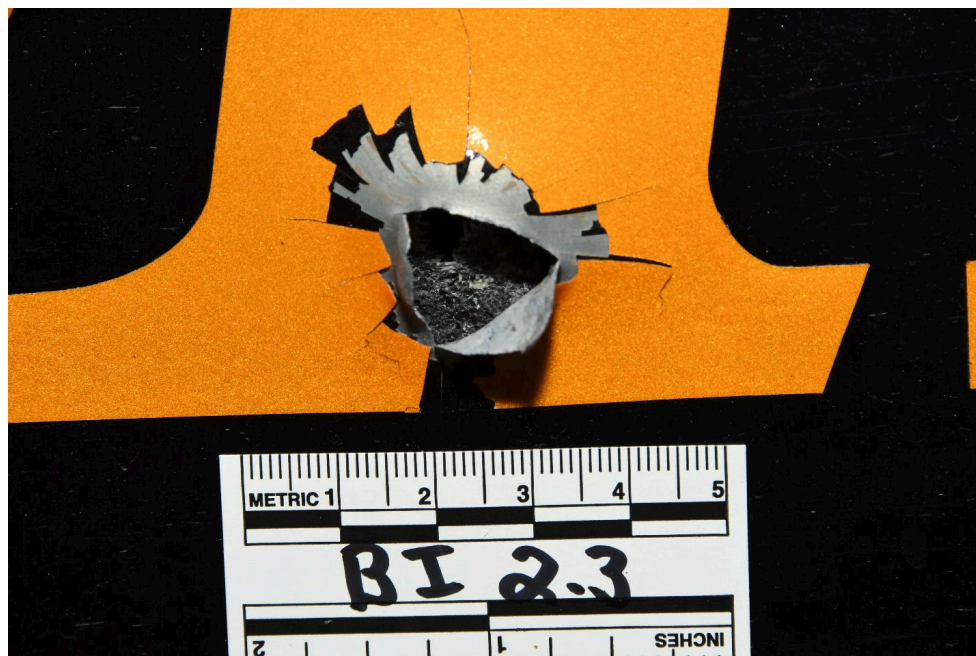
Figure #14 - Close-up of BI 2.3

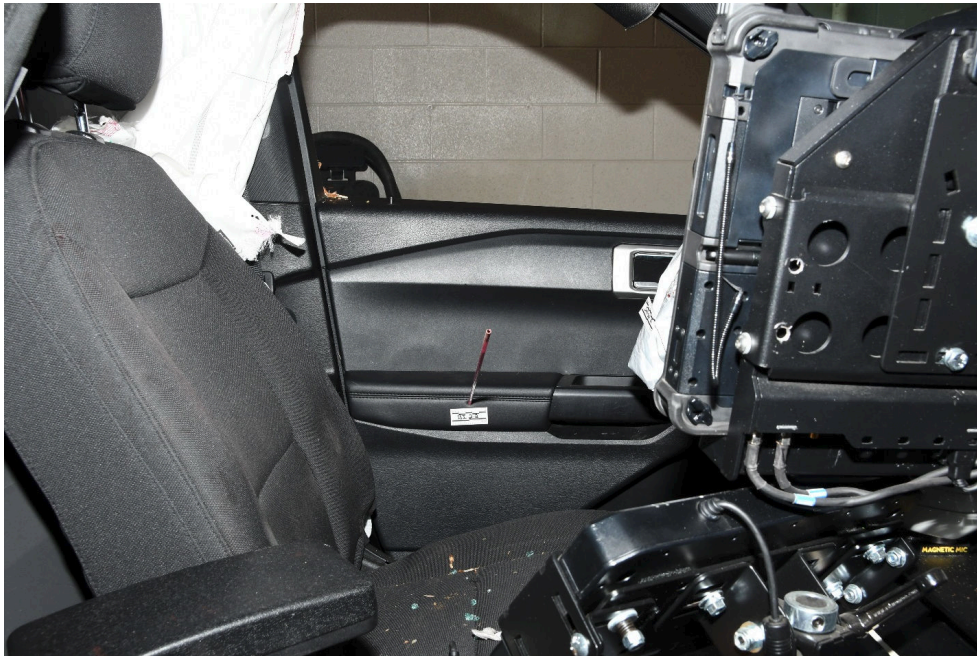
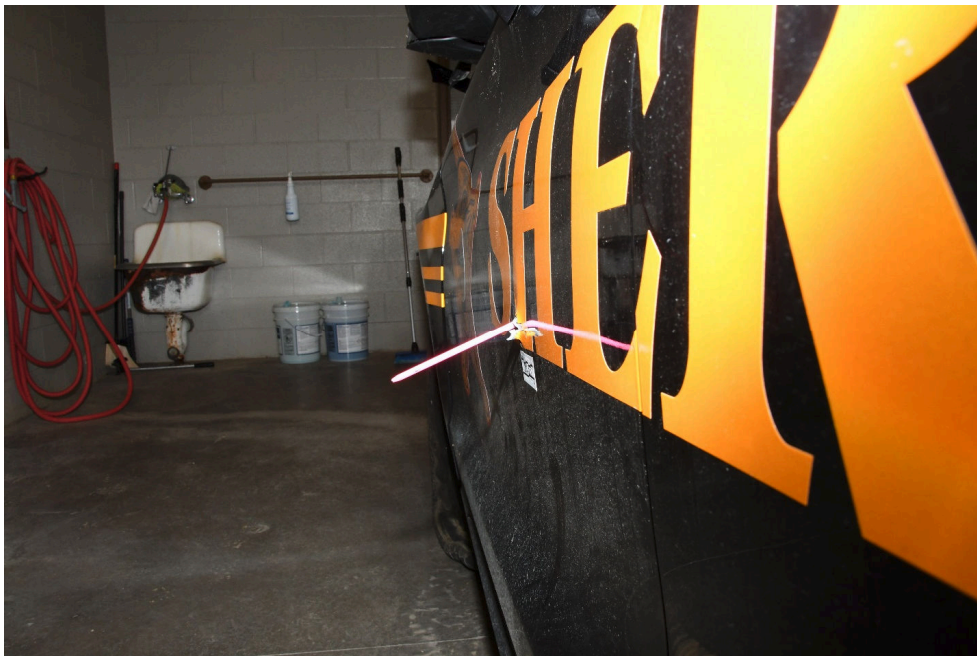
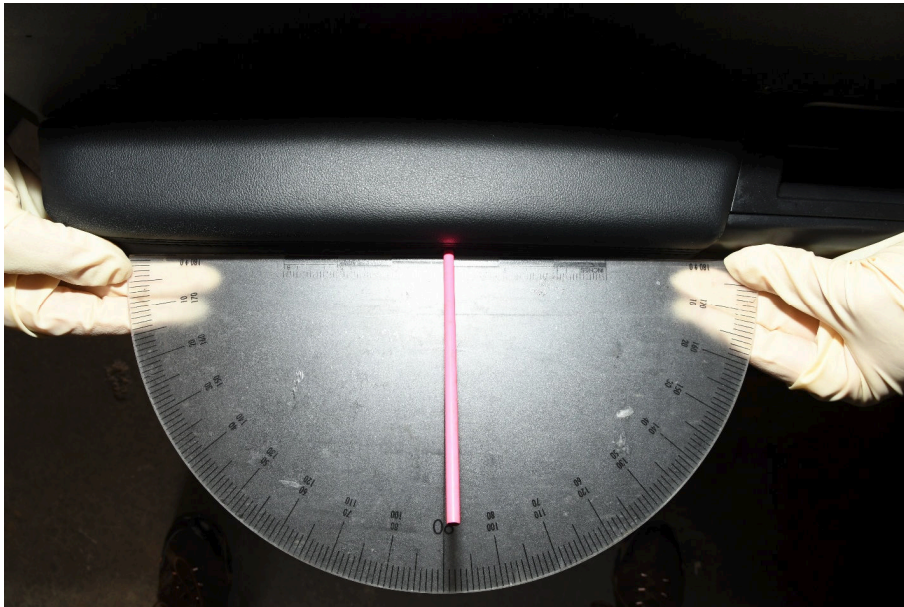
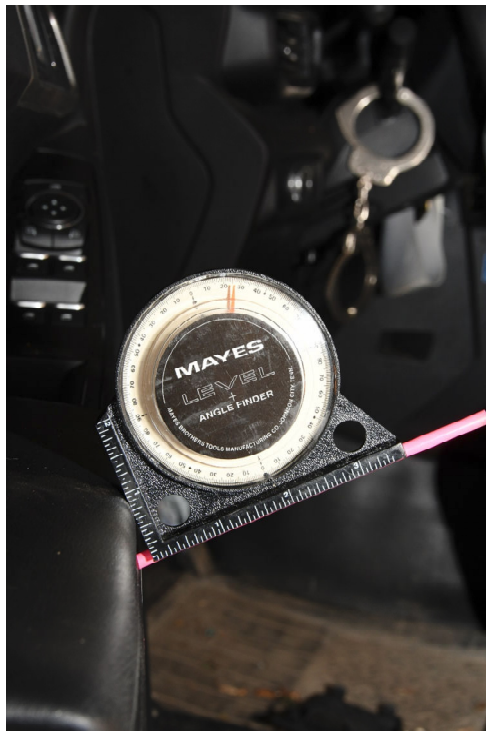
A trajectory rod was placed between the impacts and the horizontal angle of impact was recorded as 92° and vertical angle of impact was recorded as 26° downward using an angle finder and protractor (Figures #15-18). The vehicle's front driver side tire was flat, and the vehicle was sloped approximately 3°. The vehicle was further documented using a Leica BLK360 3D scanner and the horizontal angle of impact was recorded as 92° and vertical angle of impact was calculated as 21° downward using the Leica Map360 Trajectory software (Figures #19-20).

Figure #15 - Overall photo of trajectory

Figure #16 - Overall photo of trajectory

Figure #17 - Horizontal angle

Figure #18 - Vertical angle

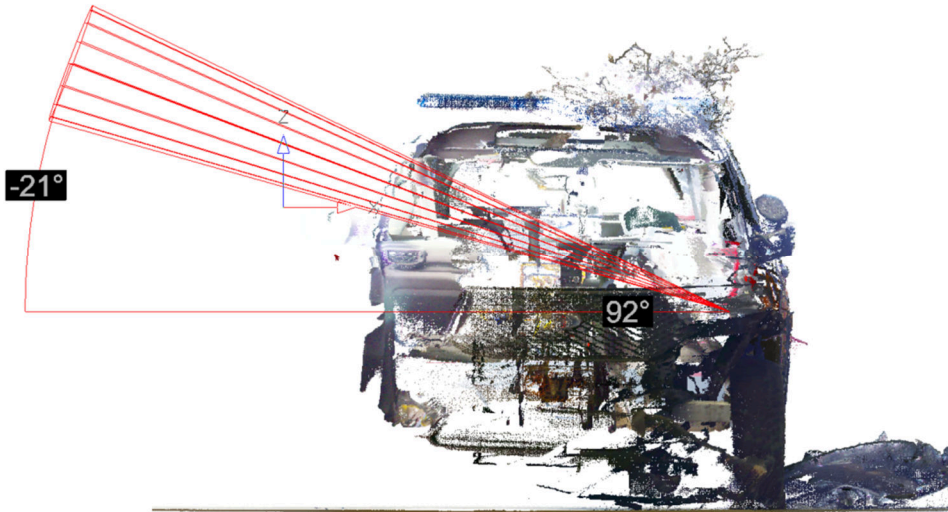
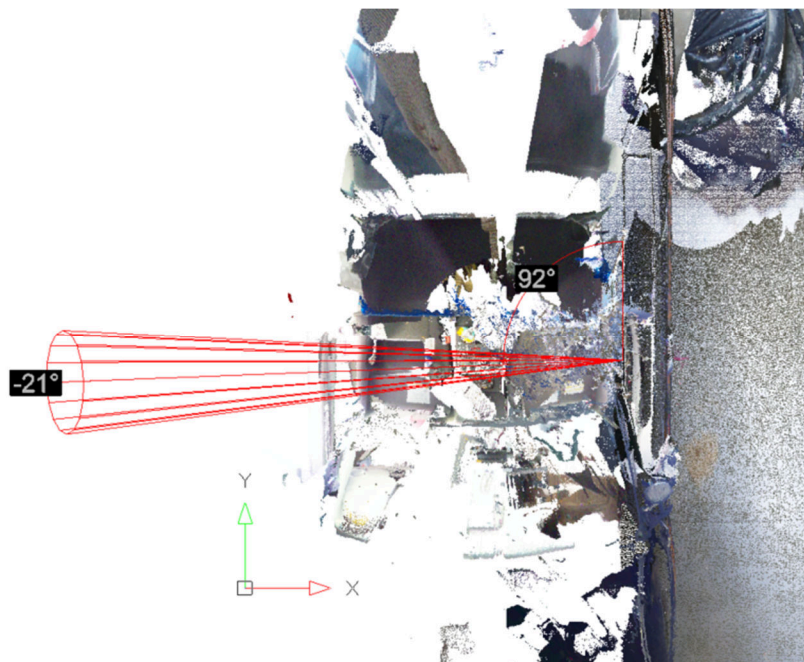
Figure #19 - Front view trajectory, Leica Map360

Figure #20 - Top-down view of trajectory, Leica Map360
