Ohio Attorney General's Office Bureau of Criminal Investigation Investigative Report

2026-1239

Officer Involved Critical Incident - 31000 Block U.S Route
250, Uhrichsville, Ohio, 44683, Harrison County

Investigative Activity: Crime Scene Processing

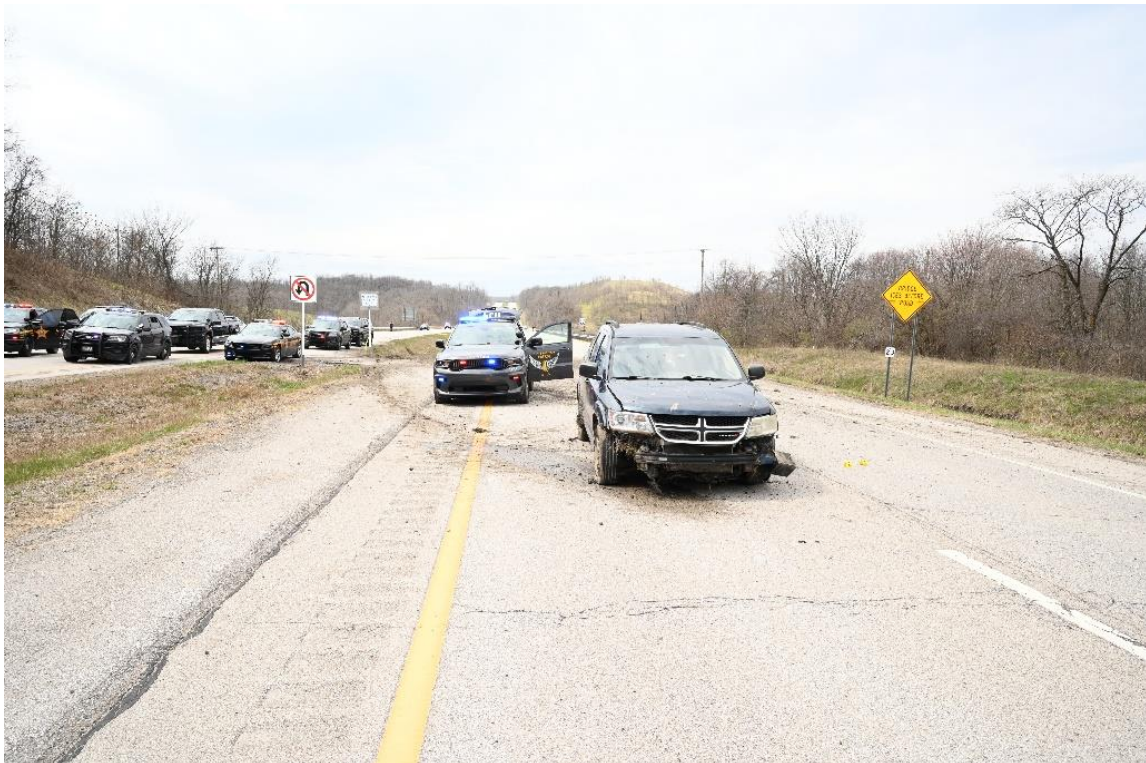
**US 22 westbound lanes at mile marker 23
(vehicles facing east in the westbound lanes)**

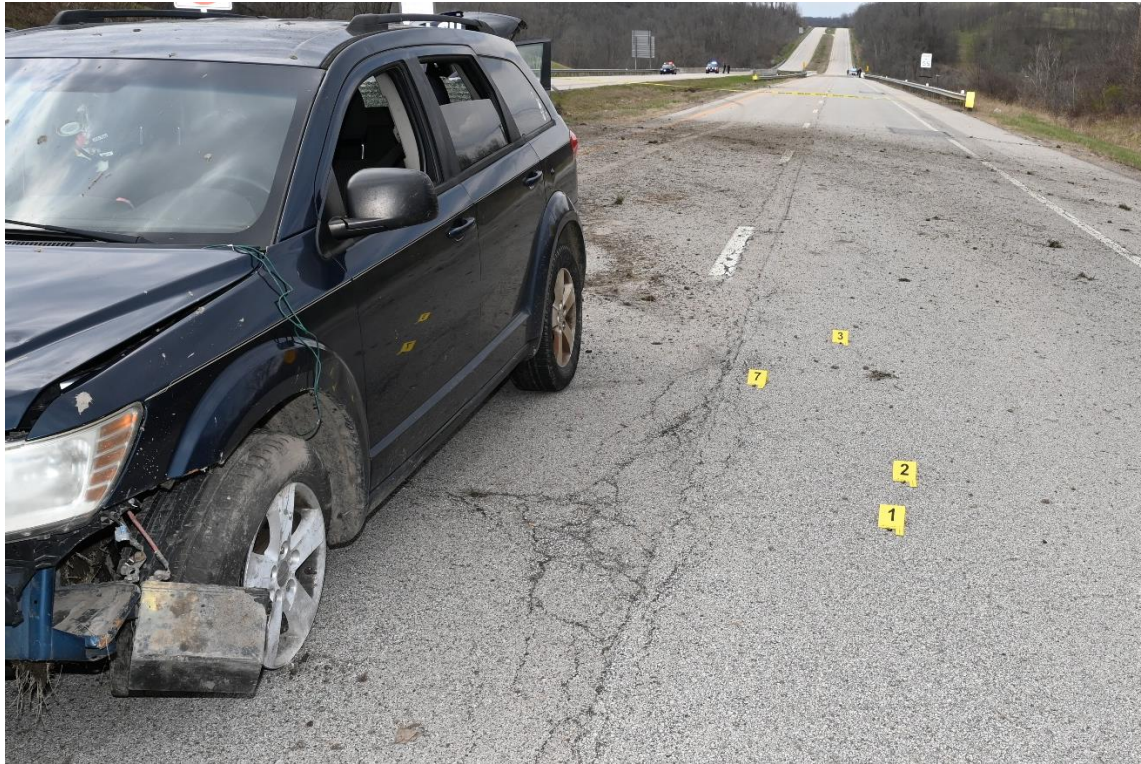
Items 1, 2, 3, and 7

During the photographic documentation of the scene, several items were located on the pavement, including four cartridge casings (Items 1, 2, 3, and 7) north of the Dodge Journey. Each casing was determined to be a GLR-brand 9mm Luger cartridge casing.

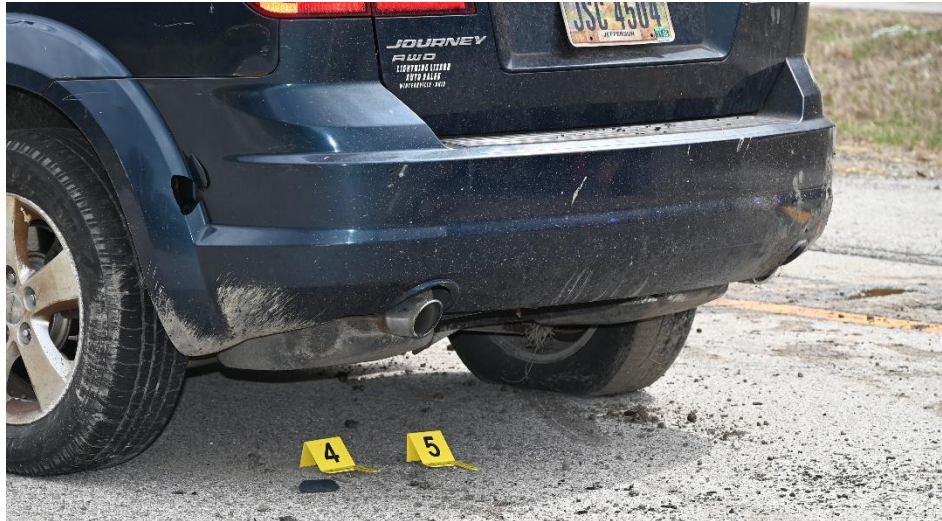
Items 4 and 5

Additionally, a copper jacket (Item 4) and a ballistic fragment (Item 5) were also located on the pavement under the rear of the Dodge Journey.

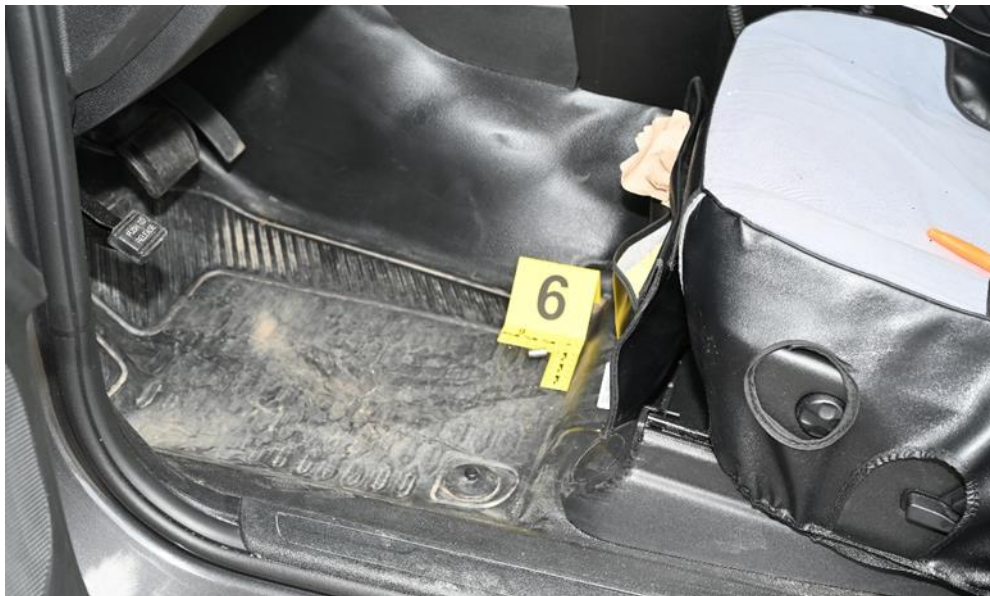
Item 6

SA Lulla and SA Doran began the examination of OSP Cruiser # [REDACTED]. While examining the interior of the vehicle, a WIN-brand 9mm cartridge casing was recovered from the driver's floor (Item 6).

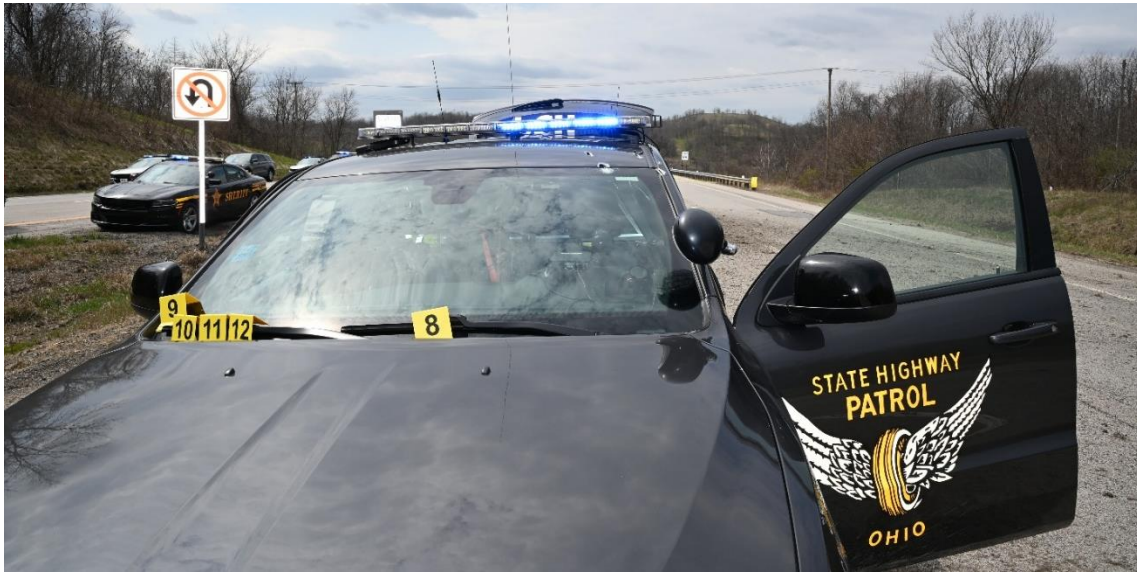
Upon further examination, five additional WIN-brand 9mm cartridge casings were discovered on the vehicle's cowl and marked as Items 8, 9, 10, 11, and 12.

**Items 8, 9, 10, 11, and 12
WIN brand 9mm cartridge casings**

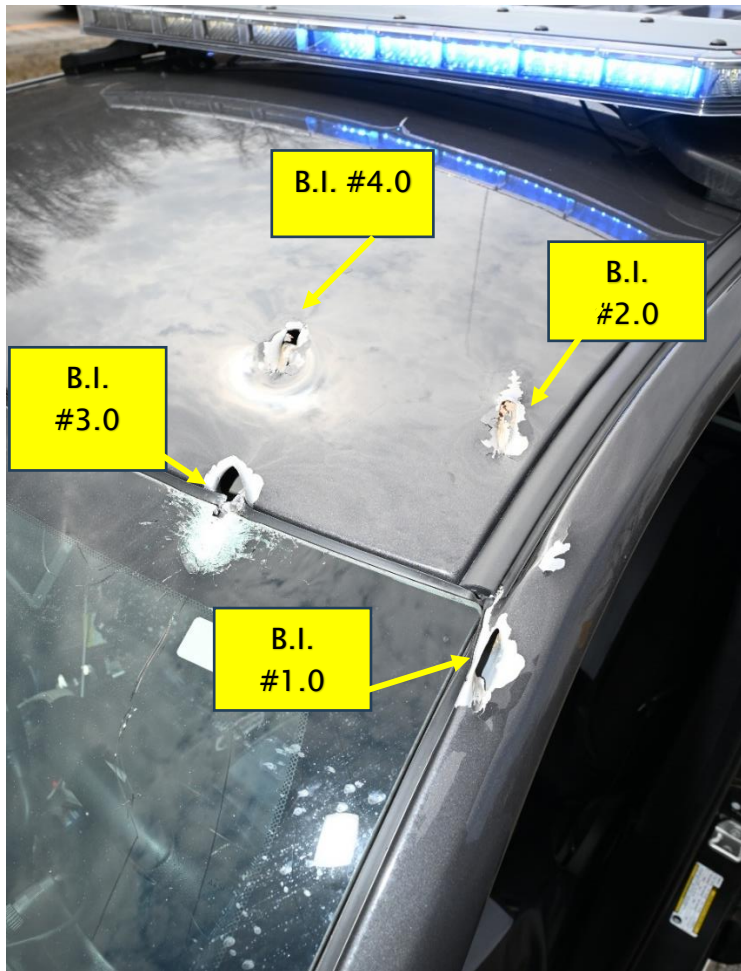
The SAs examined four ballistic impacts (B.I.) that were observed near the upper left corner of the cruiser's front windshield.

Ballistic Impacts (B.I.) on OSP Unit # [REDACTED]

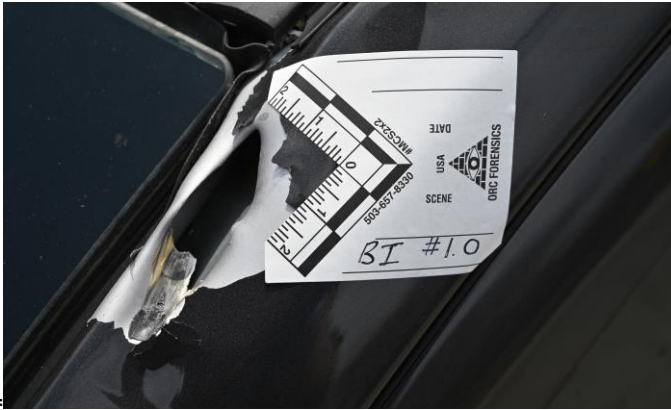
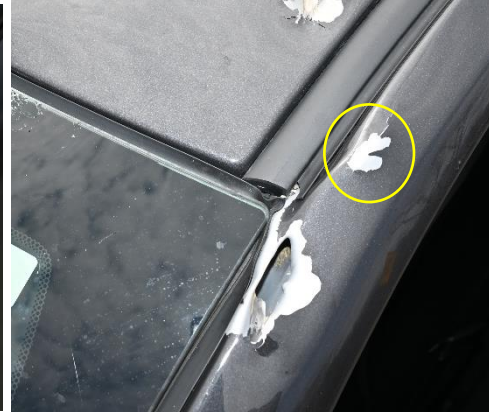
Secondary impact

B.I. #1.0 A projectile perforated the doorframe of the driver's door while traveling from the front to the back, leaving an elliptical-shaped hole, with a secondary impact observed further back on the doorframe. The projectile came to rest inside the doorframe and was not recovered.

Trajectory rods were placed in B.I.# 1.0 and B.I.# 4.0, which were later scanned using the BLK360 scanner to determine the trajectory that the bullet had traveled prior to striking the vehicle.

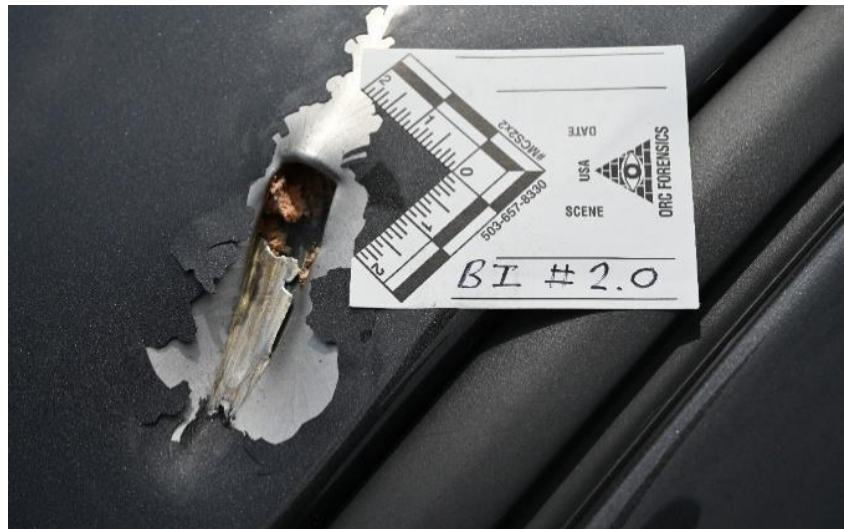
B.I. #2.0 A projectile perforated the roof of the vehicle, traveling from the front to the back and slightly left to right, leaving an elliptical-shaped hole. The projectile terminated between the roof and the headliner of the vehicle and was not recovered.

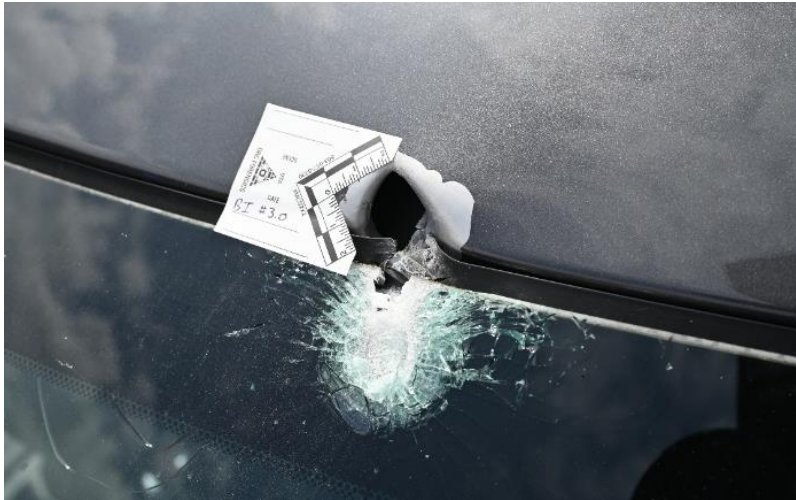
B.I. #3.0 A projectile, traveling from front to back, struck the top edge of the front windshield before perforating the roof, leaving an irregular circular hole. The projectile terminated between the roof and the headliner of the vehicle and was not recovered.

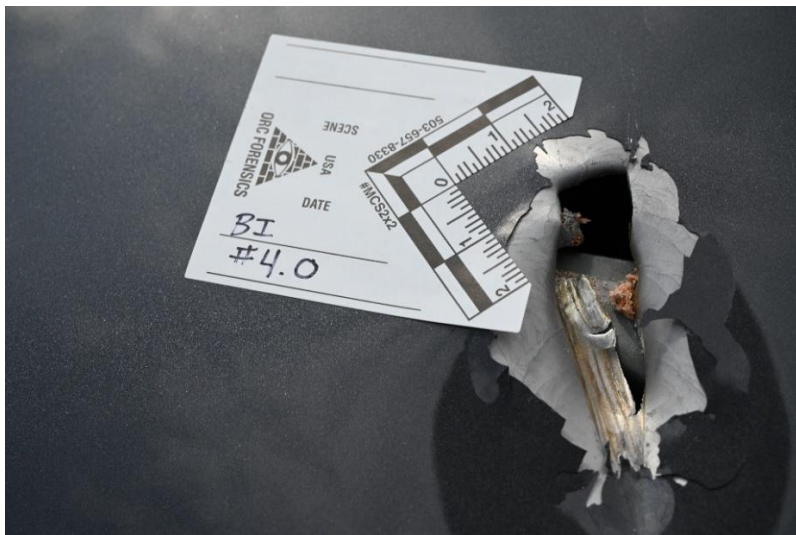
B.I. #4.0 A projectile, traveling from front to back and slightly left to right, perforated the roof of the vehicle, leaving an elliptical-shaped hole. The projectile terminated between the roof and the headliner and was not recovered.

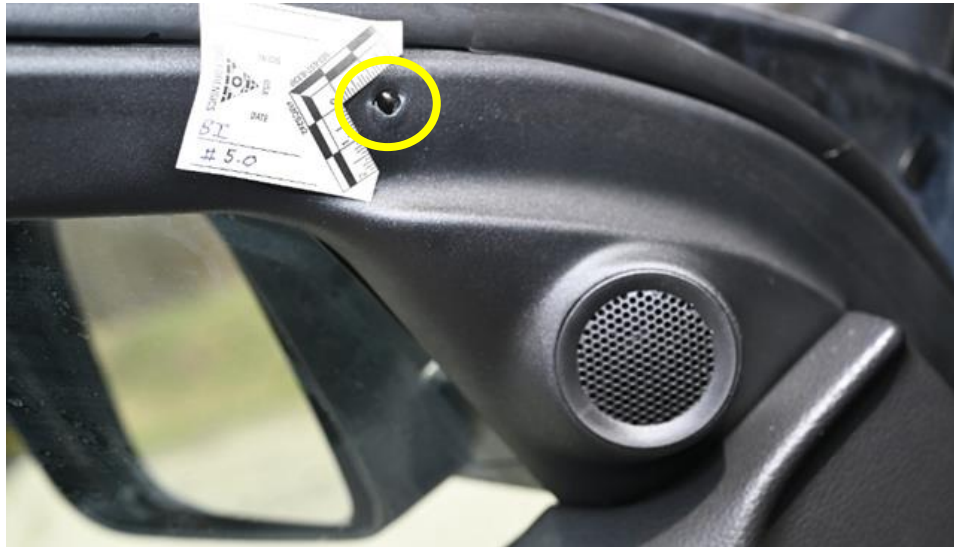
A fifth B.I. was observed on the interior molding of the driver's door of OSP Unit
[REDACTED]

**B.I. #5.0
Interior plastic molding on left front (driver's) door**

B.I. #5.0 A projectile penetrated the interior plastic molding of the driver's window frame, leaving a circular hole. The position of the driver's door when it was struck could not be determined. The projectile traveled from the interior side of the door outward. The projectile was not recovered.

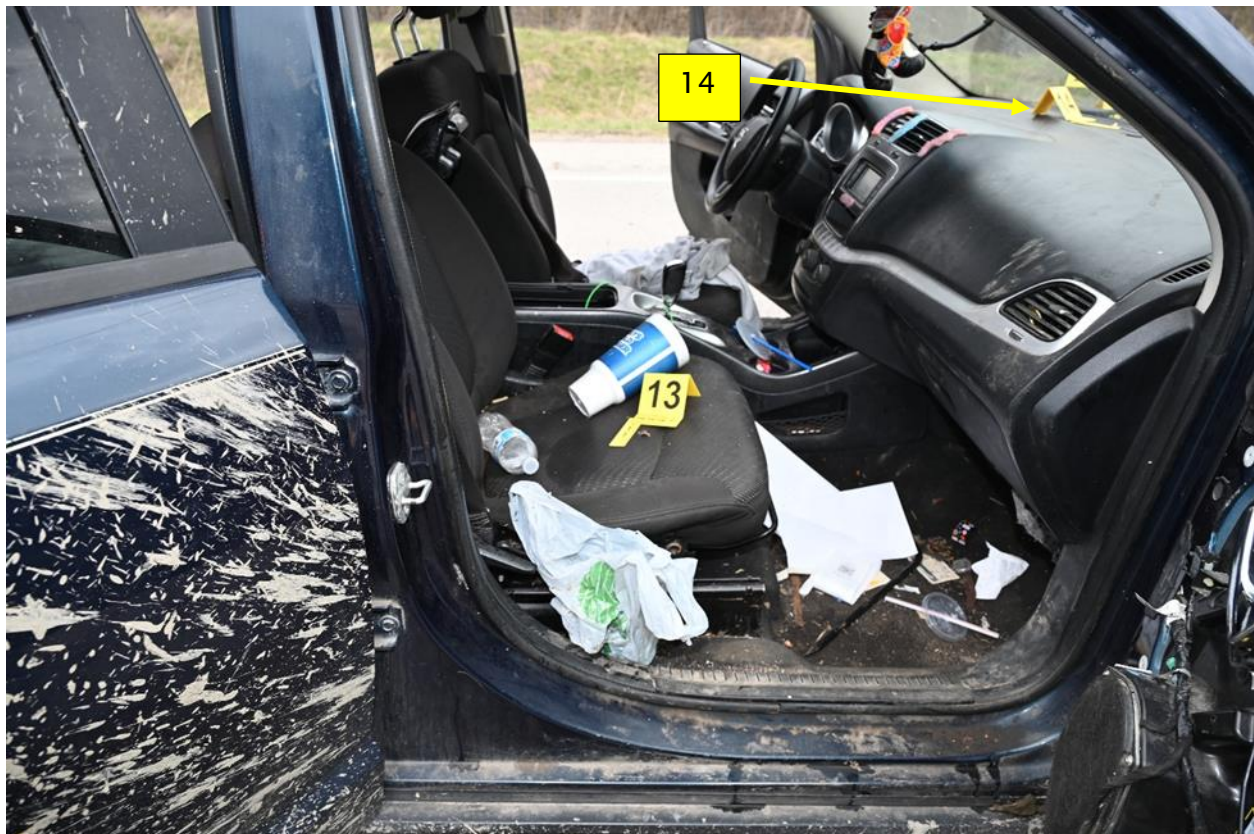
Location of Items 13 & 14

During the examination of the vehicle's interior, a copper jacket was located on the right front passenger seat (Item 13), and a projectile was located on the dashboard (Item 14). Additional items recovered included a GFL brand 9mm Luger cartridge found on the right front floor (Item 15) and a GFL brand 9mm Luger cartridge casing located on the left front floor (Item 16).

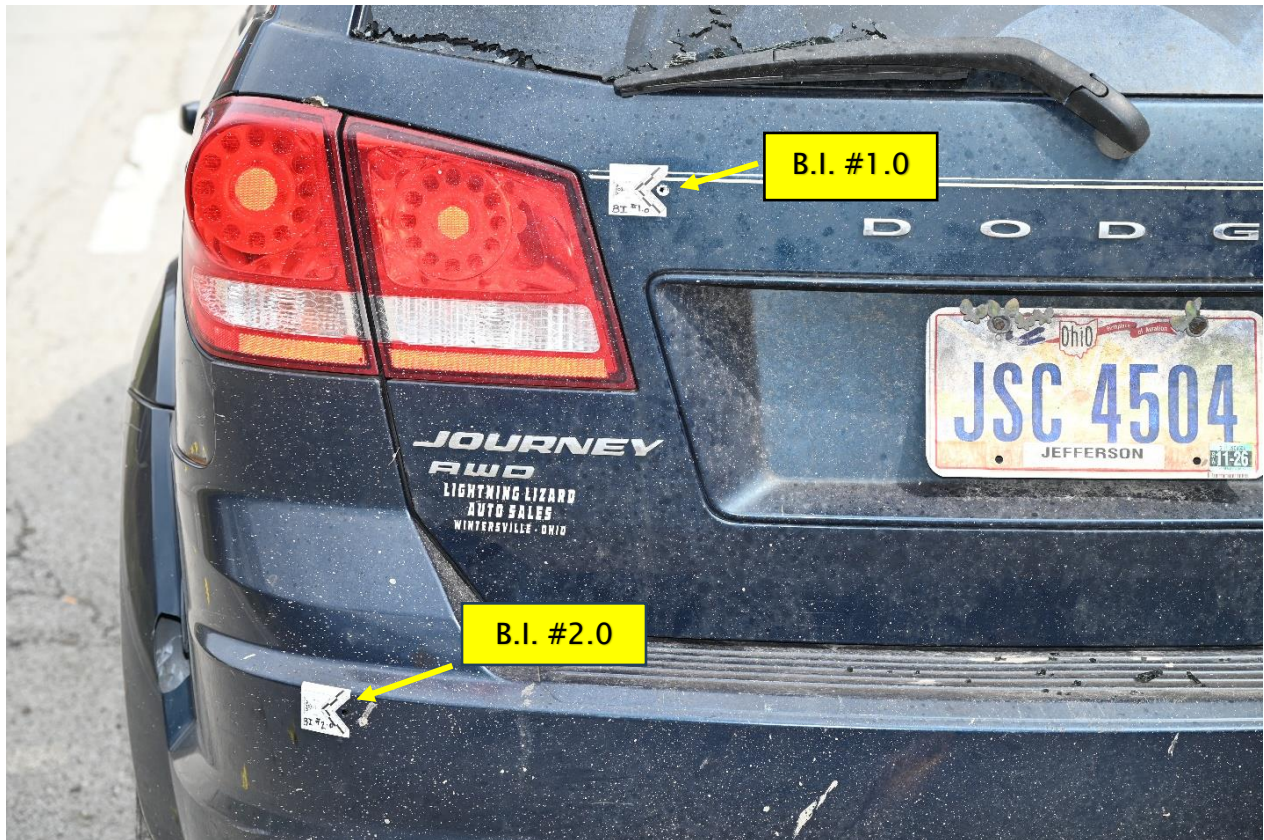
B.I. #1.0 & B.I. #2.0

Two ballistic impacts were observed on the rear of the Dodge Journey, and were marked as B.I. #1.0 and B.I. #2.0

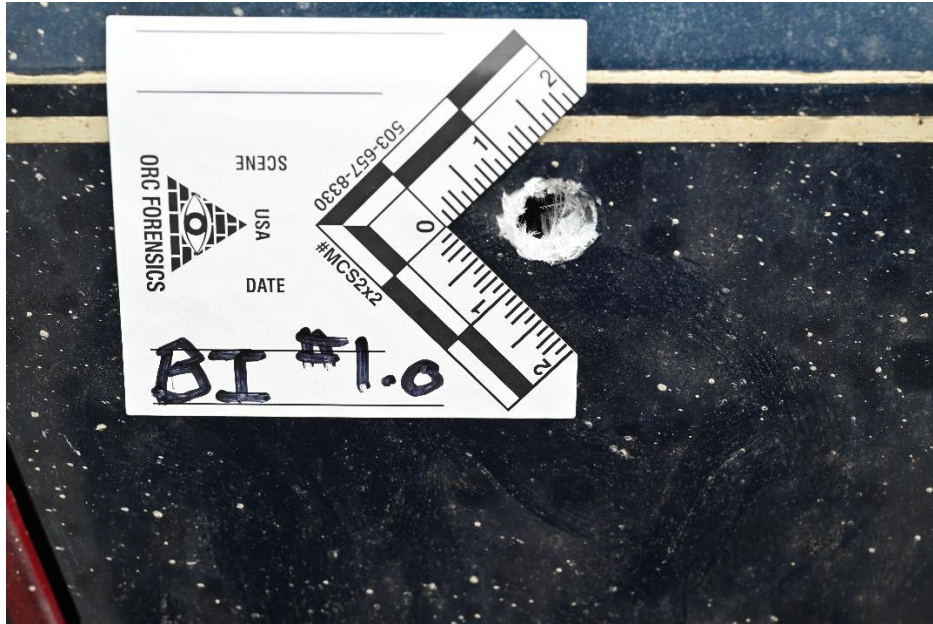
B.I. #1.0 The bullet perforated the rear tailgate leaving a symmetrical hole and traveled from back to front. A secondary impact was located on the interior side of the tailgate. The bullet continued into the passenger cabin.

After a trajectory rod was placed in B.I. #1.0 the area was scanned using the Leica BLK360 scanner to determine the trajectory that the bullet had traveled prior to striking the vehicle.

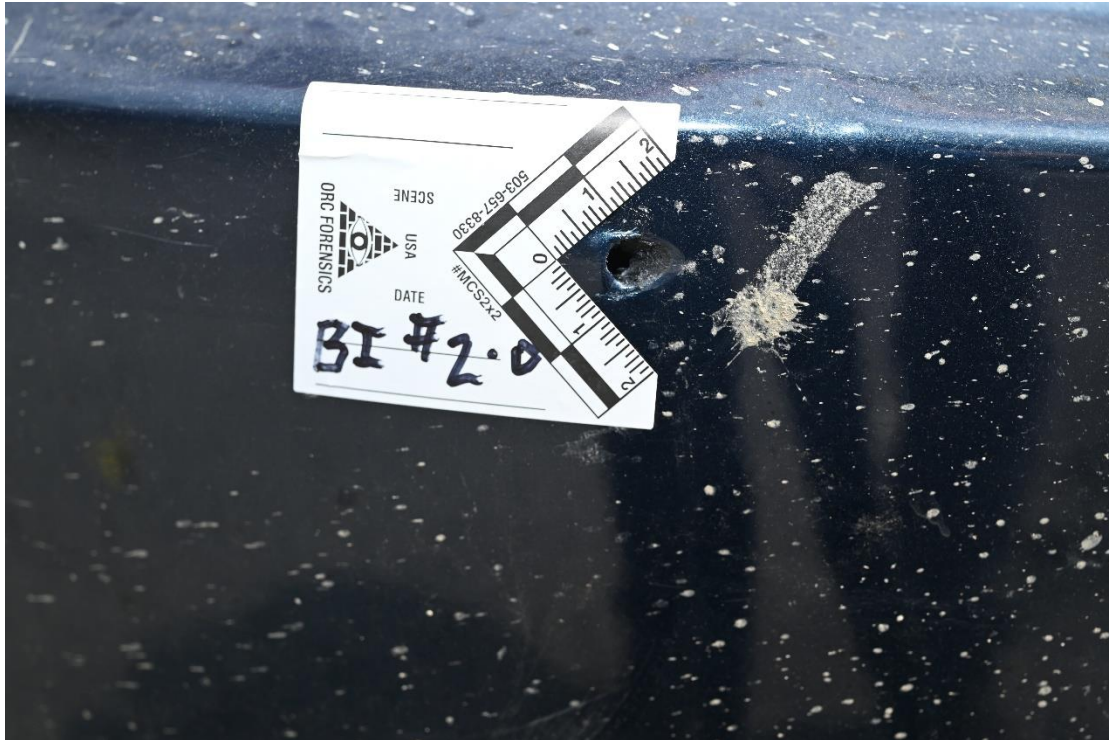
B.I. #2.0 The bullet perforated the left rear bumper traveling from back to front and right to left. A nearly symmetrical hole was made; however, a trajectory rod was unable to be inserted.

A piece of plastic was discovered on the pavement below a hole in the vehicle's left rear bumper, and the plastic trim behind the rear left tire was damaged. Based on the damage, it appeared as though the bullet entered the bumper on the rear of the vehicle, traveling right to left and back to front, and struck the rear bumper on the driver's side, behind the rear left tire. No bullet was recovered from this apparent impact.

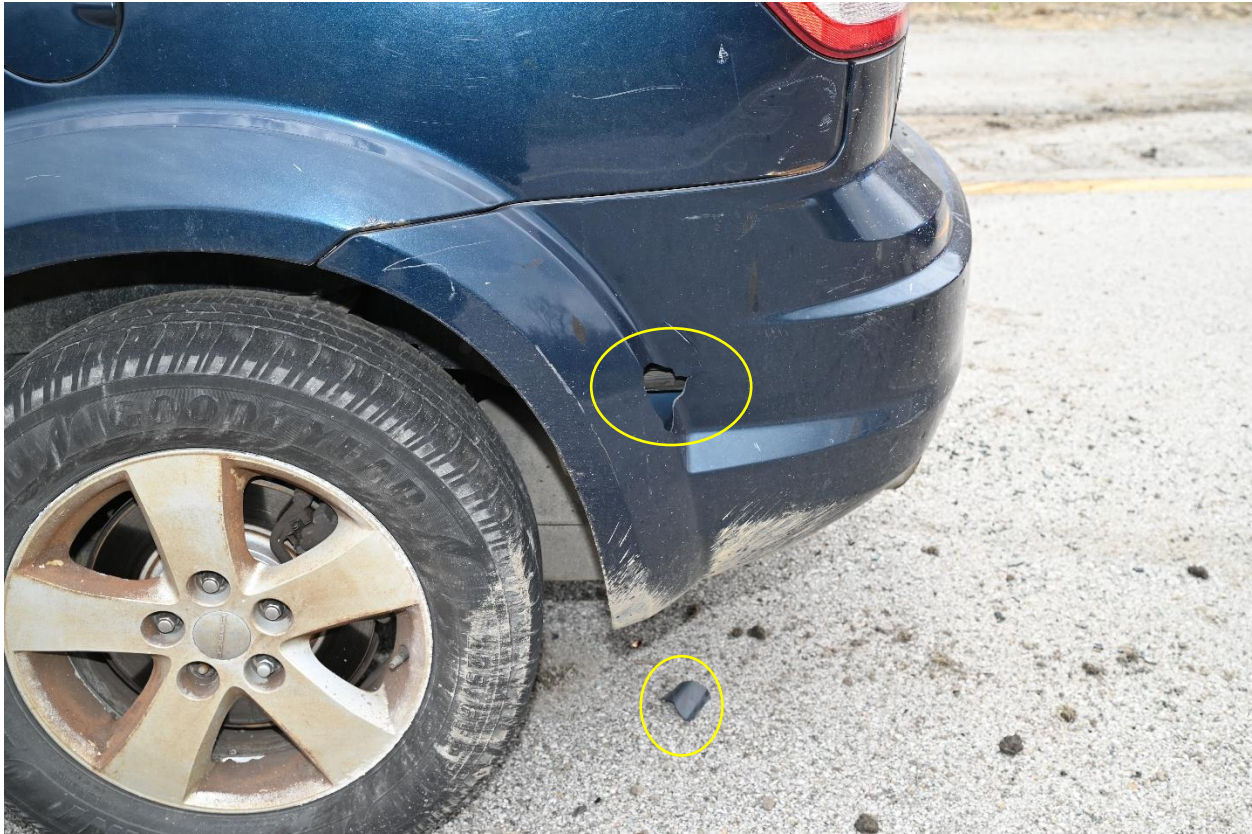
Damage on Dodge Journey's left rear bumper
