Ohio Attorney General's Office
Bureau of Criminal Investigation
Investigative Report

2023-1614

Officer Involved Critical Incident - 428 Foster Ave, Cambridge (L)

Investigative Activity: Processing of Vehicles (Scenes 3 &4)
Collection autopsy evidence (Scene 5)

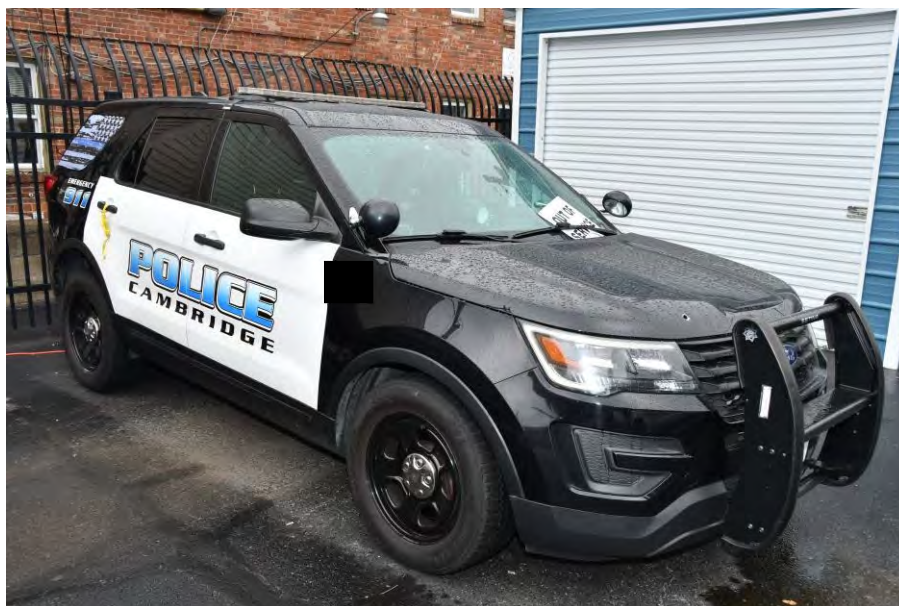
At approximately 0900 hours, SA Rowley met with Detective Angler who advised a search warrant would be obtained for the Tahoe while SA Rowley processed the police cruiser. SA Rowley photographed the cruiser as it was found upon arrival. Visible damage was observed on the passenger side hood as a suspected ballistic event (BE). Upon further examination the bullet appeared to have entered the hood (BE1) and continued into the engine compartment and struck the shock/strut support (BE 1.2). No projectile was recovered. The cruiser was leaking fluid and had a flat driver front tire. Captain Peoples stated the vehicle could be put on a lift at a tire shop near the impound lot. SA Rowley further inspected the vehicle on a lift and discovered BE2 that entered the front grill near the driver side. BE2 struck the radiator and penetrated the air box. The air filter was removed and a projectile was recovered as item 1. Both ballistic events on the cruiser had a general flight path of front to rear with a downward angle.

Image 2. Cruiser # [REDACTED] BE1 visible passenger side hood

No other items of evidence were recovered from cruiser # [REDACTED] and the vehicle was left at the shop for repairs.

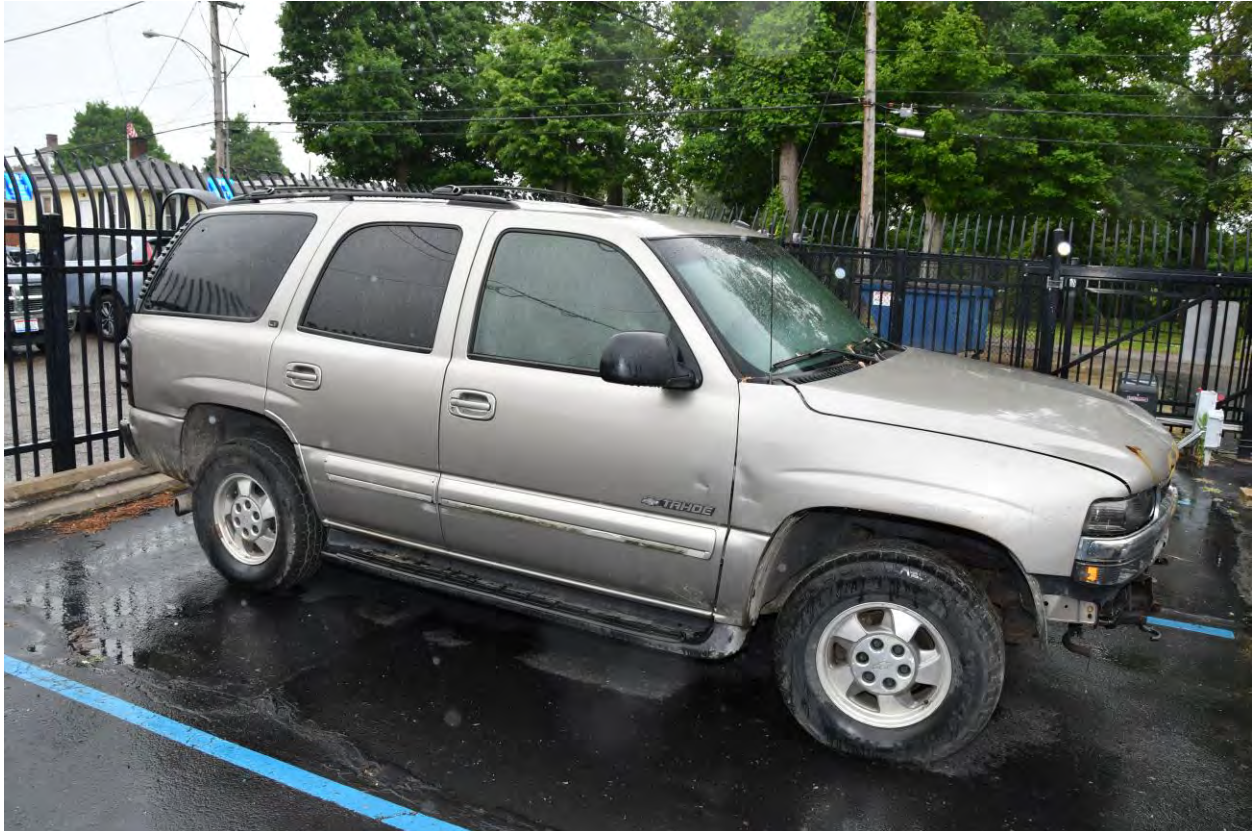
Image 3. 2002 Chevrolet Tahoe OH-JLE6671

Multiple ballistic events were observed on the exterior of the vehicle and labeled as BE1-BE8. A projectile was collected from the driver side dashboard (item #1) near a crack in the windshield labeled as BE1. BE2 was located on the roof of the front passenger side and was an elongated oval at a shallow angle that continued through the interior of the vehicle. BE2 had a general shot direction from passenger side to driver side. It appeared to have a flight path connected to item 1. BE3 was located on the rear passenger roof, was similar to BE2 in shape, and had the same general shot direction. A projectile was recovered embedded in the roof sheet metal at BE3 (item 2). No other projectiles were located and all ballistic events are detailed in the diagram below.
