# Ohio State Highway Patrol

## Crash Reconstruction Report

Crash Number: 12-0580-12  
Location: South Center Boulevard, City of Springfield, Clark County, Ohio  
Crash Date: June 13, 2021  
Primary Investigating Officer: Trooper B. Boutot, Ohio State Highway Patrol, Springfield

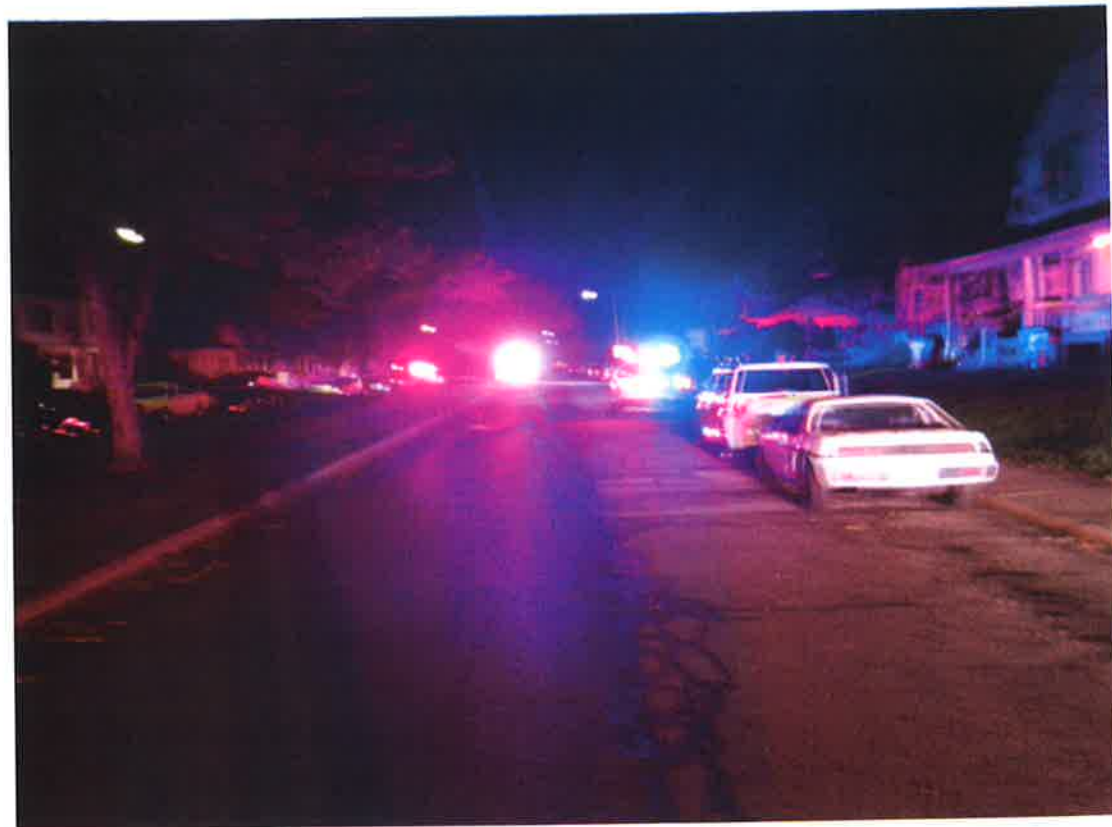
Image 1

The photograph to the right is taken looking south on South Center Boulevard.

As mentioned in section 3.1, it is clear the color difference in the road. South Center Boulevard was paved with an overlay patch in summer 2020.

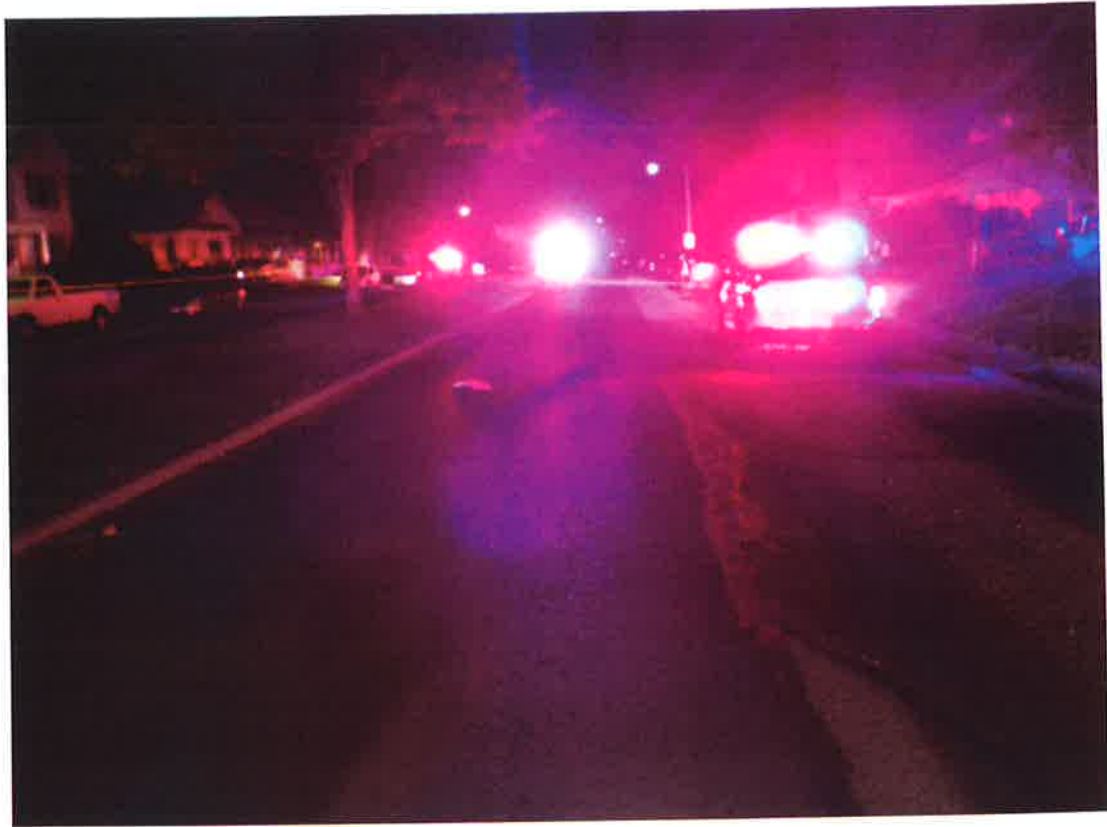
Image 2

Continuing south on South Center Boulevard. An object is seen in the left portion of the road.

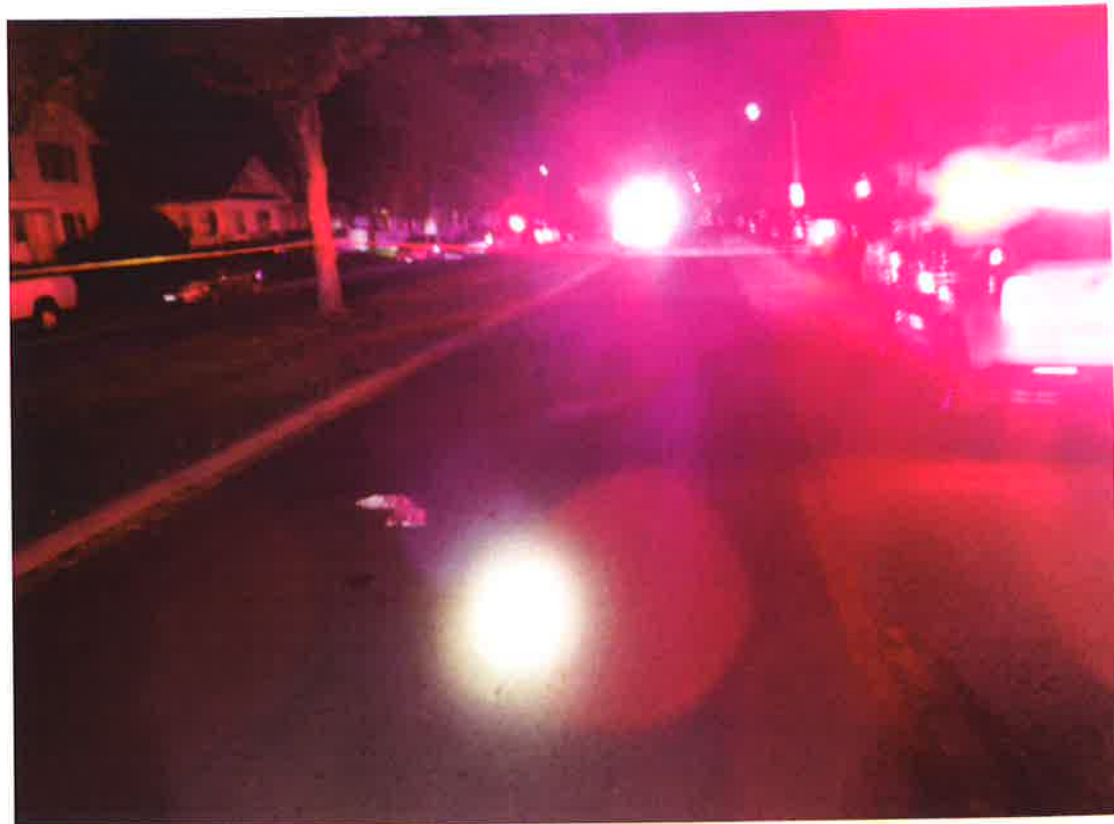
Image 3

Closer to the object in the roadway.

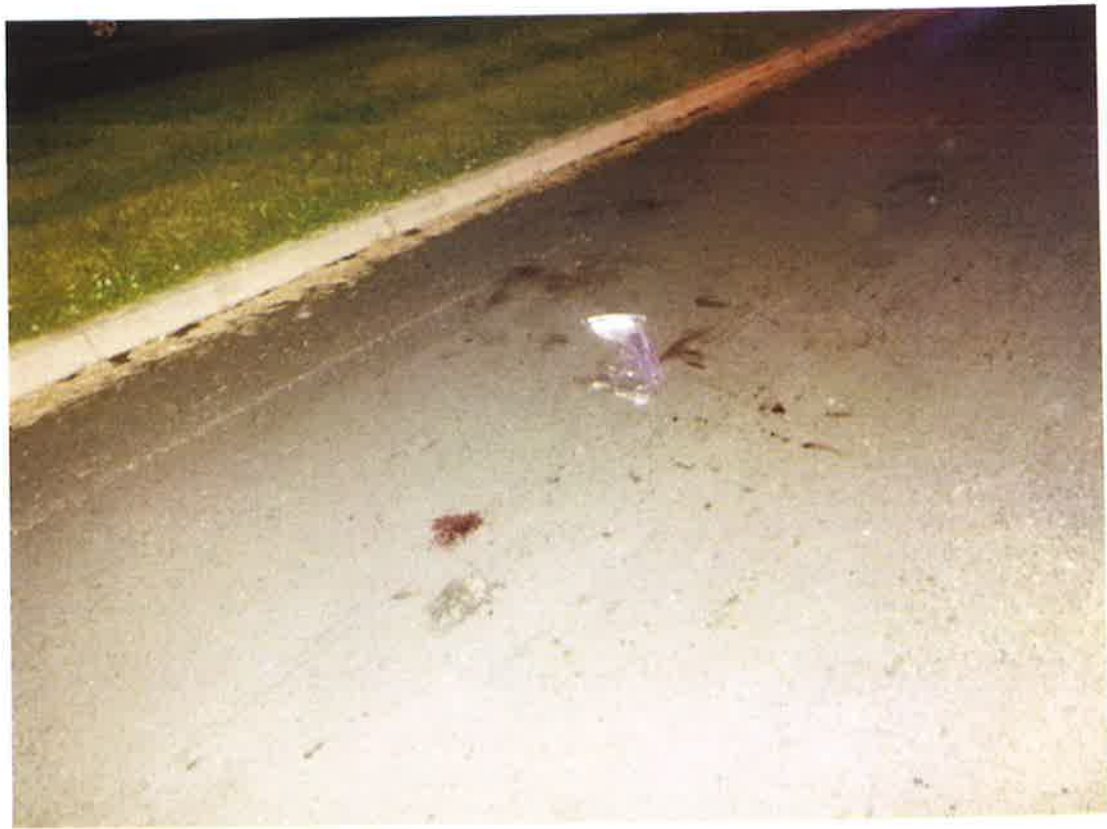
Image 4

Closer to the object, it is a plastic object, potentially from rendering aid to Eric Cole. Also blood is noticeable on the pavement.

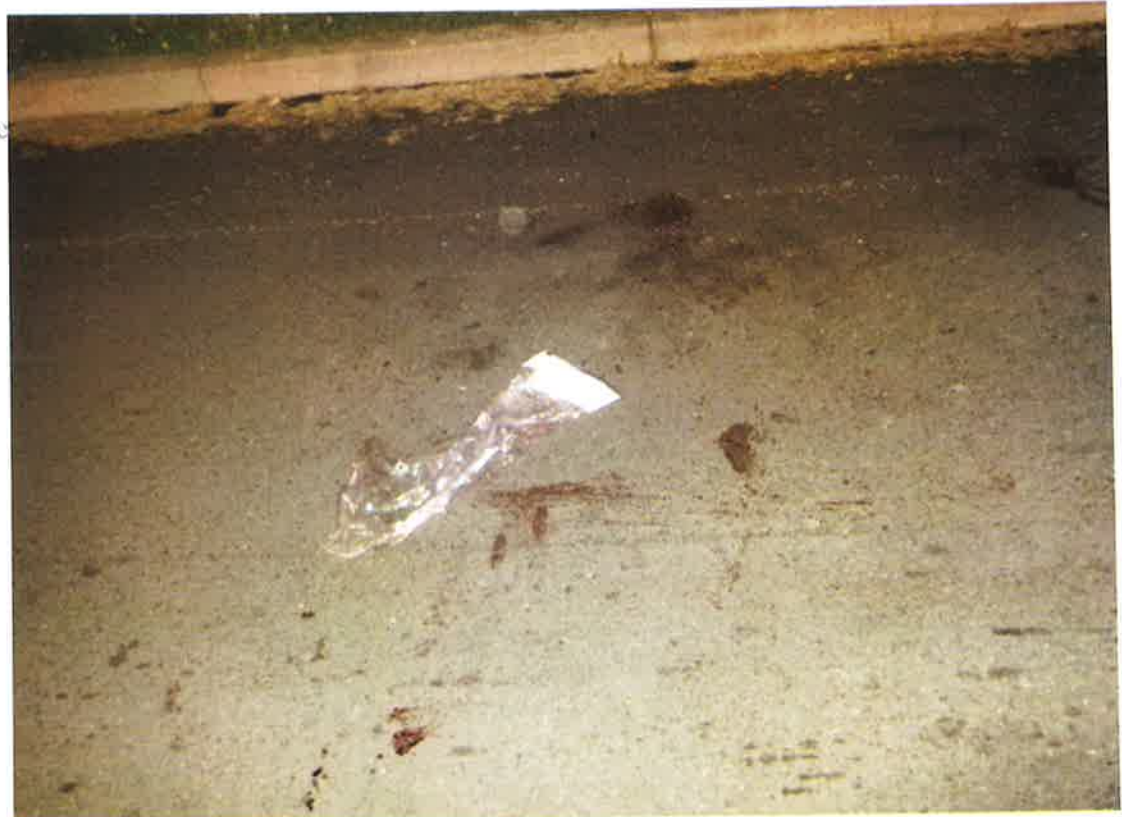
Image 5

Closer to the plastic bag of some sort, in addition to the blood on the pavement.

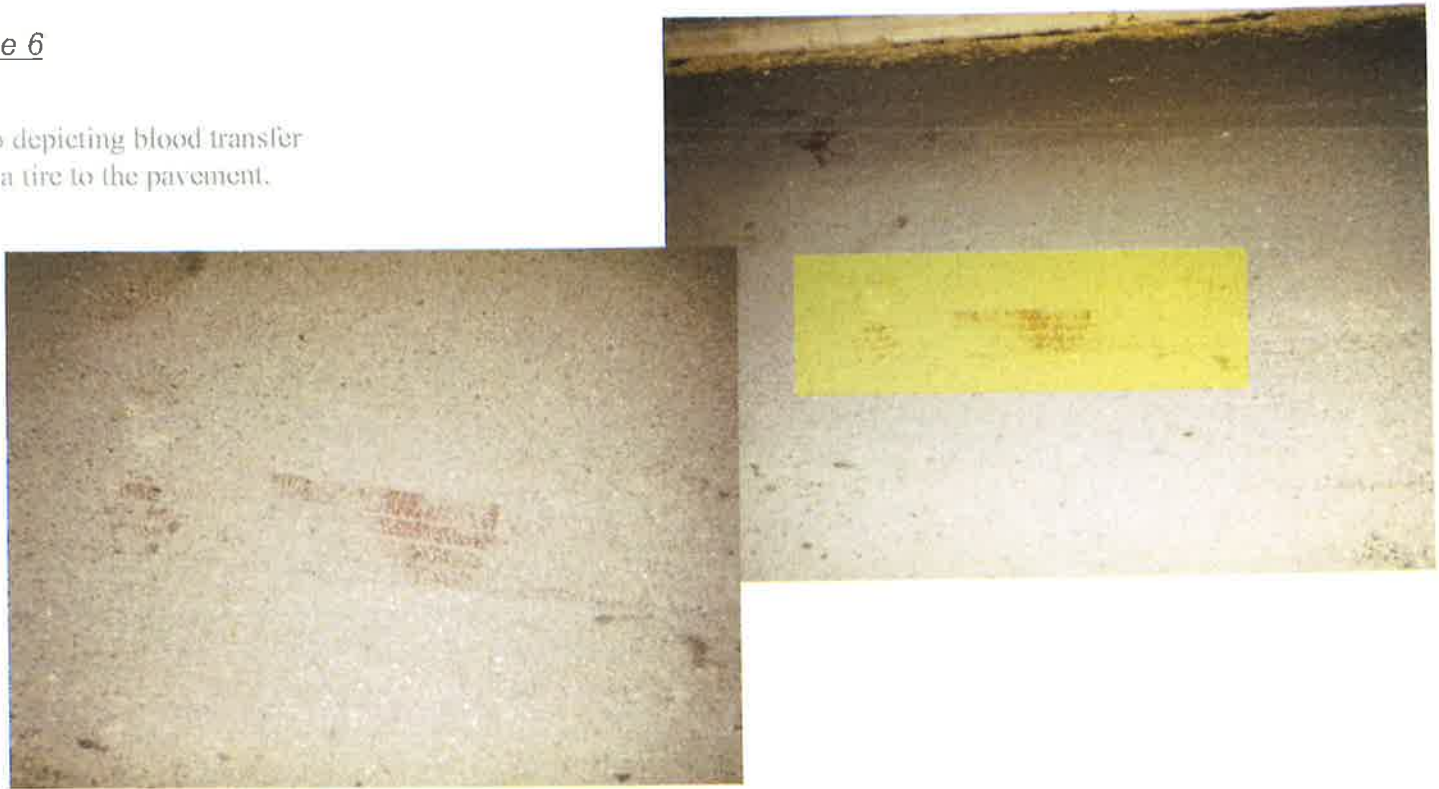
Image 6

Photo depicting blood transfer from a tire to the pavement.

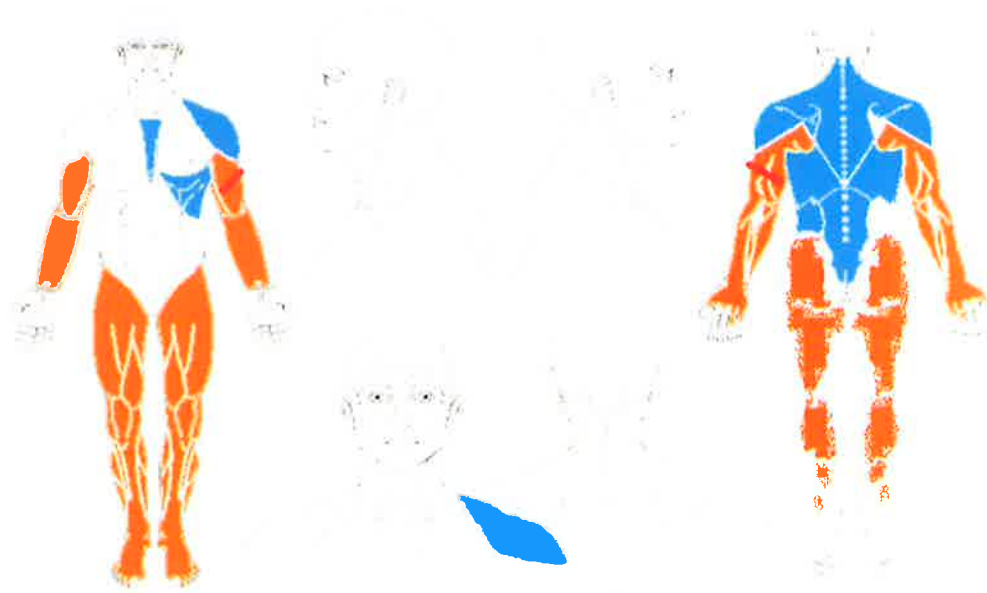
*Cole's Injuries Depicted (as interpreted)*

Pathologist. Figure 2 was produced to provide a visual aid of injuries. It is not intended to serve as an exact model of Eric Cole's injuries.

- Blunt force trauma of the torso (blue):
  - Abrasions of the back and left lower chest
  - Laceration of the left shoulder/back
  - Fracture of the sternum and multiple ribs (left, 1-10)

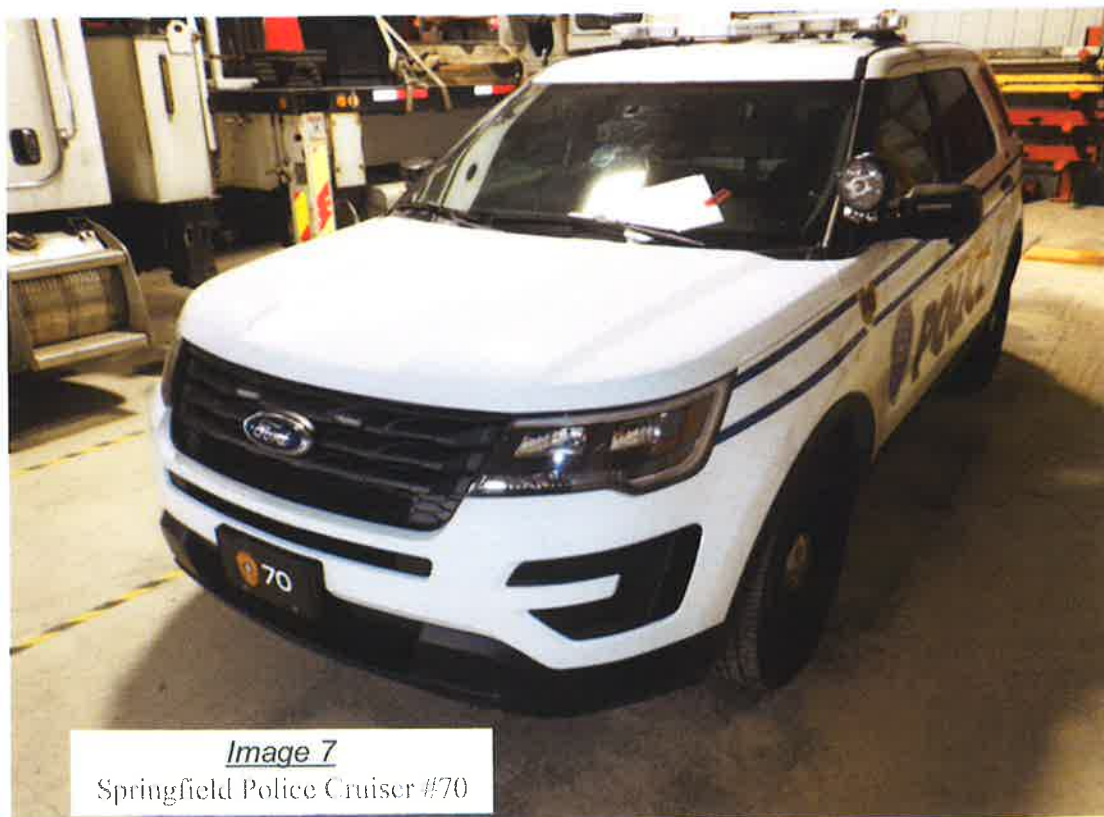
Image 7  
Springfield Police Cruiser #70

Troopers on scene noted on the crash report, the headlights were checked and working properly.

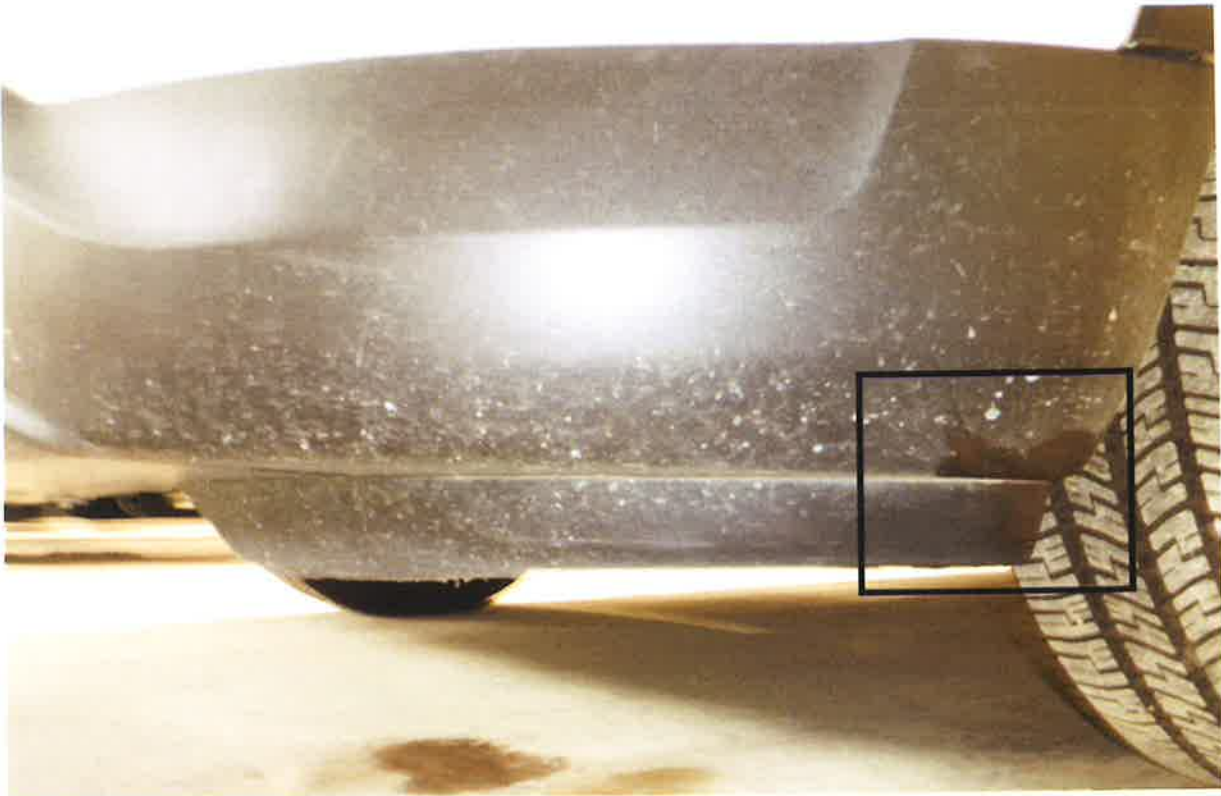
Image 8  
Blood on plastic splash guard

The Ford did not receive any contact damage as a result of the crash. What was documented was the transfer of blood onto the vehicle. Blood was located on the left front corner of plastic splash guard below left front fender <sup>Image 8</sup>.

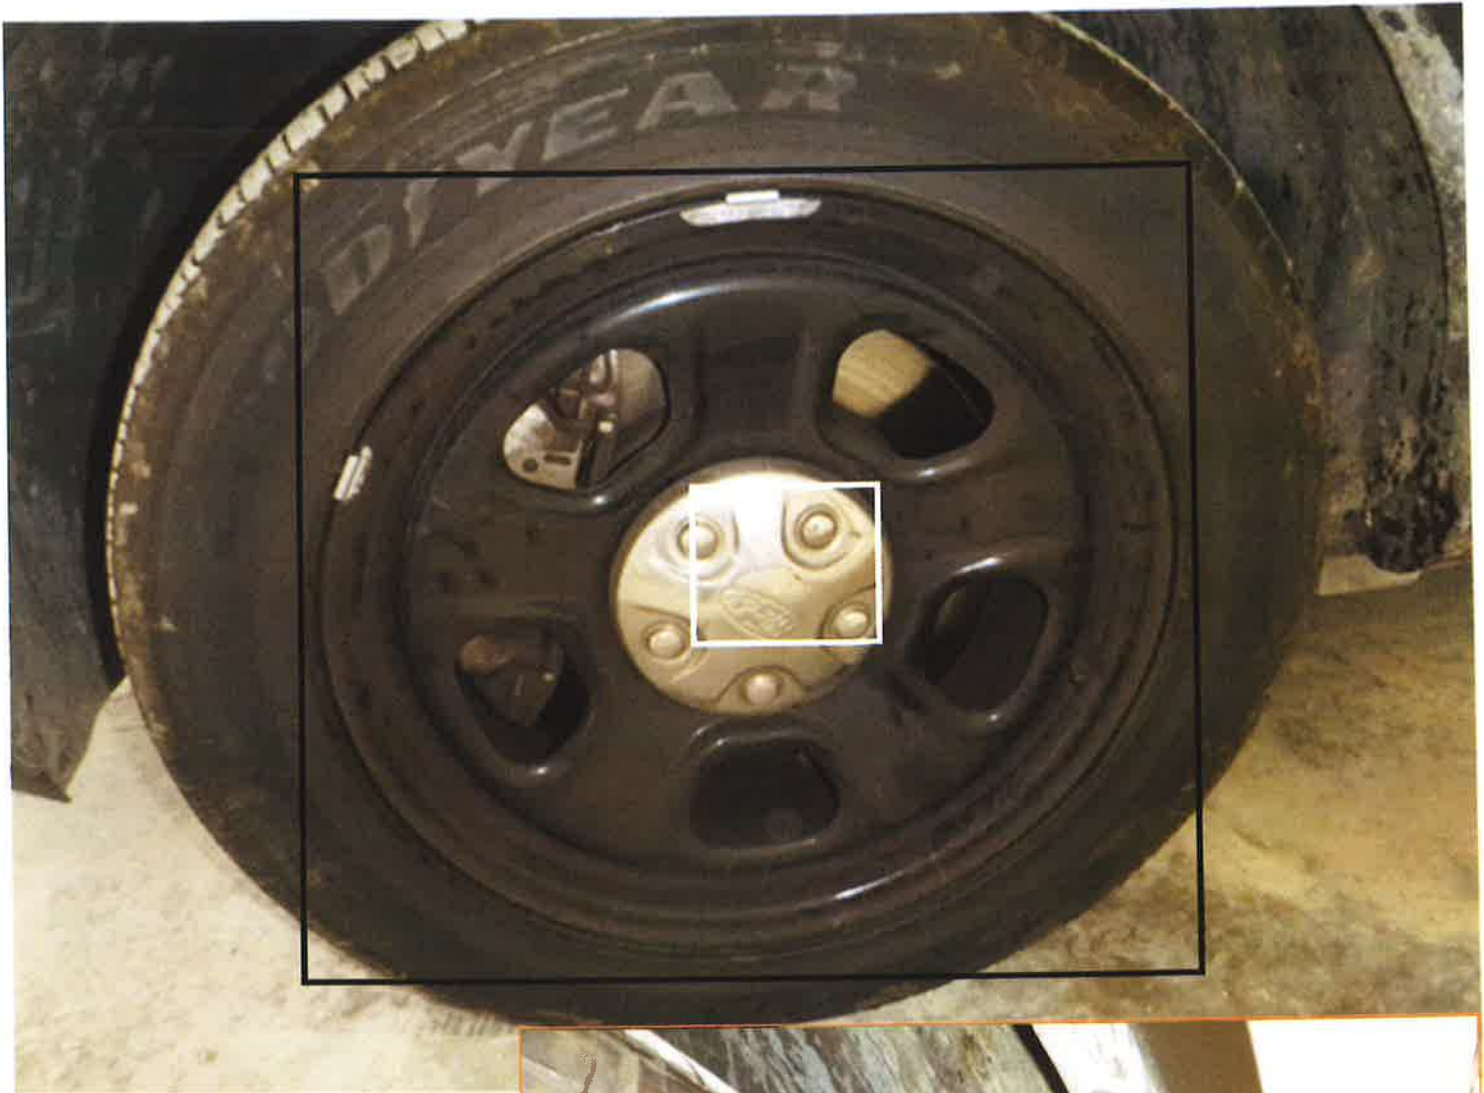
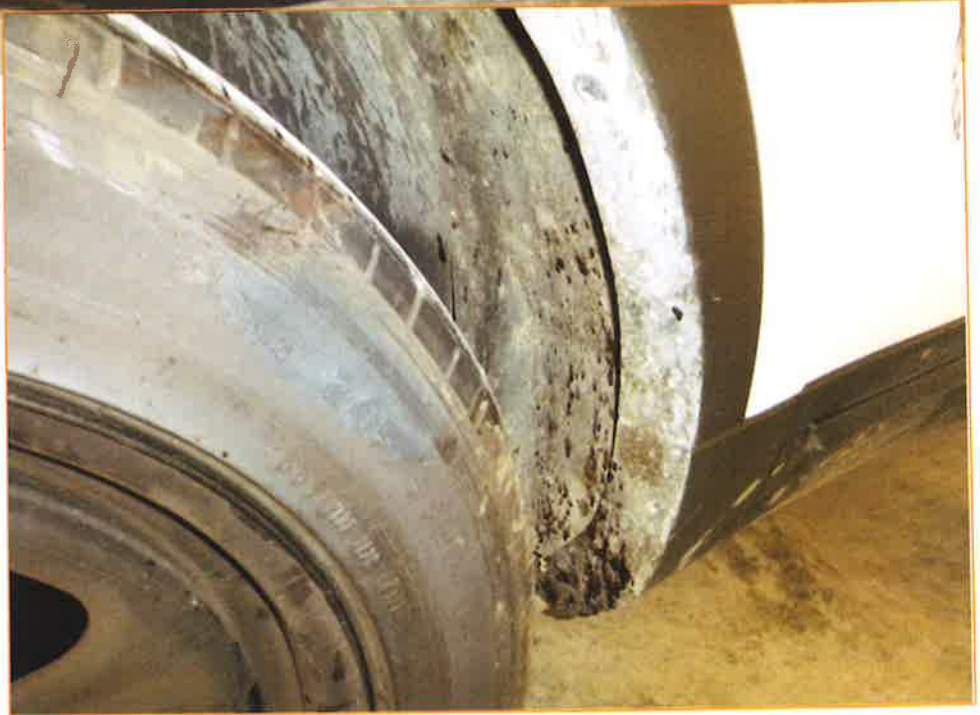
*Image 9*  
Blood on front left wheel  
(Including hub cap and wheel well)

Blood transfer was located on the left front tire, to include the hub cap and in the wheel well. <sup>Image 9</sup>.

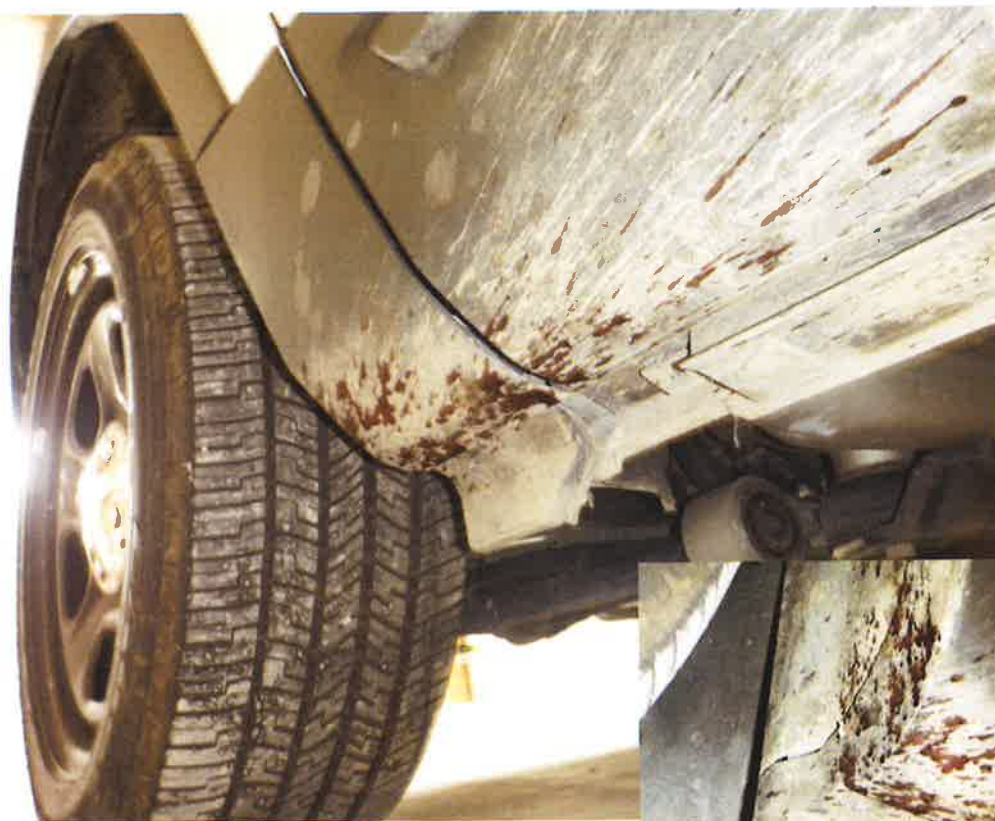
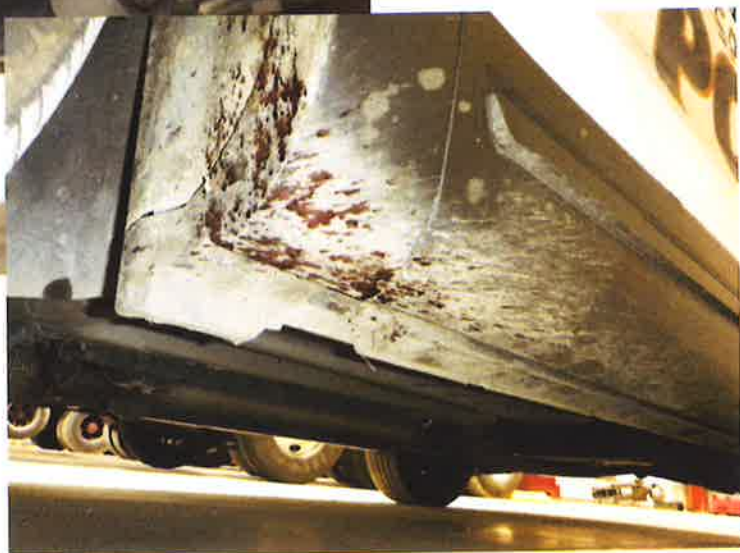
Image 10  
Blood on left rocker panel

Lastly, blood was visible on the underside of the left rocker panel <sup>Image 10</sup>.
