## Ohio Attorney General's Office **Bureau of Criminal Investigation** Investigative Report

2024-4066 Officer Involved Critical Incident - 1004 Park Lane, Apartment A, Middletown, Ohio (Butler County) (L)

Investigative Activity:	Re-examination of Bullet Hole
Involves:	Christopher Gorak
Activity Date:	01/07/2025
Activity Location:	1004 Park Lane, Apartment A, Middletown Ohio
Authoring Agent:	Crime Scene Technician Holly Ryczek #205

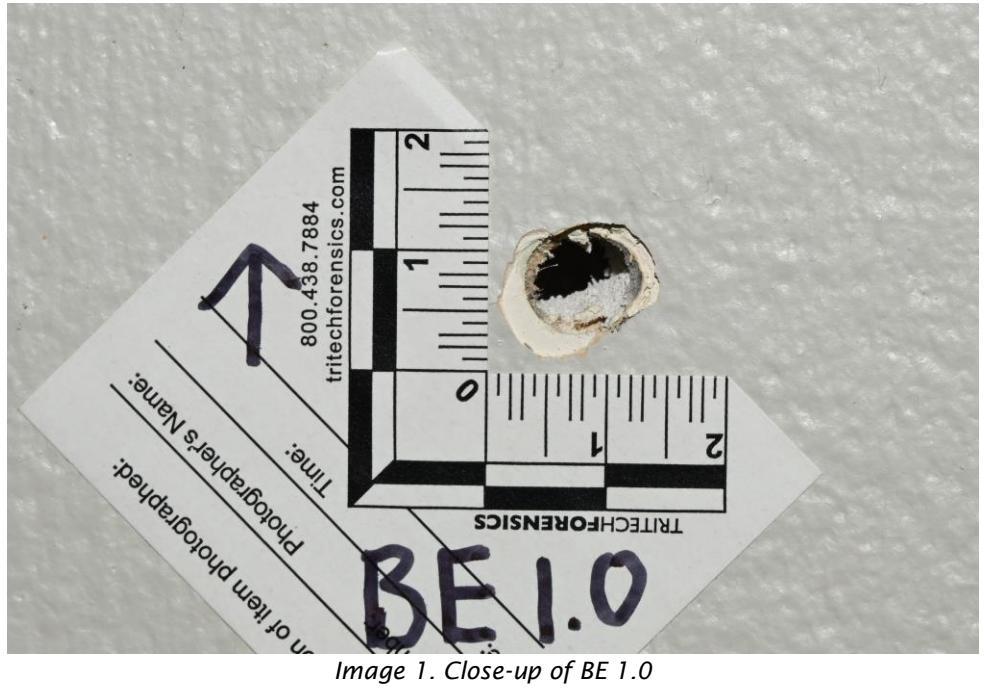
Image 1. Close-up of BE 1.0

A suspected bullet hole was located on the north interior wall of the living room to the west of the sliding glass balcony door. The hole was labeled as BE 1.0 for identification purposes. It was oval in shape and dark margins of suspected bullet wipe<sup>1</sup> were observed on the periphery of the hole. A lead-in mark<sup>2</sup> was observed on the right side of the oval. The bullet that created BE 1.0 penetrated the interior wall and no exit was observed on the opposite side of the wall which was brick.

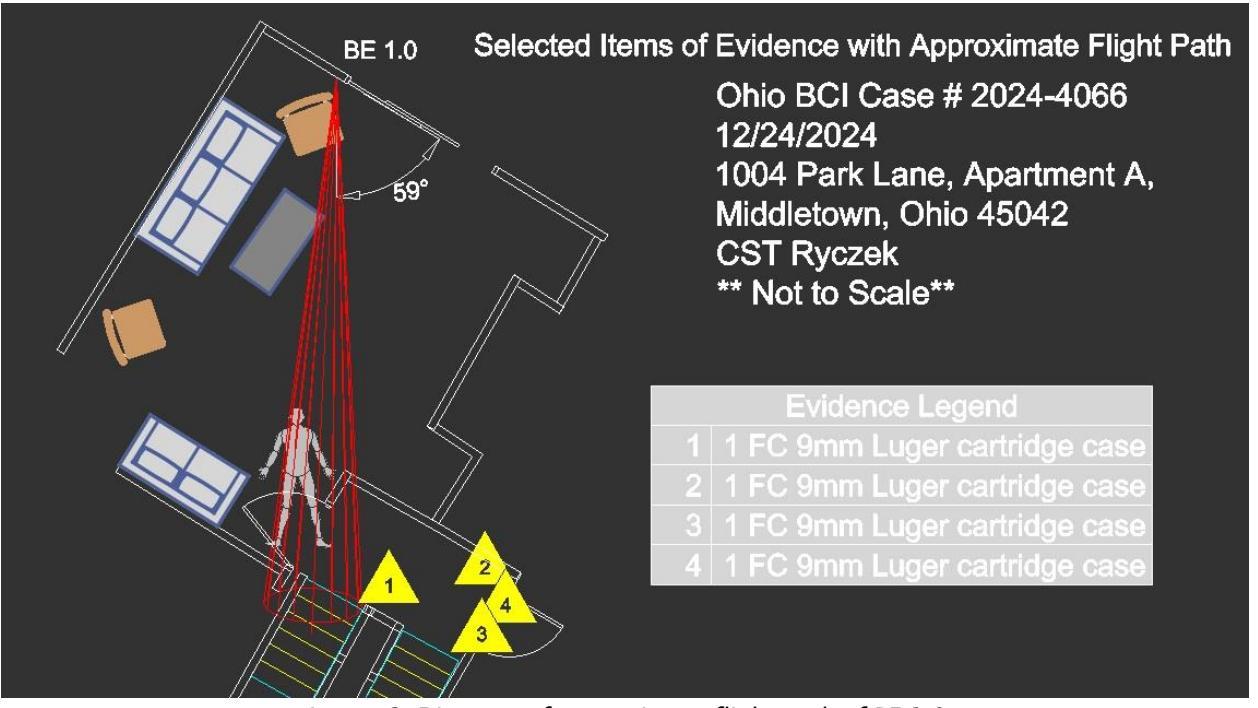
Image 2. Diagram of approximate flight path of BE 1.0

Before cutting into the wall to search for a potential projectile, a trajectory rod was placed into BE 1.0. CST Ryczek utilized a laser connected to the trajectory rod to visualize the flight path of BE 1.0. In general, this indicated the muzzle was in the general area of the hallway stairwell.

Angular measurements of the trajectory rod were taken on scene, and it was found that the projectile penetrated the wall at a downward angle of three degrees and 59 degrees horizontally (from right to left), relative to the interior wall of the residence.

Once the wall was cut, it was observed that the projectile perforated the drywall (BE 1.0), perforated a stud (BE 1.1 and 1.2) and penetrated a thin piece of wood that was against the interior of the brick wall (BE 1.3). The wall and surrounding area were searched for a projectile; however none was recovered.
