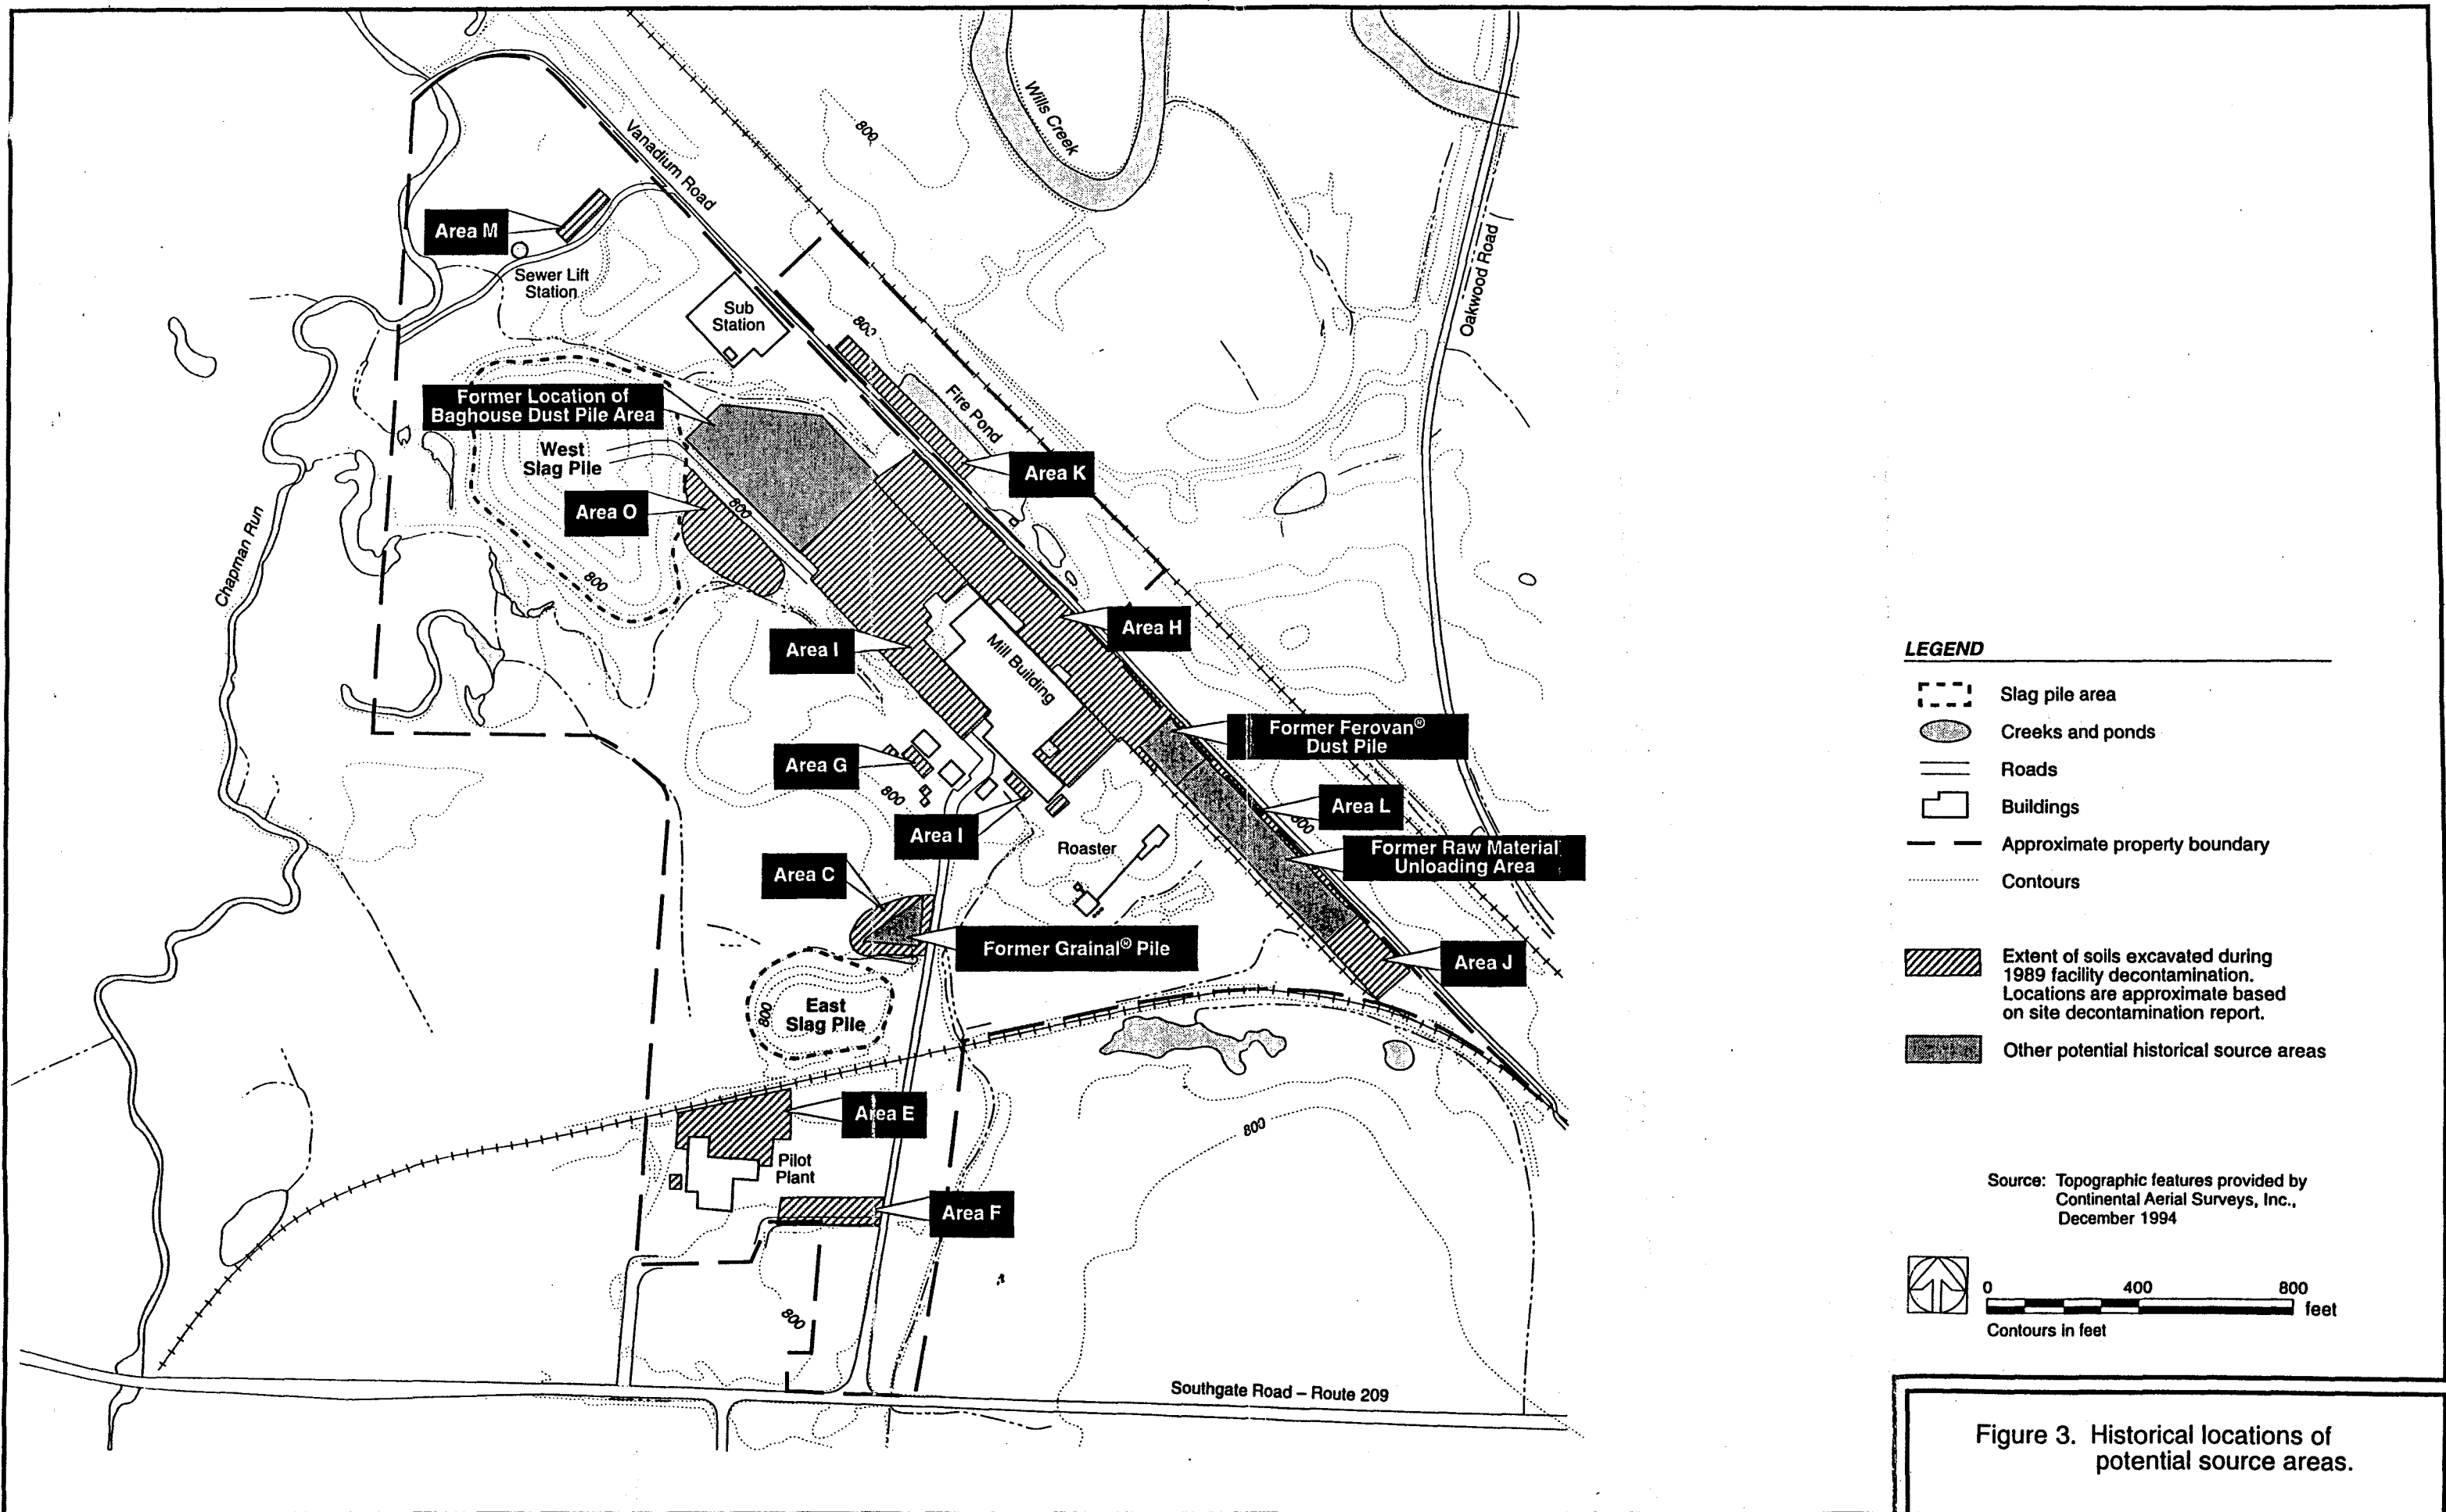
**Figure 3. Historical locations of potential source areas.**

Extent of soils excavated during 1989 facility decontamination. Locations are approximate based on site decontamination report.
-

Other potential historical source areas

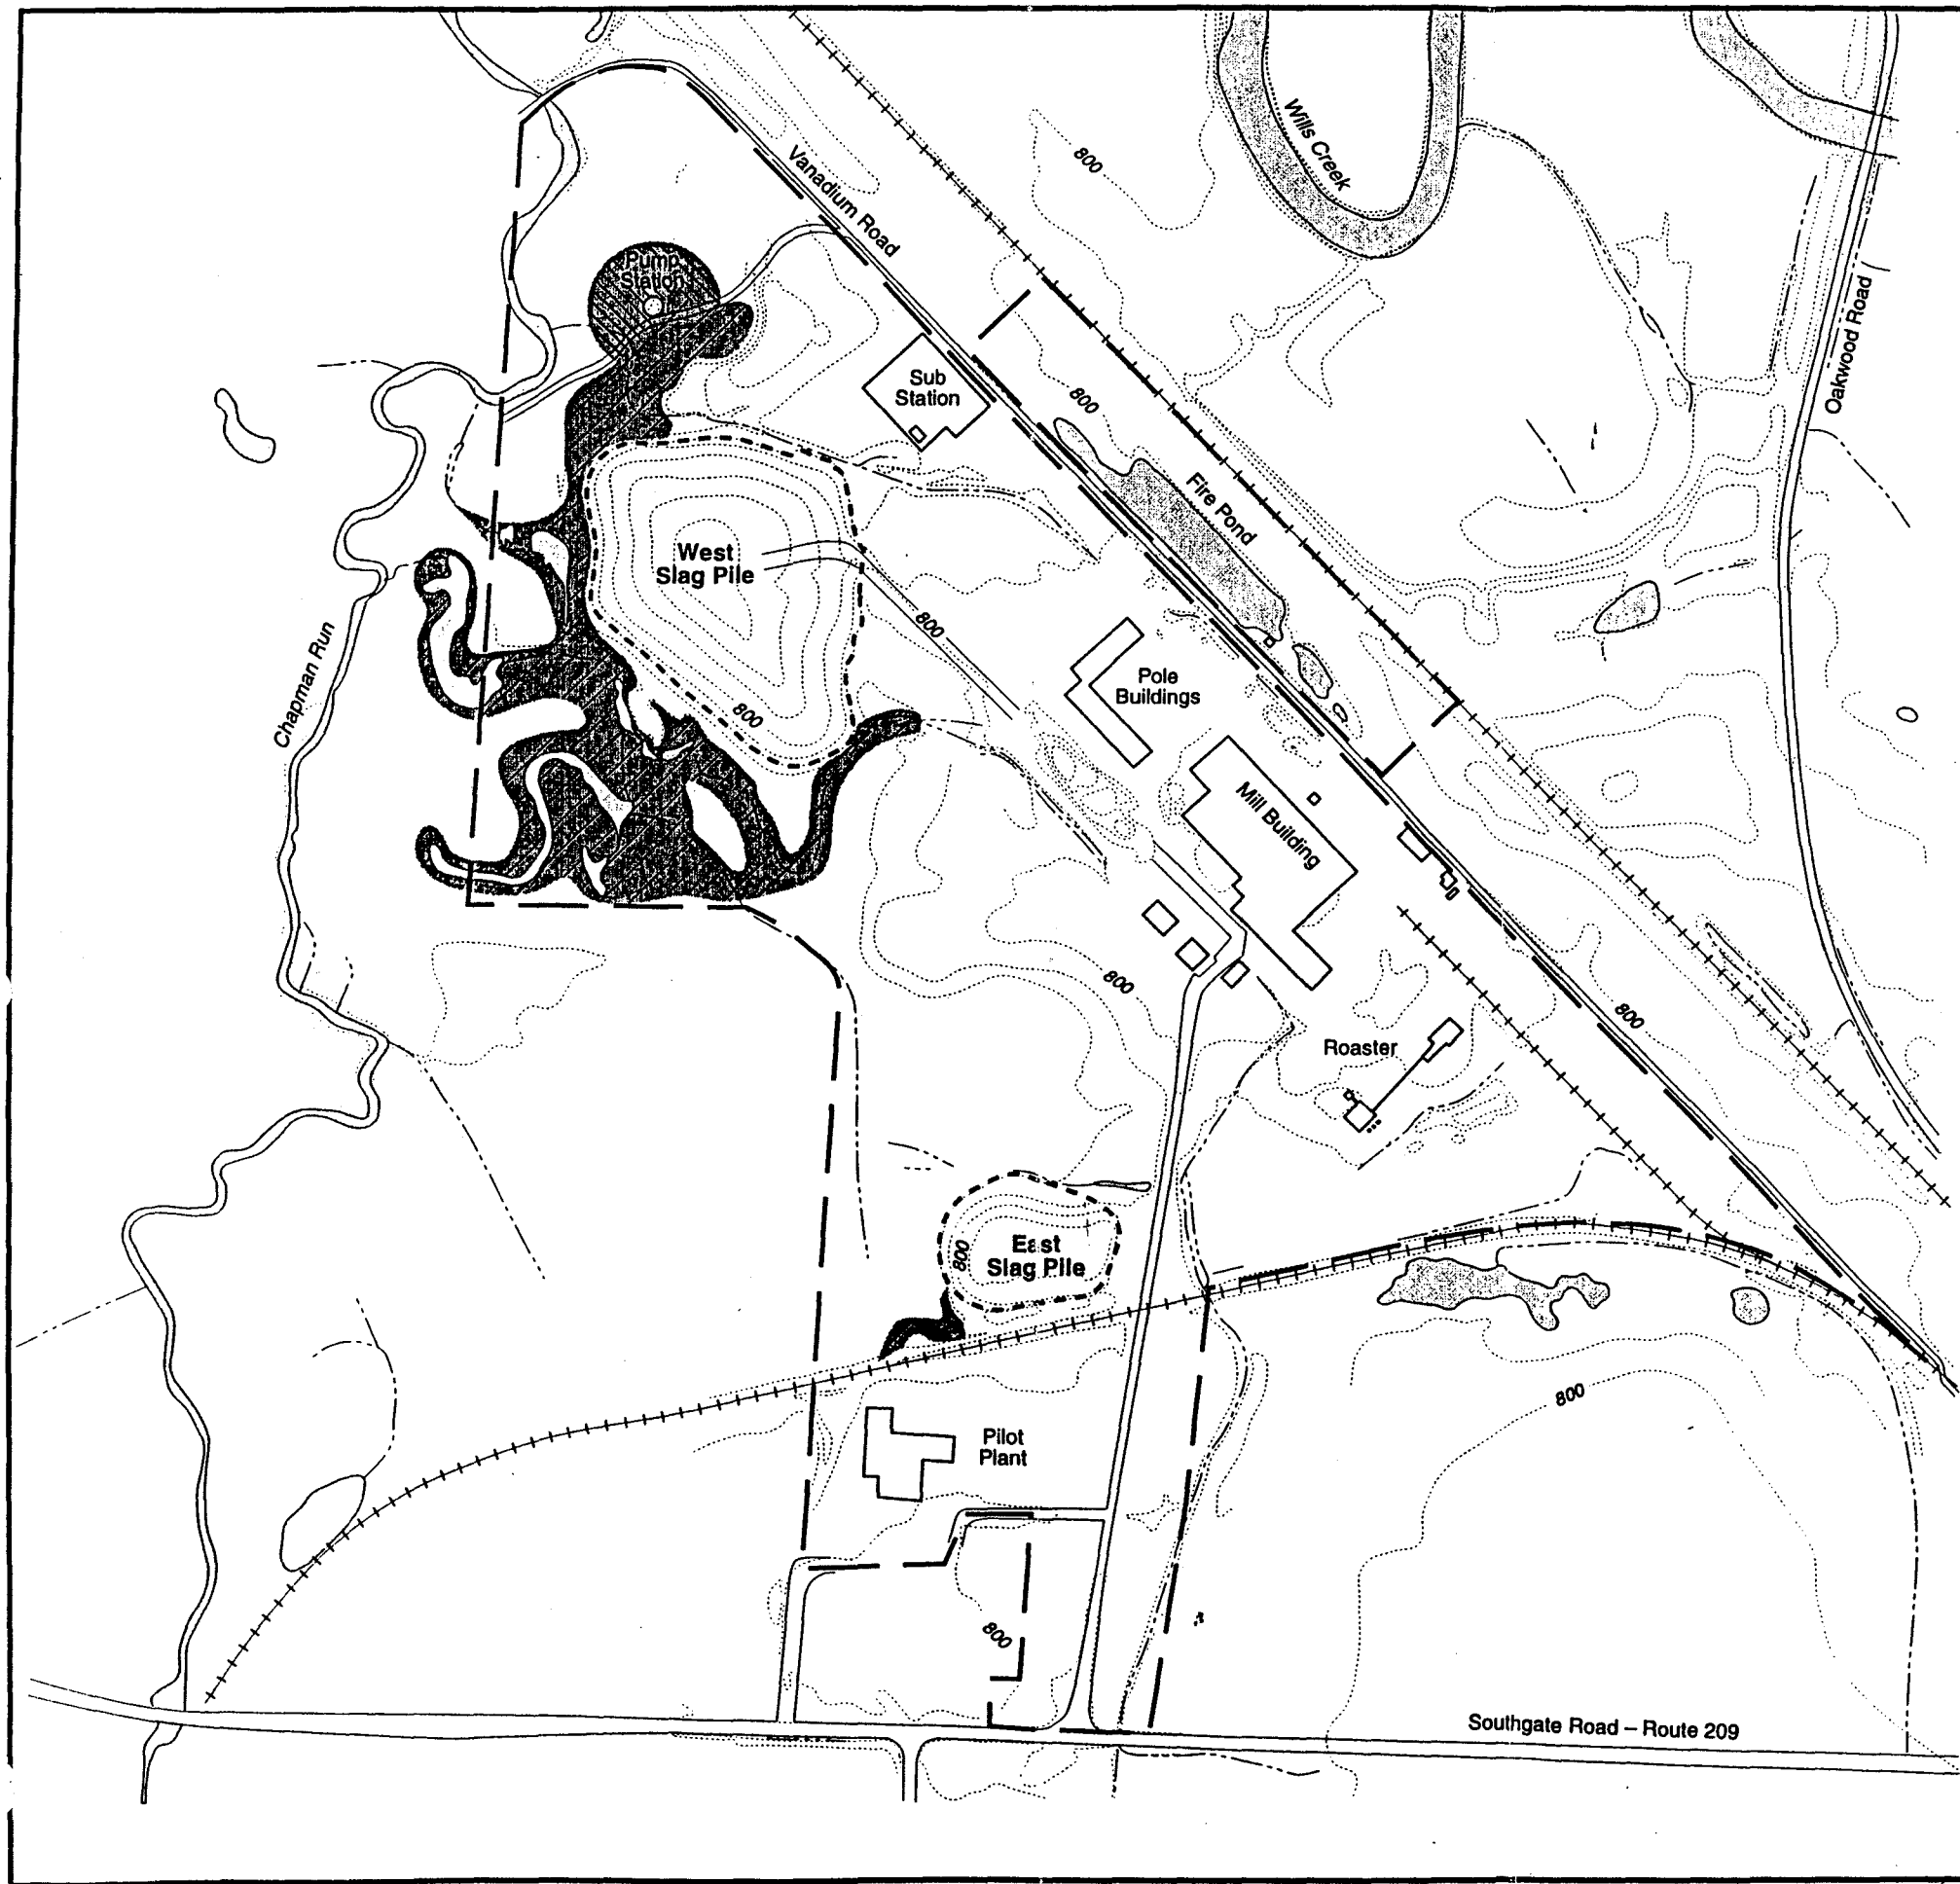
**Figure 5. Preliminary area of potential concern for wetland soil.**

Area of potential concern
-

Area of potential concern previously disturbed during construction of new pump station

Note: These areas will be refined upon completion of additional ecological studies.

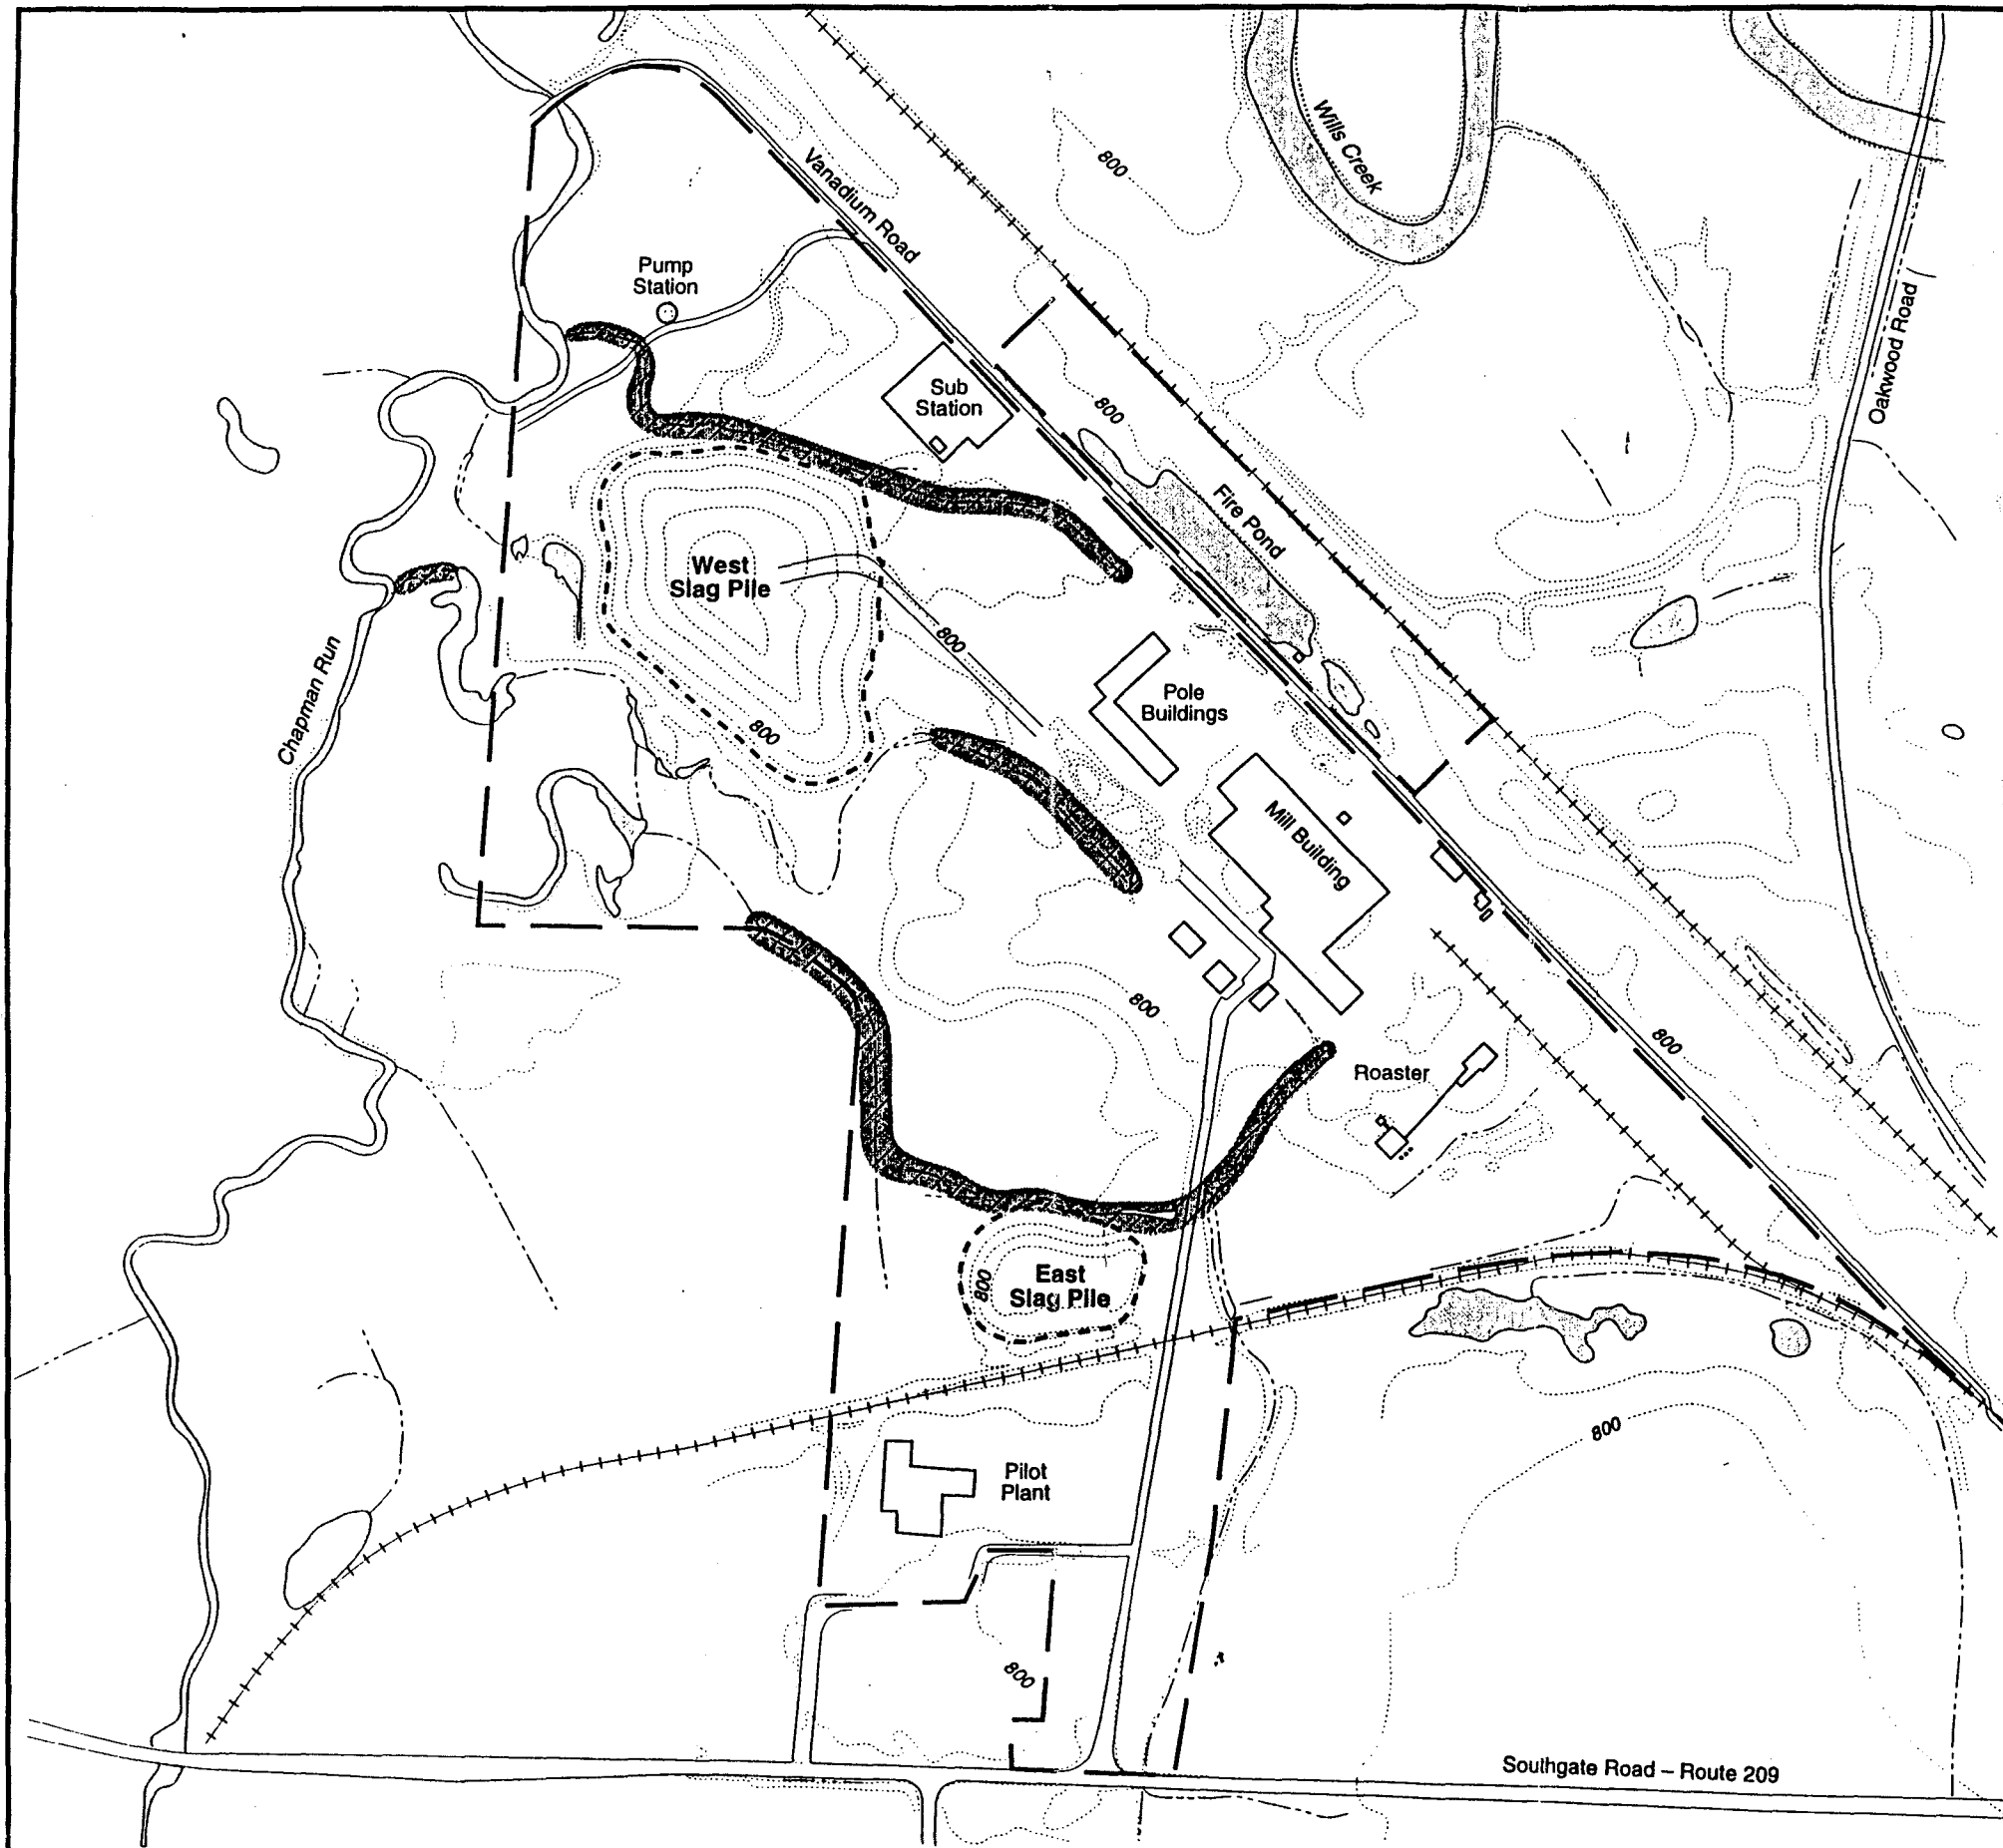
Figure 6. Preliminary area of potential concern for onsite sediment.

Note: Areas of potential concern include in-channel sediments only. These areas will be refined through further sampling in the remedial design phase in conjunction with the use of the PRG for sediments and the consideration of other factors (e.g., short term environmental effects).

Note: Area of potential concern extends along Chapman Run to confluence with Wills Creek.

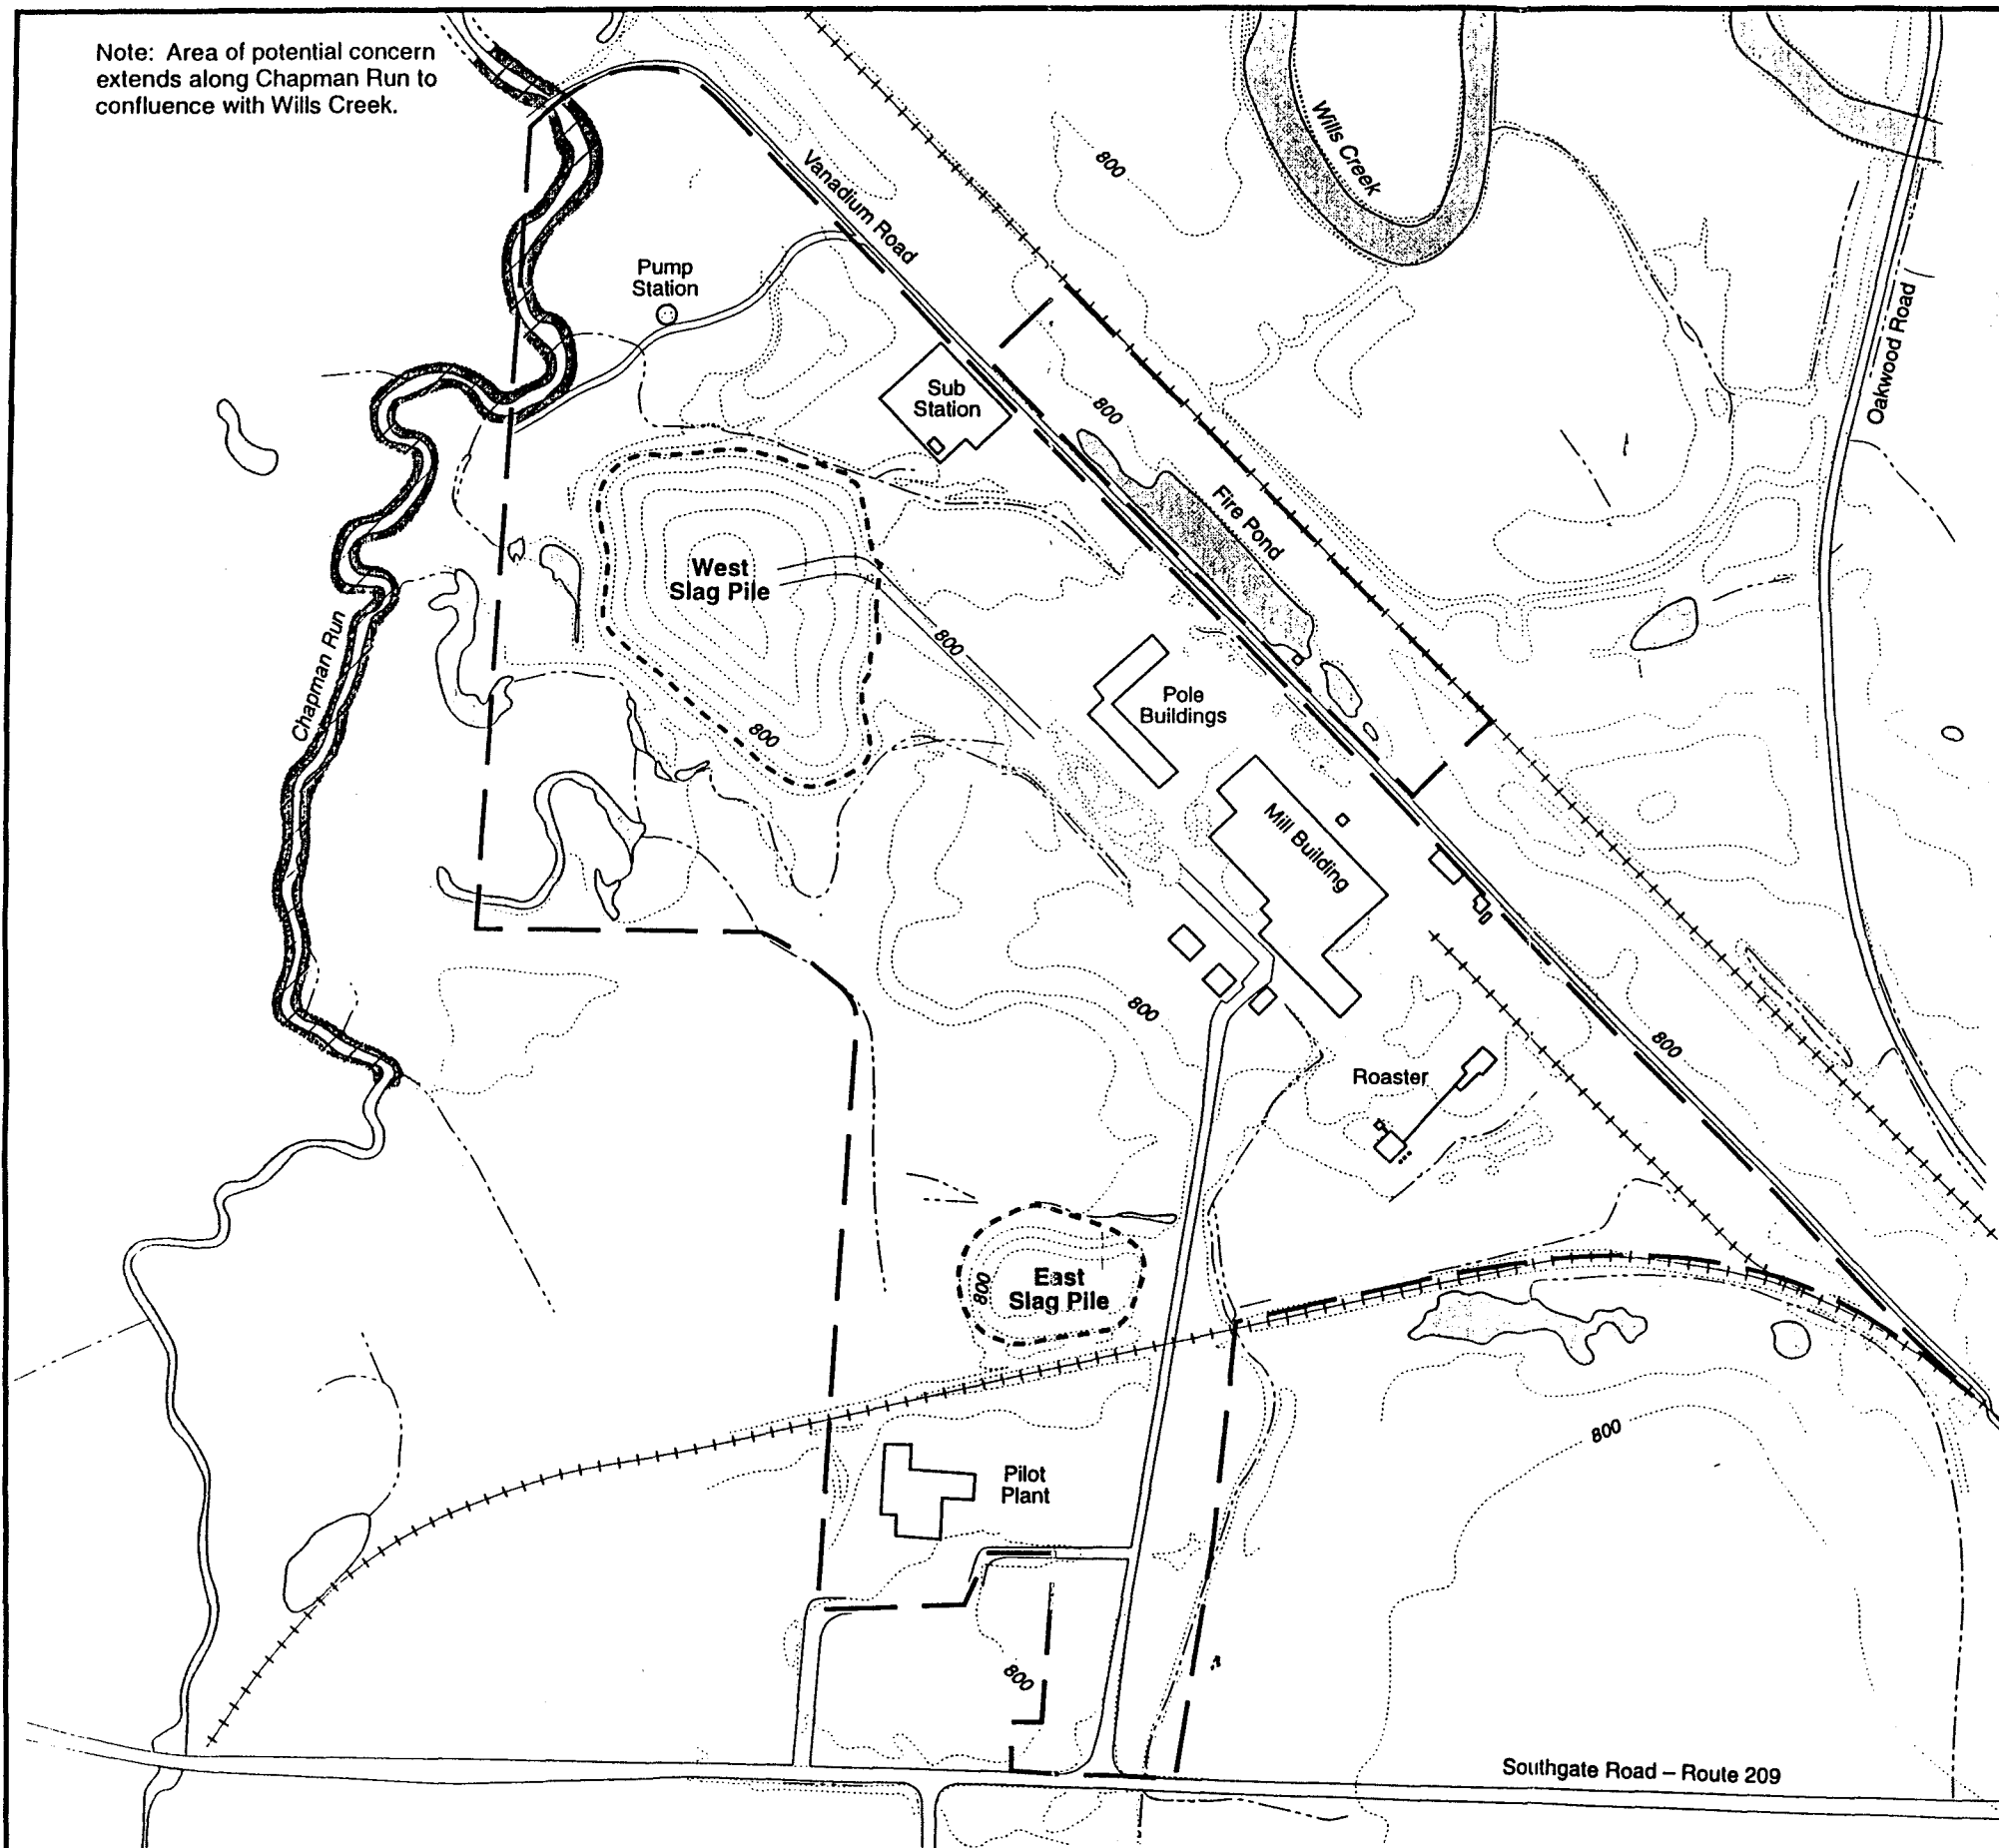
Figure 7. Preliminary area of potential concern for offsite sediment.

Note: Areas of potential concern include in-channel sediments only. These areas will be refined through further sampling in the remedial design phase in conjunction with the use of the PRG for sediments and the consideration of other factors (e.g., short term environmental effects).
